NGP ANNUAL COMPLIANCE REPORT - 2025

| Project Name | Jemena Northern Gas Pipeline |
| Approved Action | Construct and Operate a buried 622 km high-pressure gas pipeline from Tennant Creek (Northern Territory) to Mount Isa (Queensland) |

JEMENA NORTHERN GAS PIPELINE TRANSITIONAL REHABILITATION ASSESSMENT REPORT 2025

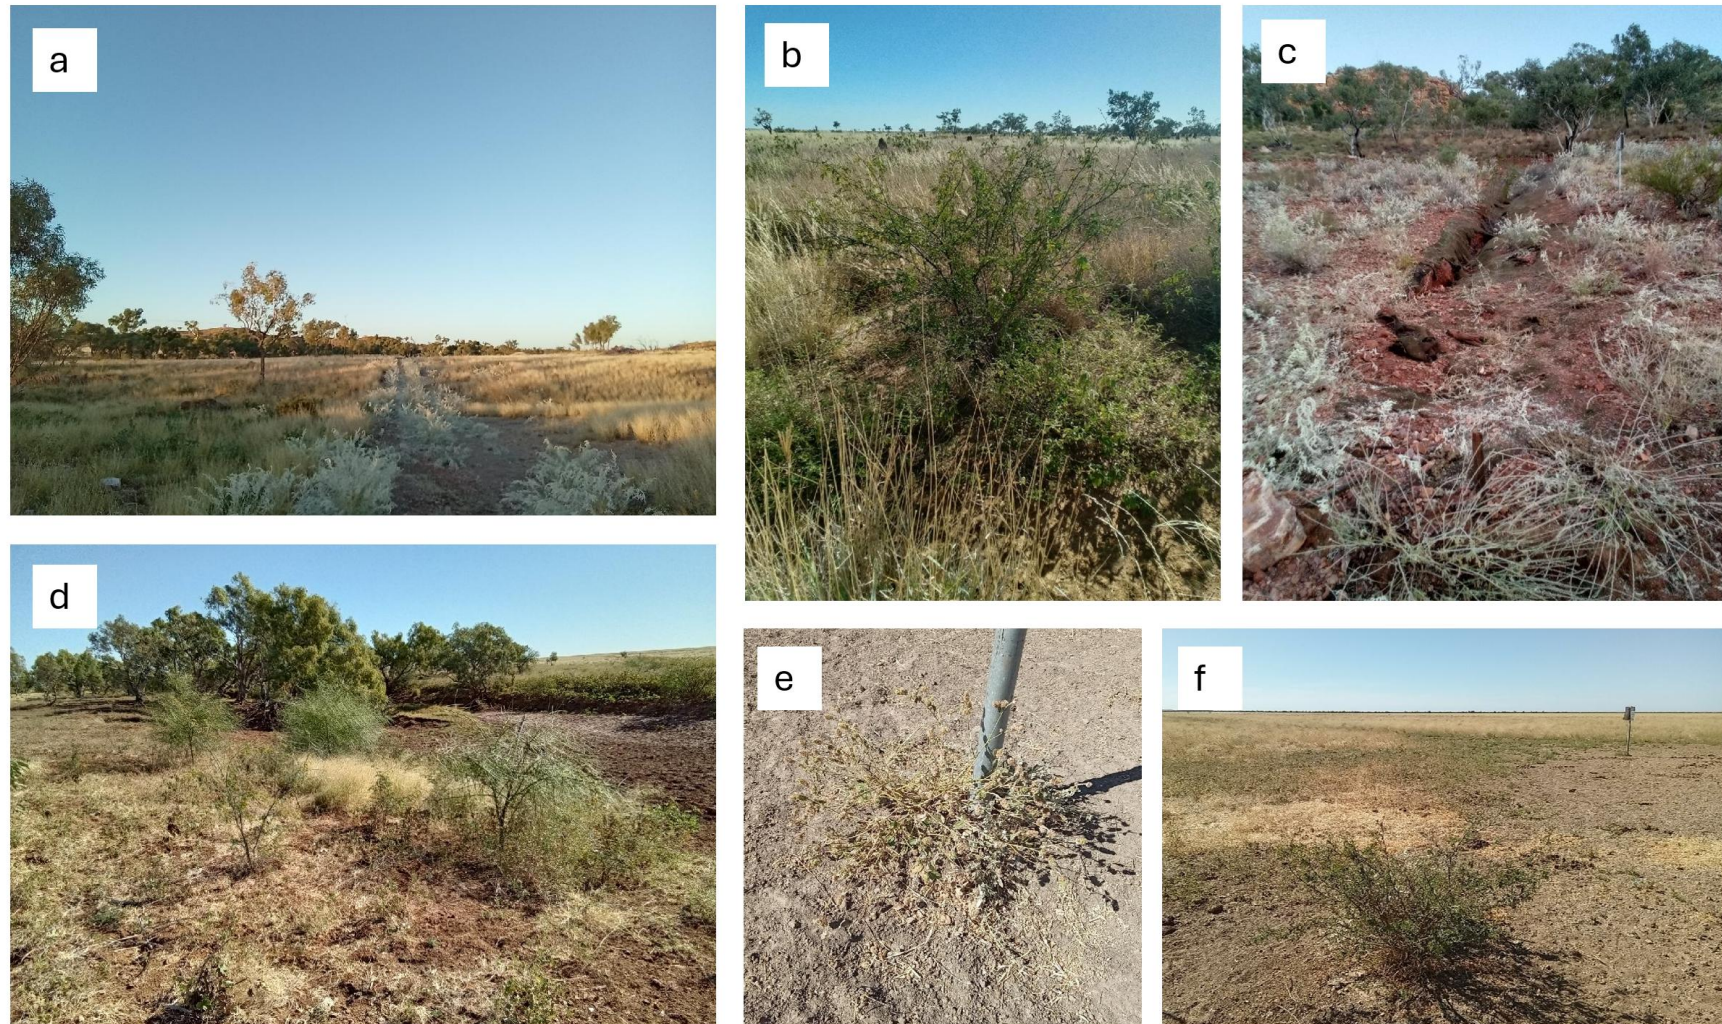
Figure 4-2. Images from the transitional rehabilitation assessment survey: a) Kapok bush along vehicle road on ROW, b) Spiky acacia, c) Kapok bush and erosion d) Mesquite e) Noogoora burr at base of infrastructure, likely from cattle scratching, f) multiple weed species including malvastrum, Noogoora burr and spiky acacia

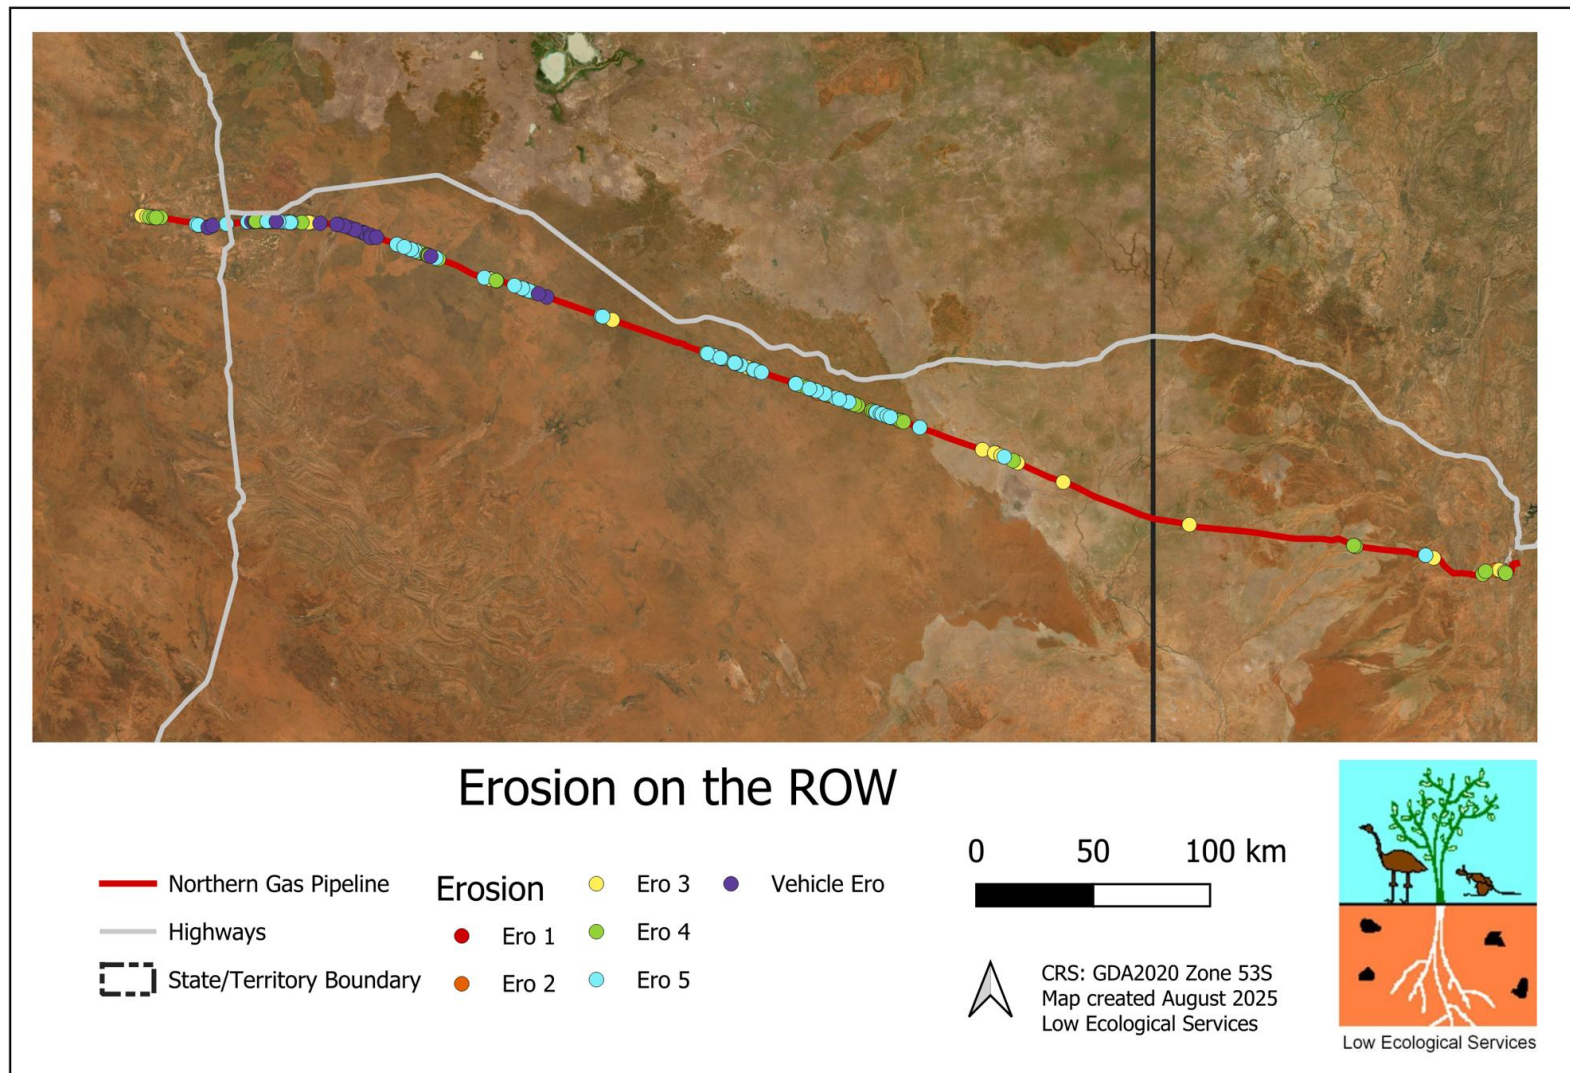
Figure 4-3. Locations of erosion observed on the NGP ROW in 2025.

The overall level of erosion over the extent of the ROW observed in the 2025 survey was low. Erosion was recorded at numerous locations along the easement; however, approximately 60% of these instances were classified as minor, and only 5% were considered moderate to severe. In areas of berm removal, sheet erosion had increased. Remediation work has decreased erosion along the length of the pipeline easement since it was last surveyed in 2024.

As noted in previous surveys (LES 2023, LES 2024), the majority of erosion was confined to the access track within the ROW, where limited vegetation cover increased susceptibility to erosion. The most common form of erosion was sheet erosion. Significant portions of the ROW had high coverage of vegetation making it difficult to accurately assess those areas for erosion, this may have led to underreporting.

Similar to the 2024 transitional rehabilitation assessment, high vegetation cover across significant portions of the ROW made accurate erosion assessment difficult in those areas. As a result, the extent of erosion may be underreported.

As a priority, it is recommended that all severe to moderate erosion should be remediated by constructing multiple series of shallow berms and back-filling and leveling where appropriate.

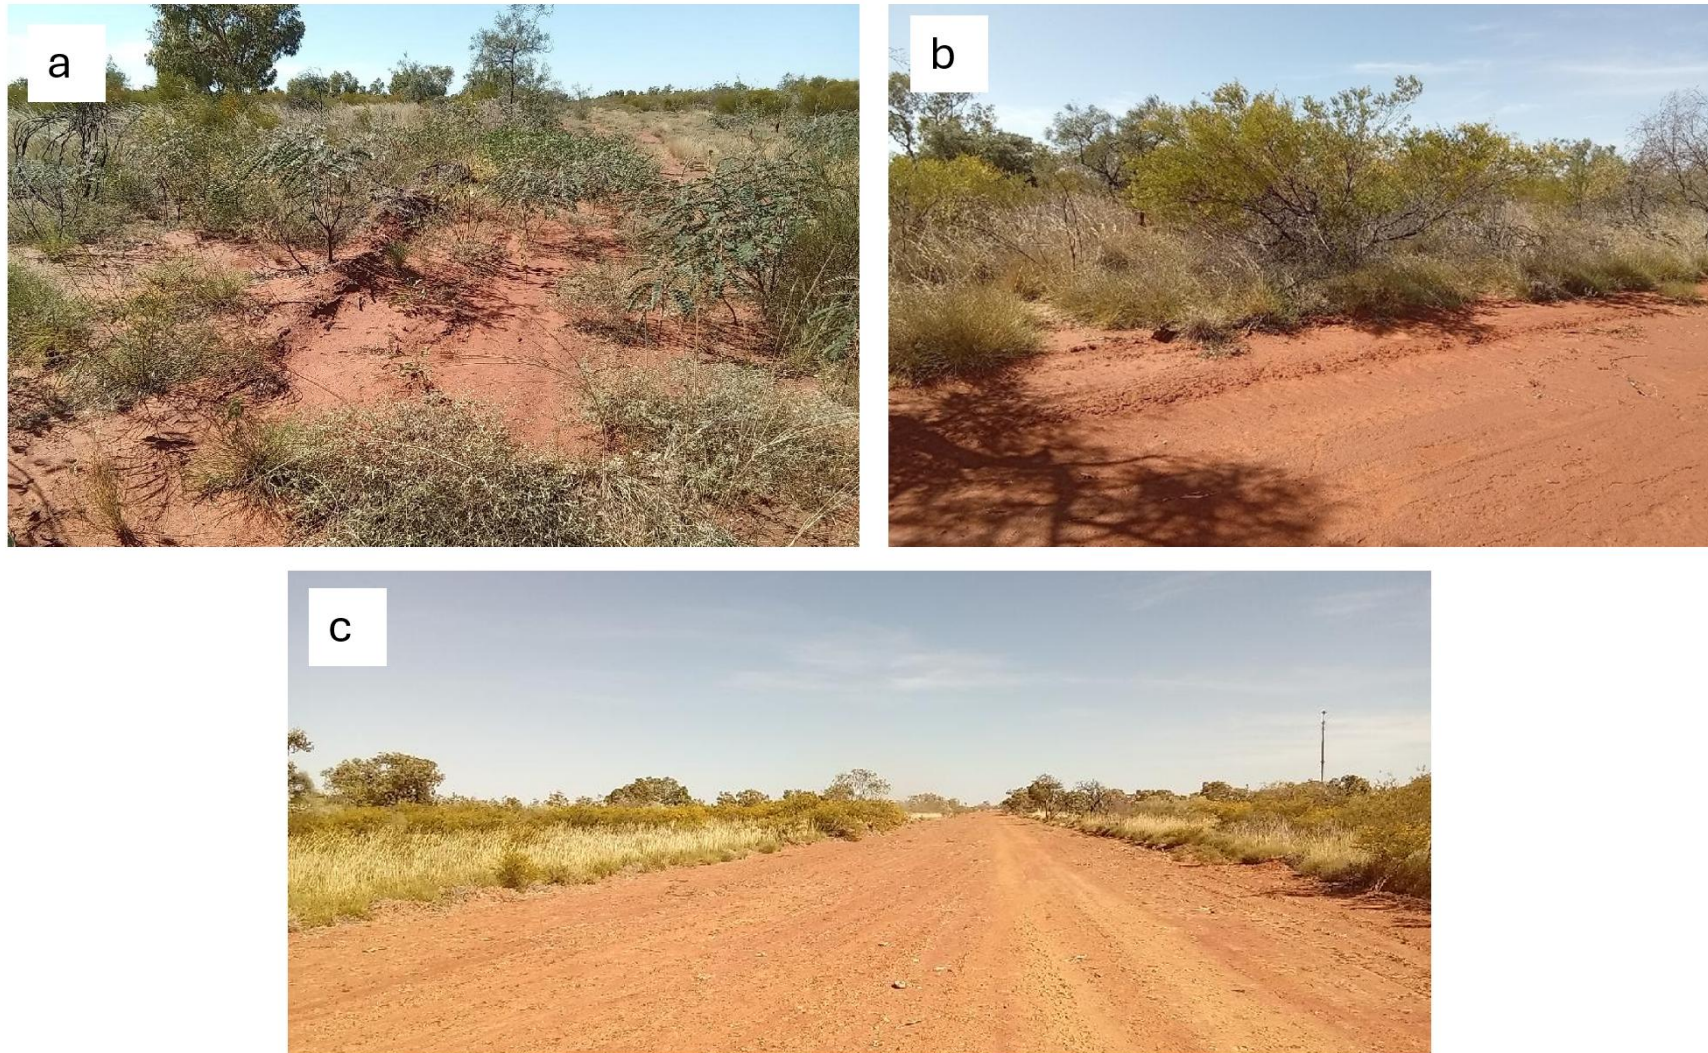
Figure 4-4. Images from the transitional rehabilitation assessment survey: a) Windrow that needs to be brought in, b) grading creating height difference c) overgraded section with berms removed, windrows built up and sheet erosion (level 5).

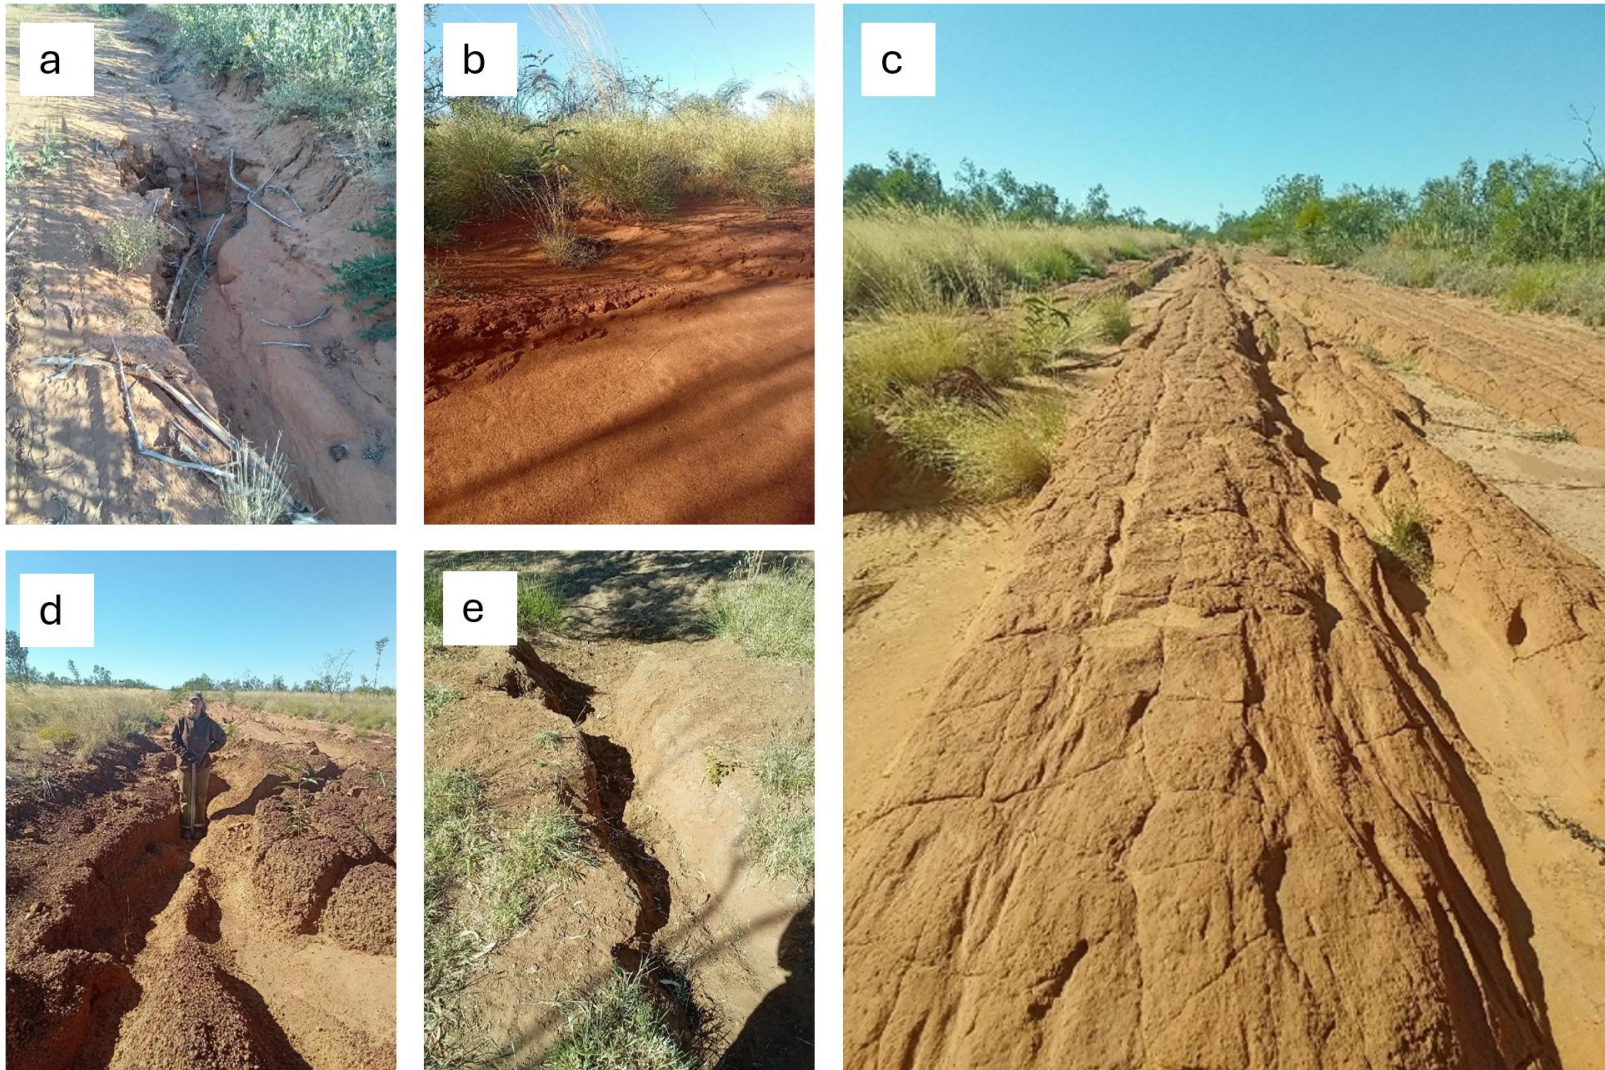
Figure 4-5. Images from the transitional rehabilitation assessment survey: a) erosion at a creek crossing, b) level 4 erosion, c) level 3 erosion, d) level 1 erosion, e) level 2 erosion.

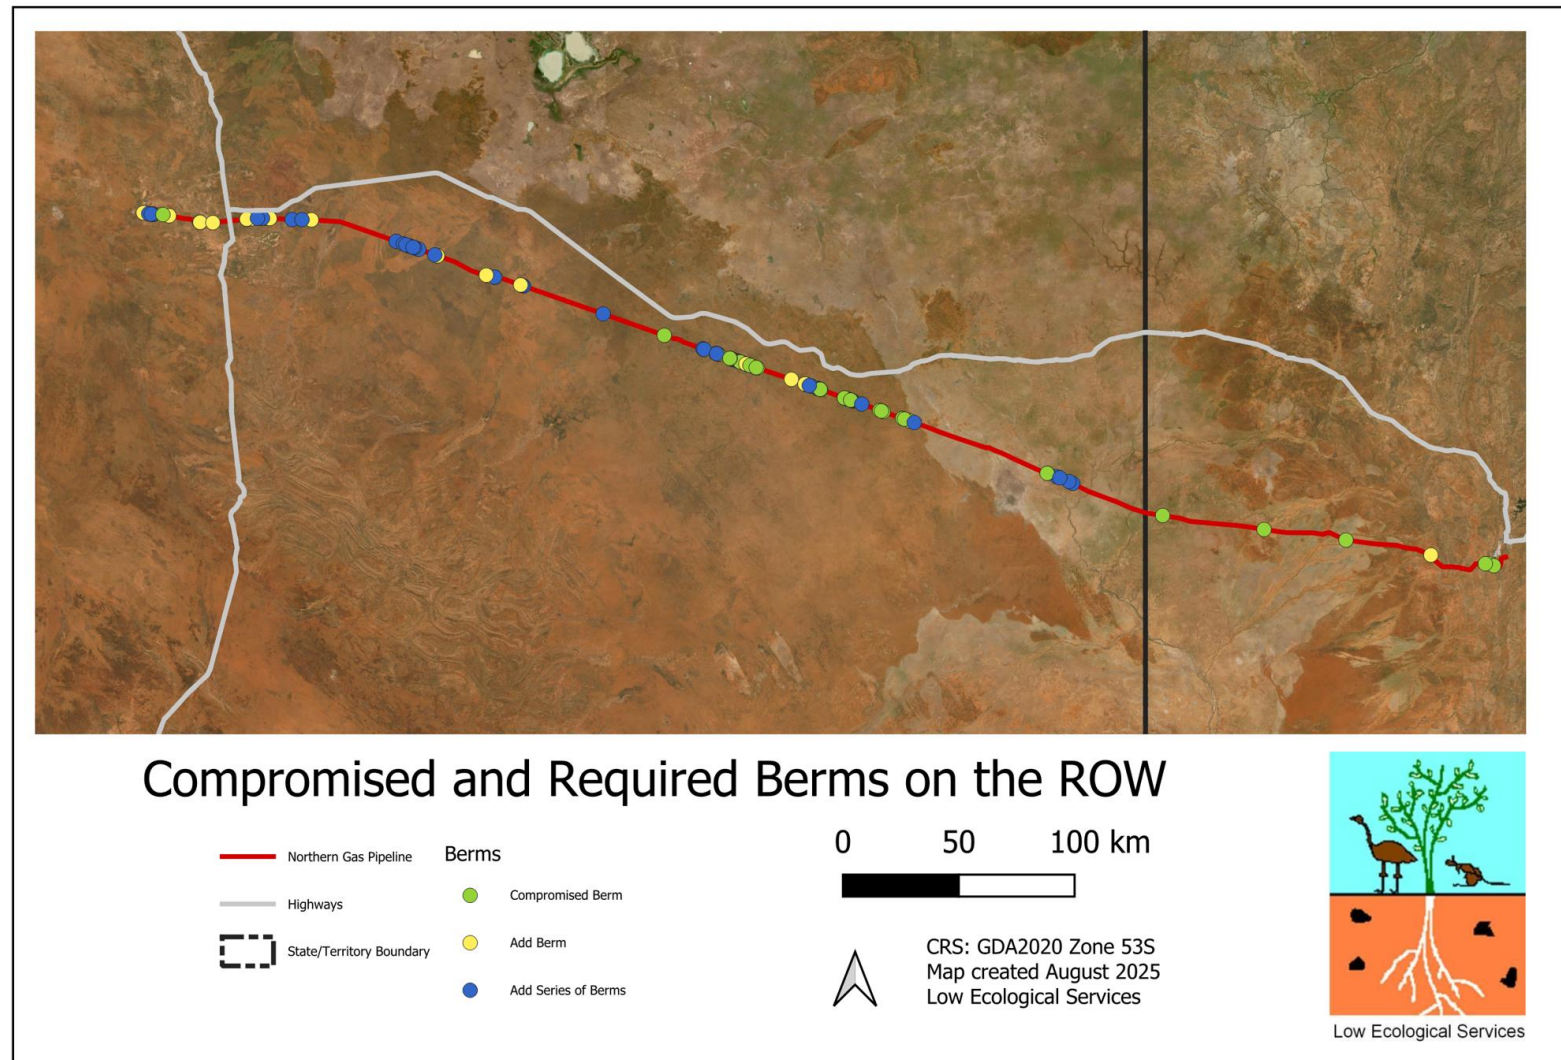
Figure 4-6. Locations of compromised berms observed on the NGP ROW in 2025.

Of the berms that remain, 42 berms are compromised. Damage was most often due to water erosion resulting in erosion channels through the berms or the berms being washed out. There were several occurrences of water flowing around the ends of berms and back onto the ROW rather than diverting outwards into adjacent land. This was often due to berms not extending far enough at the edges of the ROW. Cattle tracking has also caused erosion of berms in some instances, as well as vehicle activity along the access track of the ROW.

Several of the berms on the ROW were not appropriate in height and width. Rather than one tall narrow berm, which can impede vehicle and machinery movement, series of wide, shallow berms would be most effective.

All compromised berms should be repaired or reinstated promptly. Locations of observed compromised berms along the NGP ROW and proposed berm locations are presented in Figure . Refer to Appendix A for locations and recommendations regarding compromised berms and additional berms.

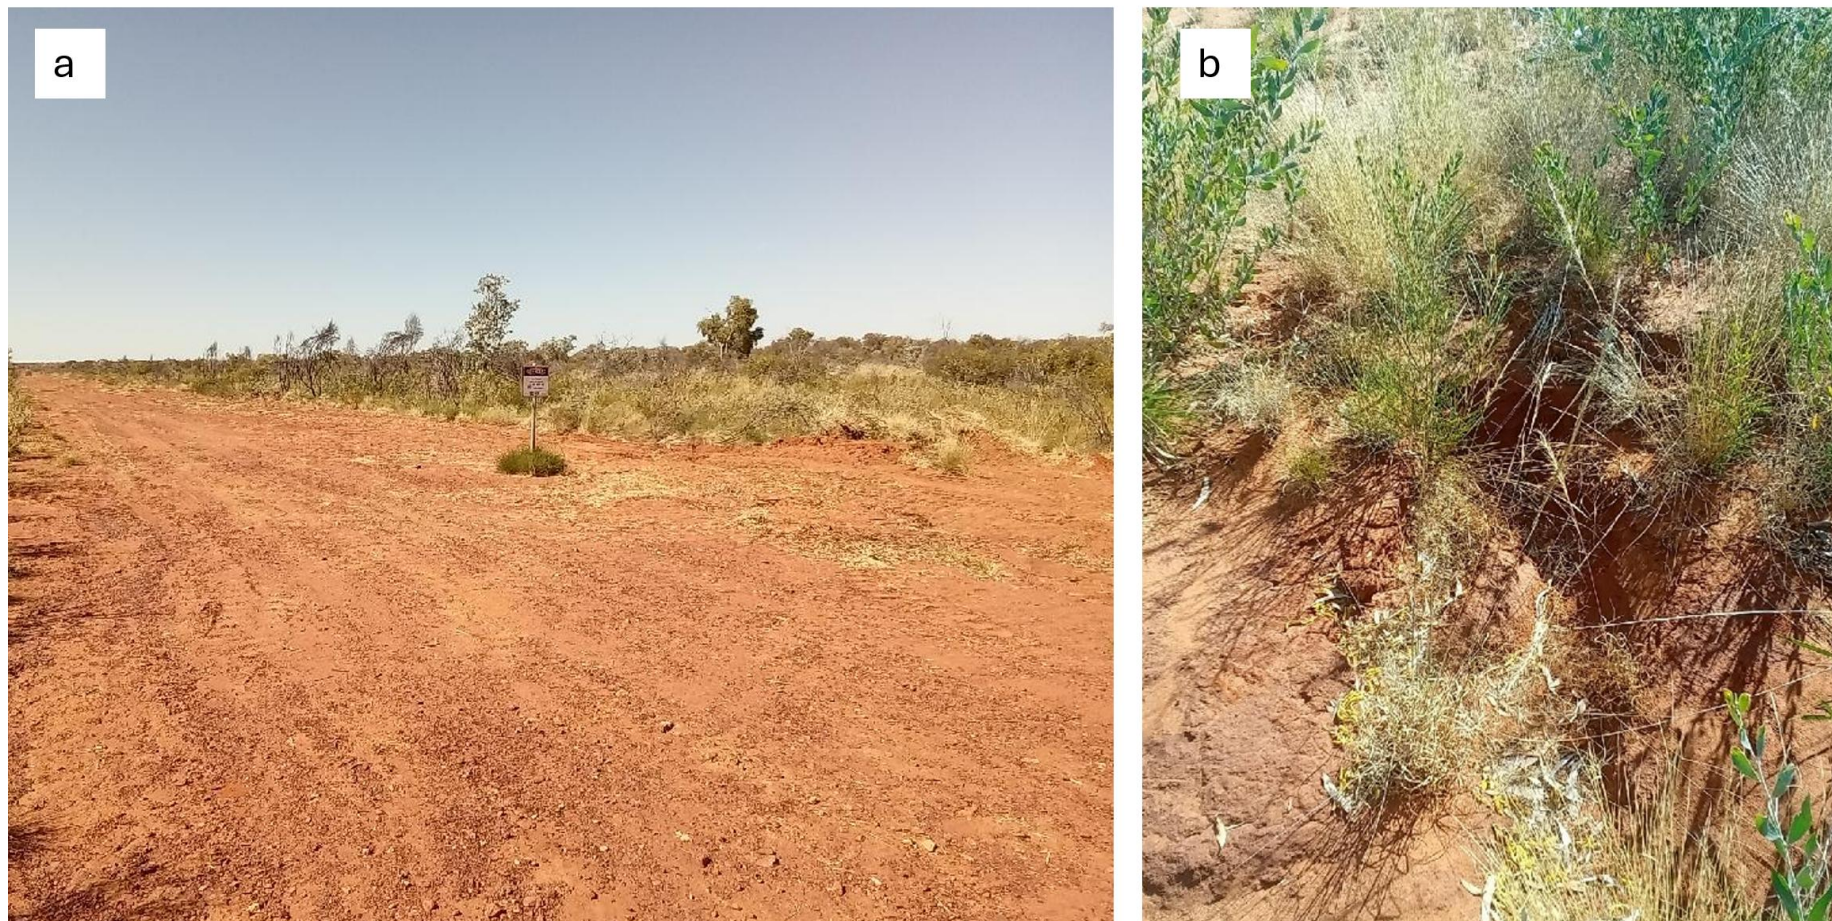
Figure 4-7. Images from the transitional rehabilitation assessment survey: a) berm has been removed in recent grading works b) compromised berm.

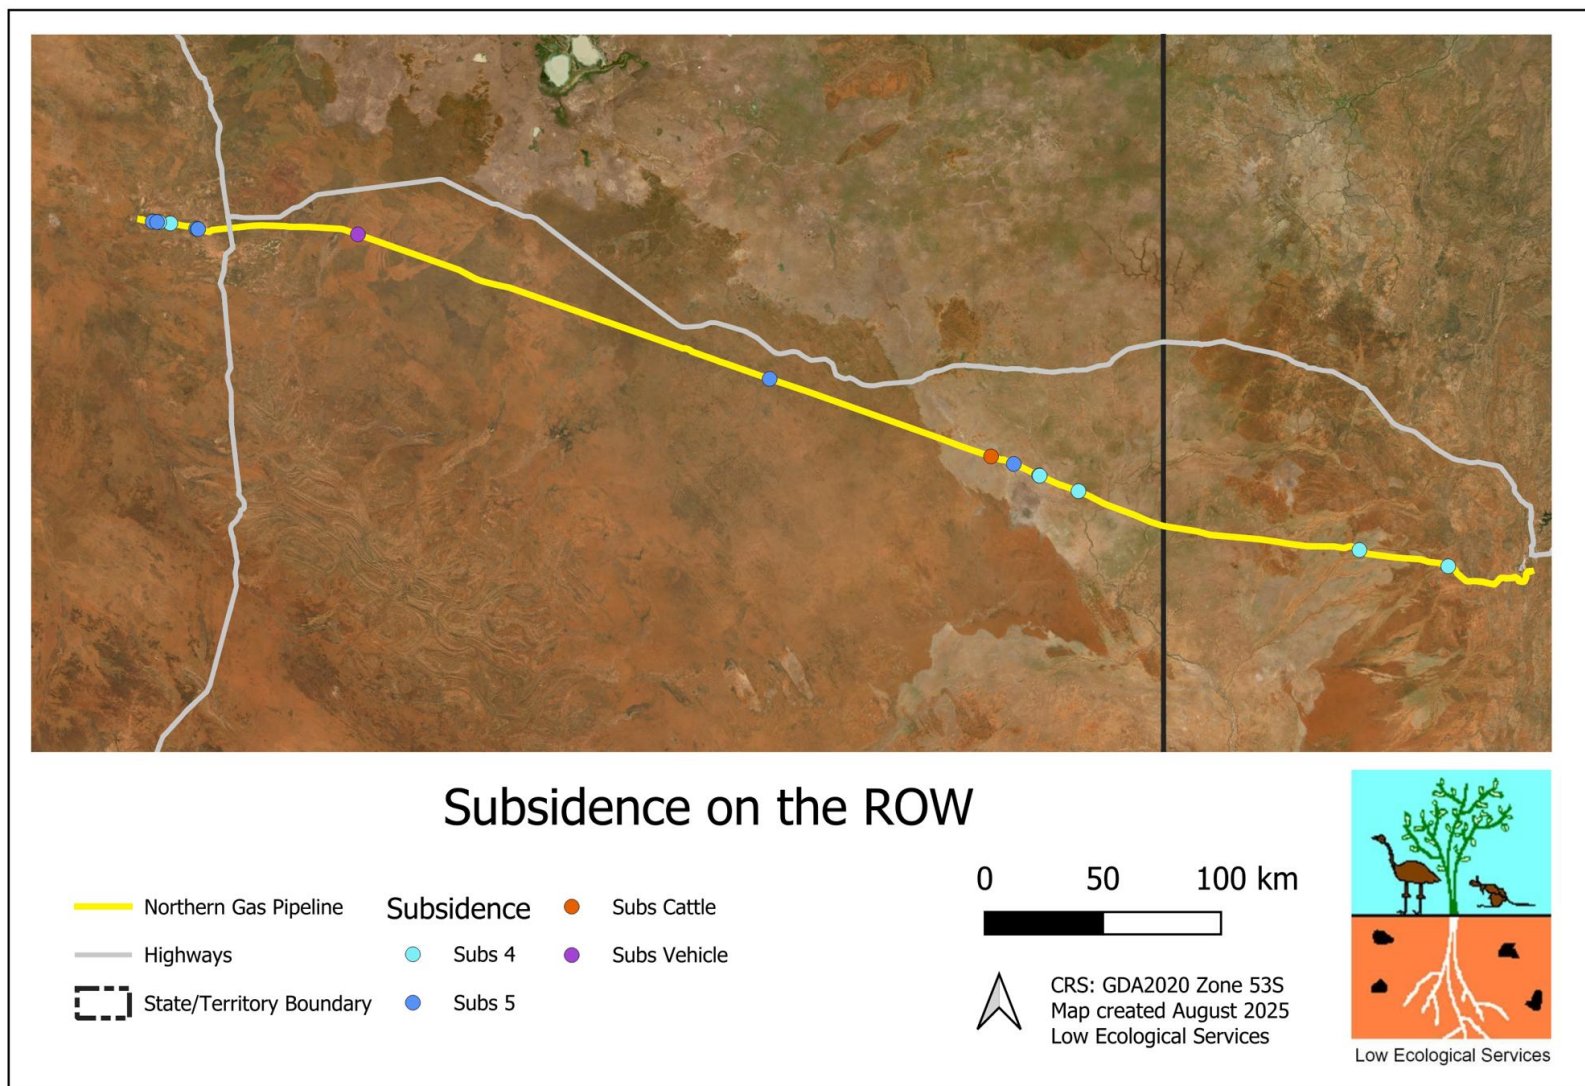
Figure 4-8. Locations of observed subsidence along the NGP ROW in 2025.

Subsidence issues were recorded at several locations on the ROW. The majority of subsidence issues observed were associated with water channelling and erosion across the pipeline or along the pipeline trench, with several locations attributed to cattle and vehicle tracks. Filling in of subsidence is recommended in all instances of significant, significant/moderate and moderate subsidence issues, some of those will require erosion control berms with monitoring recommended for minor subsidence issues.

There were few instances of significant or moderate subsidence, most of which occurred in the Barkly Tablelands. It is recommended that all significant or moderate subsidence areas be remediated through filling, while minor subsidence should be monitored over time.

Locations of observed subsidence along the NGP ROW are presented in Figure . Refer to Appendix A for locations and recommended actions.

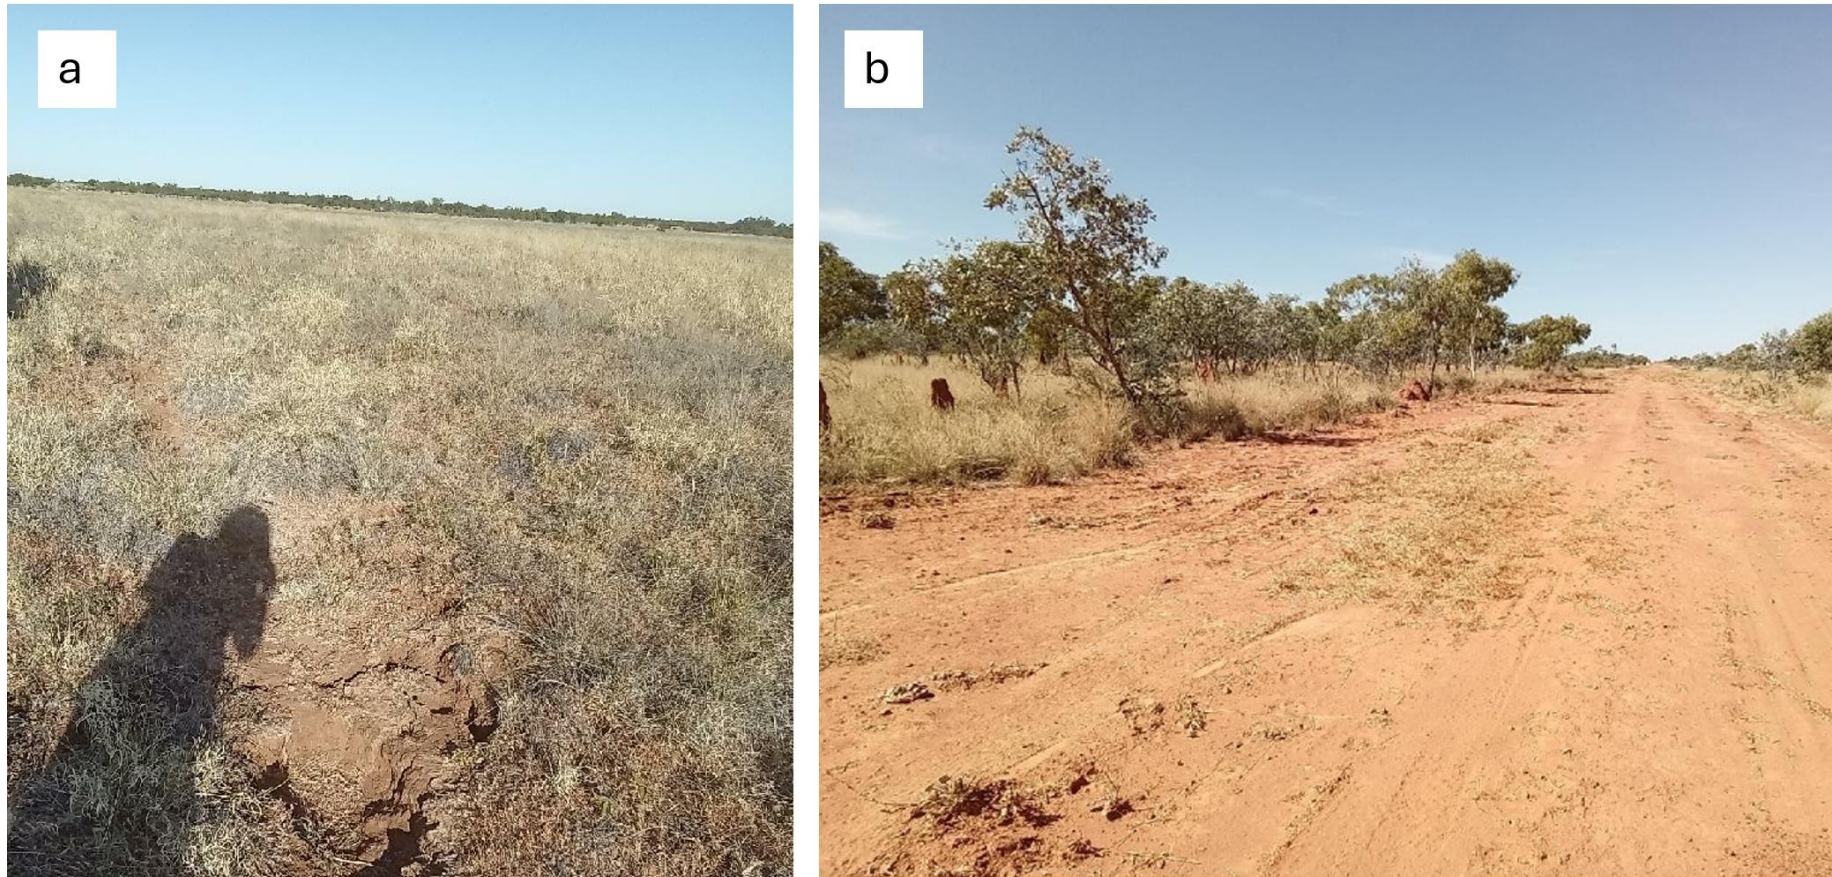
Figure 4-9. Images from the transitional rehabilitation assessment survey: a) level 2 subsidence, b) level 4 subsidence.

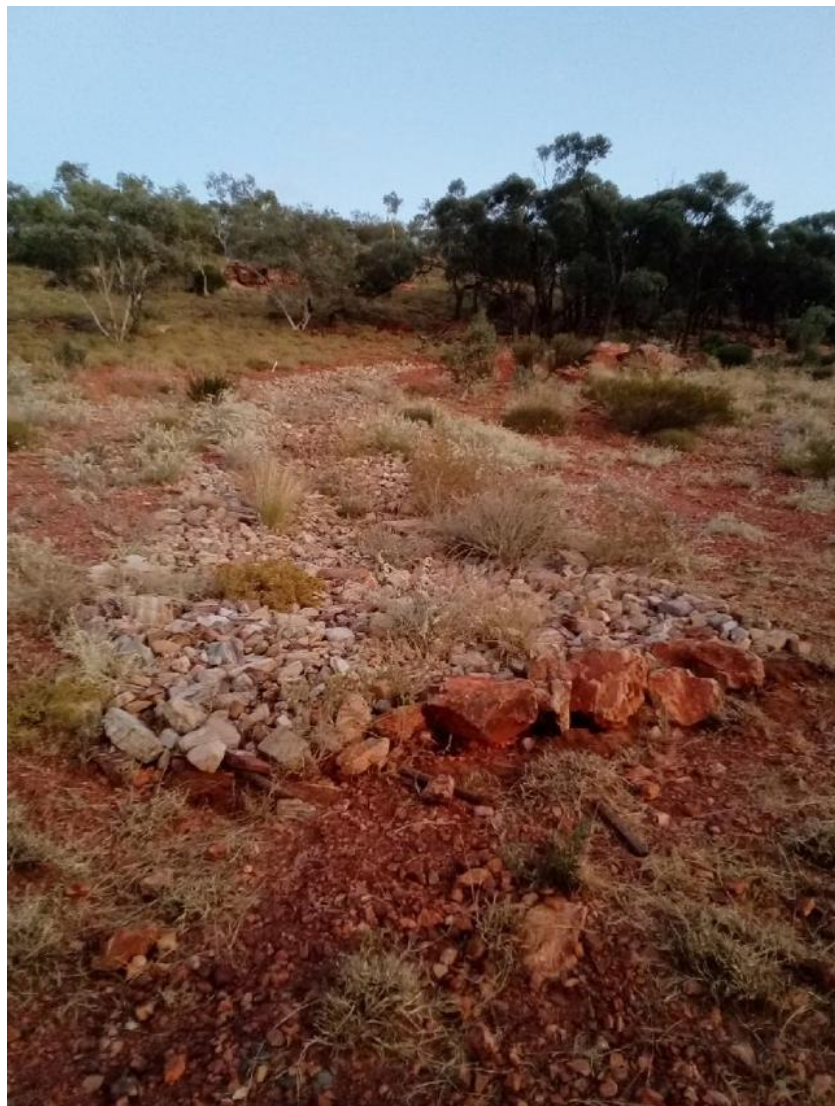
Figure 4-10. Image from the transitional rehabilitation assessment survey: remediated erosion.

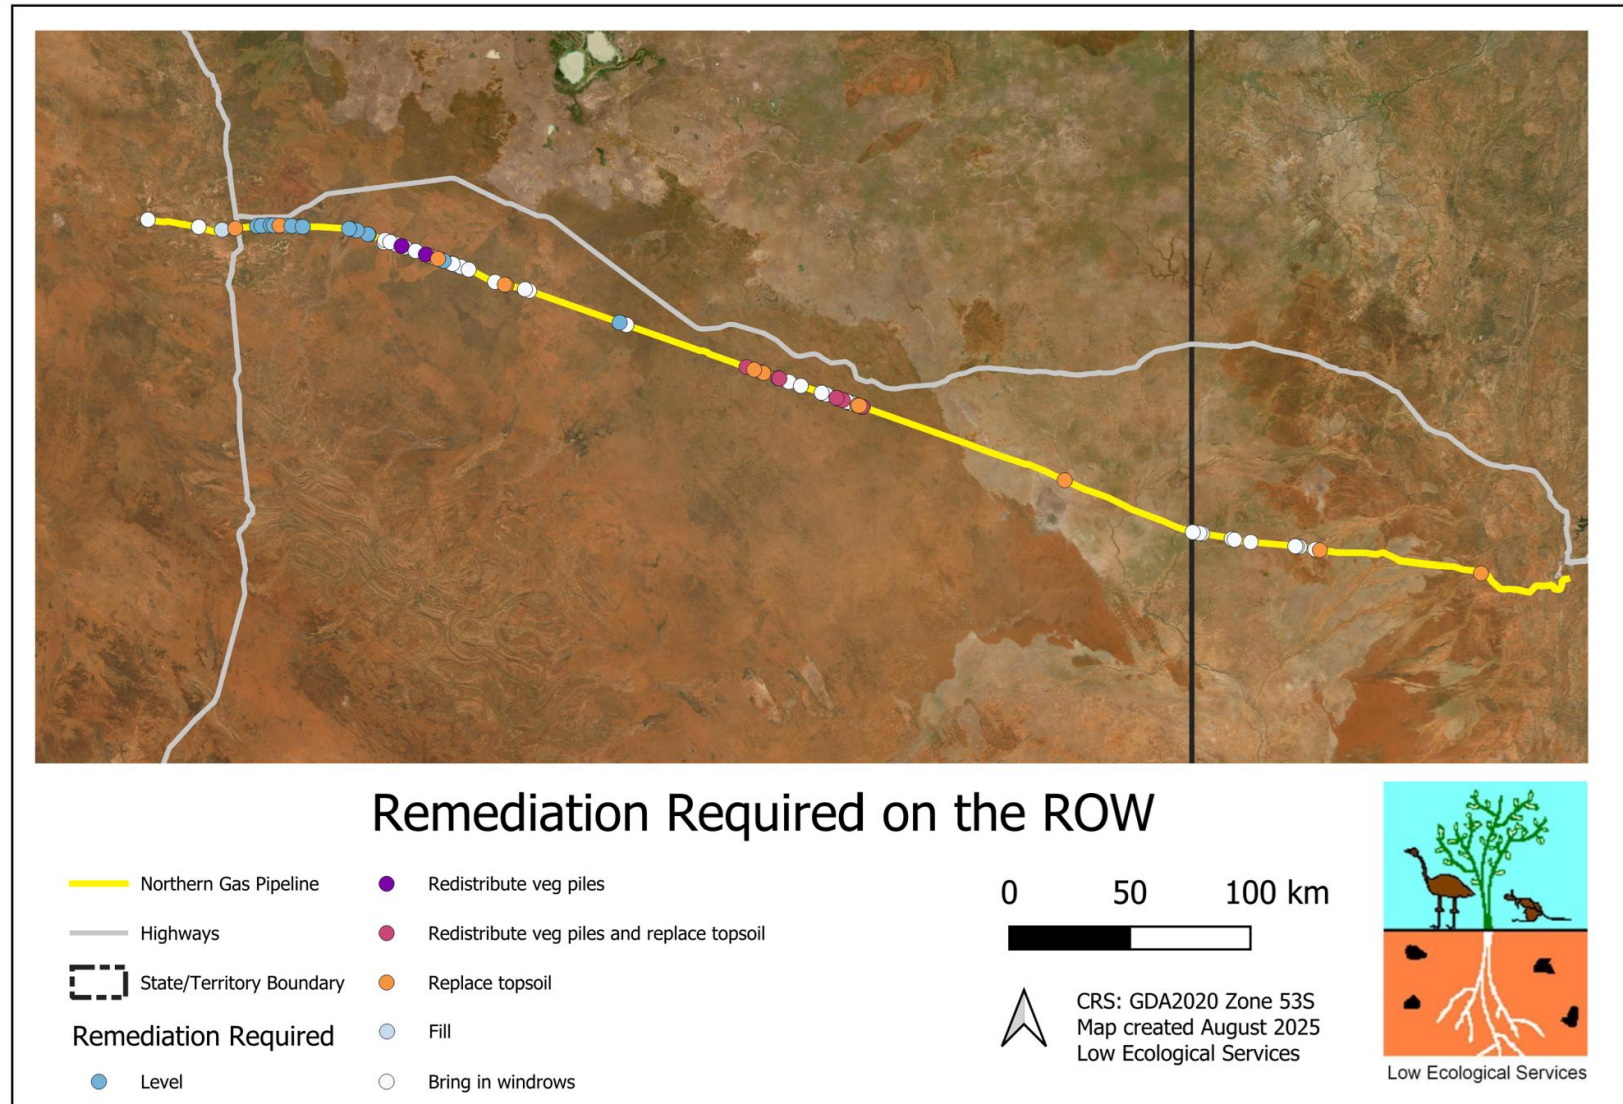
Figure 4-11. Location of additional remediation works required on the ROW.

However, as discussed above, some of the remediation work on the ROW has created new issues that now require further attention. In particular, grading has resulted in the formation of windrows, the removal of berms, and the accumulation of soil and plant material piles on the side of the ROW that need to be redistributed. In some locations, valuable topsoil has been pushed off the ROW, which is impeding revegetation. Locations of works required are shown in Figure

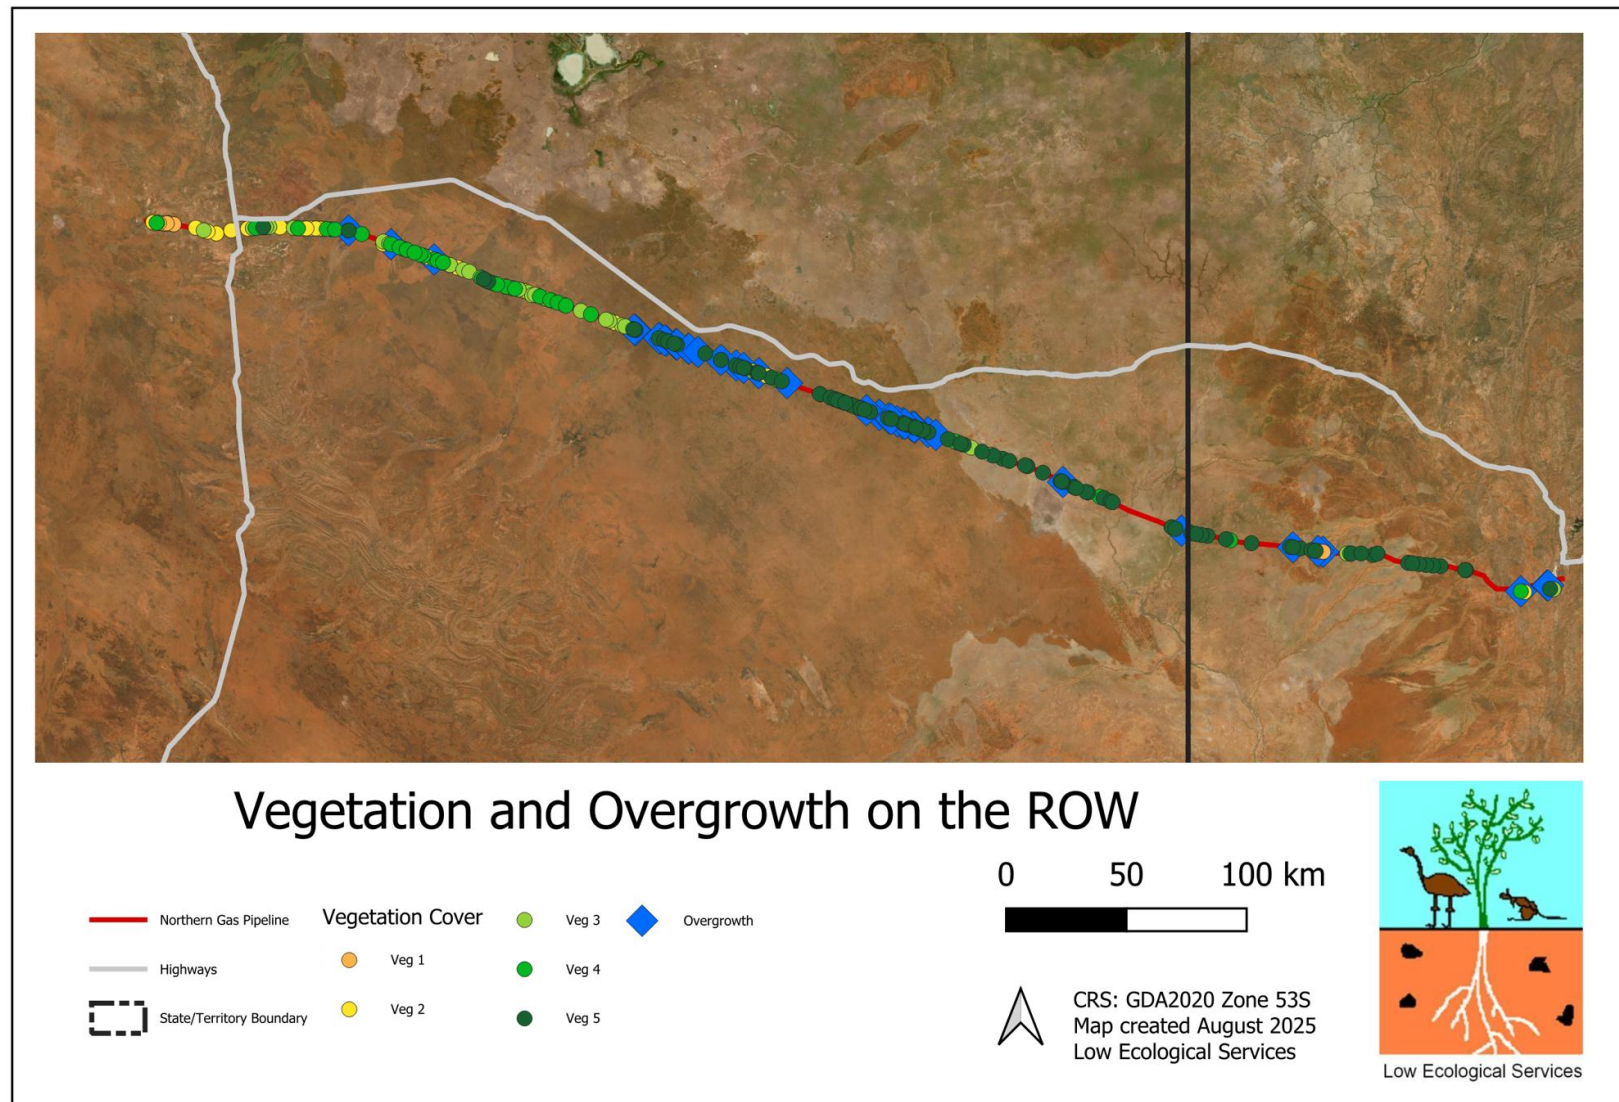
Figure 4-12. Overgrowth along the NGP ROW observed in 2025.

There was less overgrowth observed in 2025 compared to 2024 as additional sections of the pipeline clearing had been undertaken. Vegetation and topsoil cleared off the ROW has been pushed off to the side in piles. The piles contain high nutrient soil as well as seed bank for grasses, both of which will encourage rapid rehabilitation. It is recommended that these piles be redistributed along areas of the pipeline which require fill material or used to construct shallow bunds, with precautions for fauna safety that may have taken up residence in these piles. Regular ongoing maintenance to prevent an overstorey re-establishing along the ROW in the future will be required.

Regular maintenance, including slashing and overstorey suppression, will be necessary to prevent future re-establishment. Continued removal of overstorey vegetation is essential for pipeline integrity, access, and safety. Clearing activities should also be used to address land stability issues and to install or repair berms and other erosion control structures where needed.

The continued removal of the overstorey vegetation overgrowth on the pipeline easement remains a priority. During the clearing process, land stability issues can be rectified, and soil stabilisation and berms can be repaired and added where appropriate.

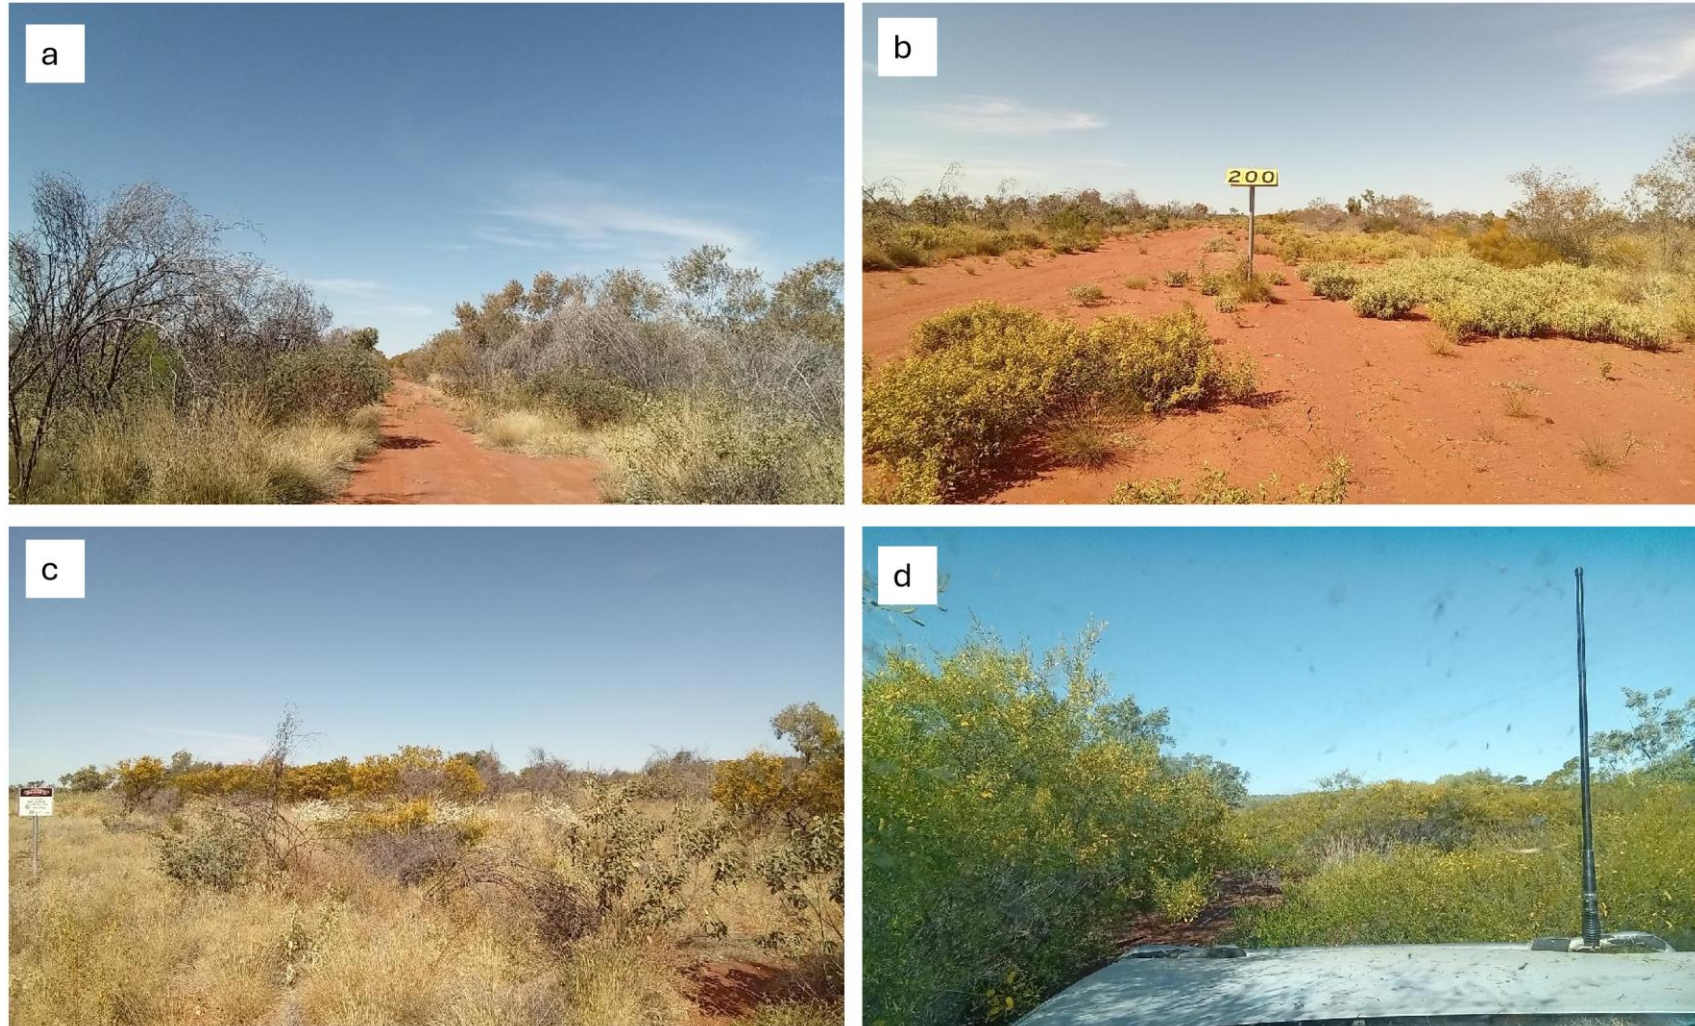
Figure 4-13. Images from the transitional rehabilitation assessment survey: a) level 5 vegetation, shrubs require clearing, landholder maintains road clear as effective fire break, b) level 2 vegetation, lack of topsoil impeding revegetation, c) and d) level 5 vegetation, shrubs require removal.
