NGP ANNUAL COMPLIANCE REPORT - 2025

| Project Name | Jemena Northern Gas Pipeline |
| Approved Action | Construct and Operate a buried 622 km high-pressure gas pipeline from Tennant Creek (Northern Territory) to Mount Isa (Queensland) |

JEMENA NORTHERN GAS PIPELINE TRANSITIONAL REHABILITATION ASSESSMENT REPORT 2025

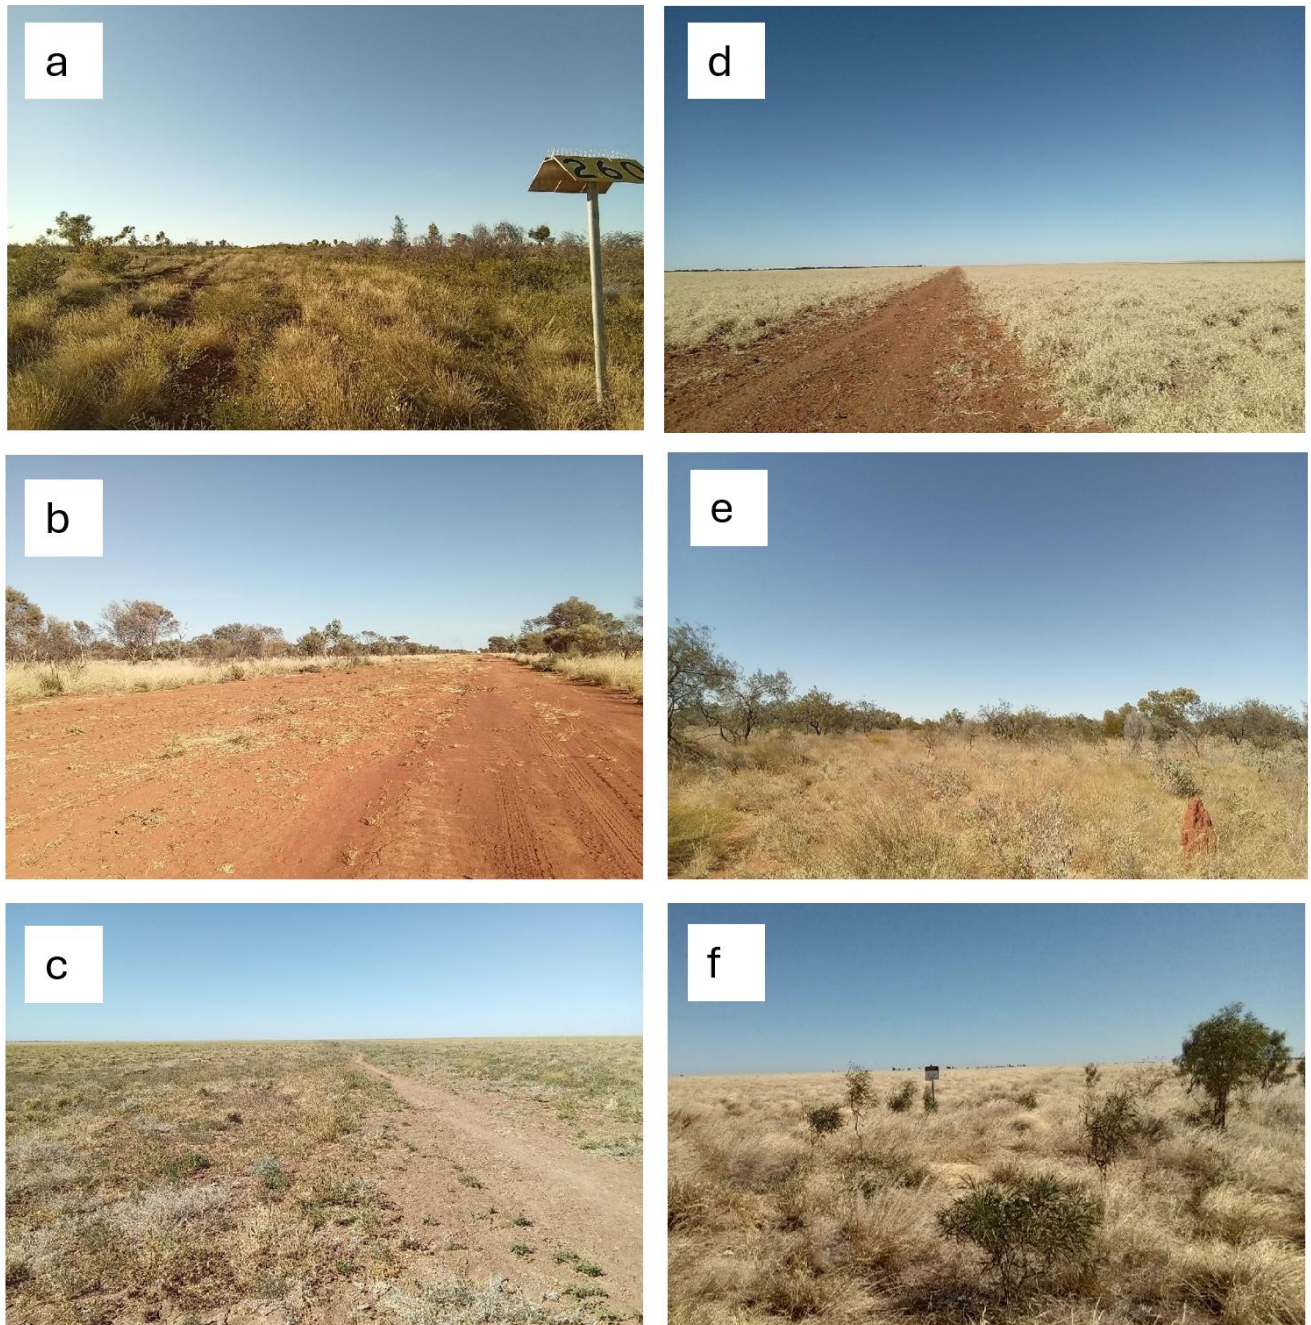
Figure 4-14. Images from the transitional rehabilitation assessment survey: a) level 5 vegetation with no shrubs, b) level 1 vegetation caused by grading, c) cattle tracks through vegetation, d) level 5 vegetation in comparison to surrounds, e) level 5 vegetation with some shrubs that will require clearing, f) level 5 vegetation with whitewood in easement, high priority to clear as growing over pipeline.

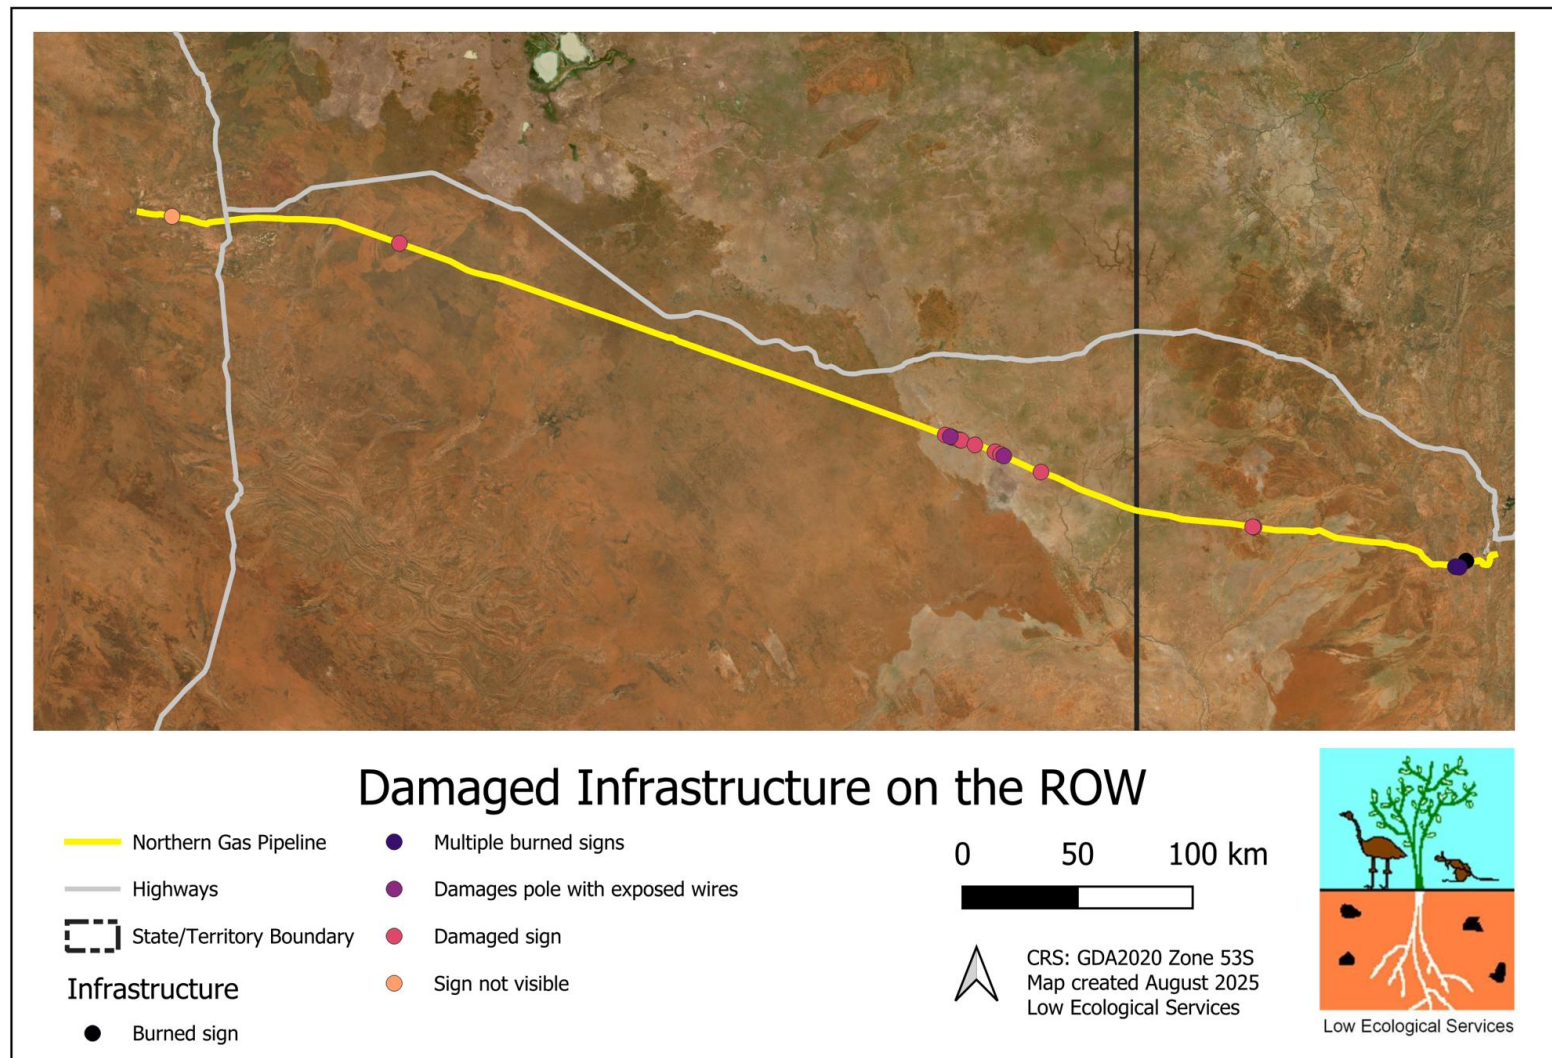
Figure 4-15. Locations of damaged infrastructure observed on the ROW in 2025.

Locations of damaged infrastructure are shown in Figure and a summary of infrastructure issues are included in Appendix A.

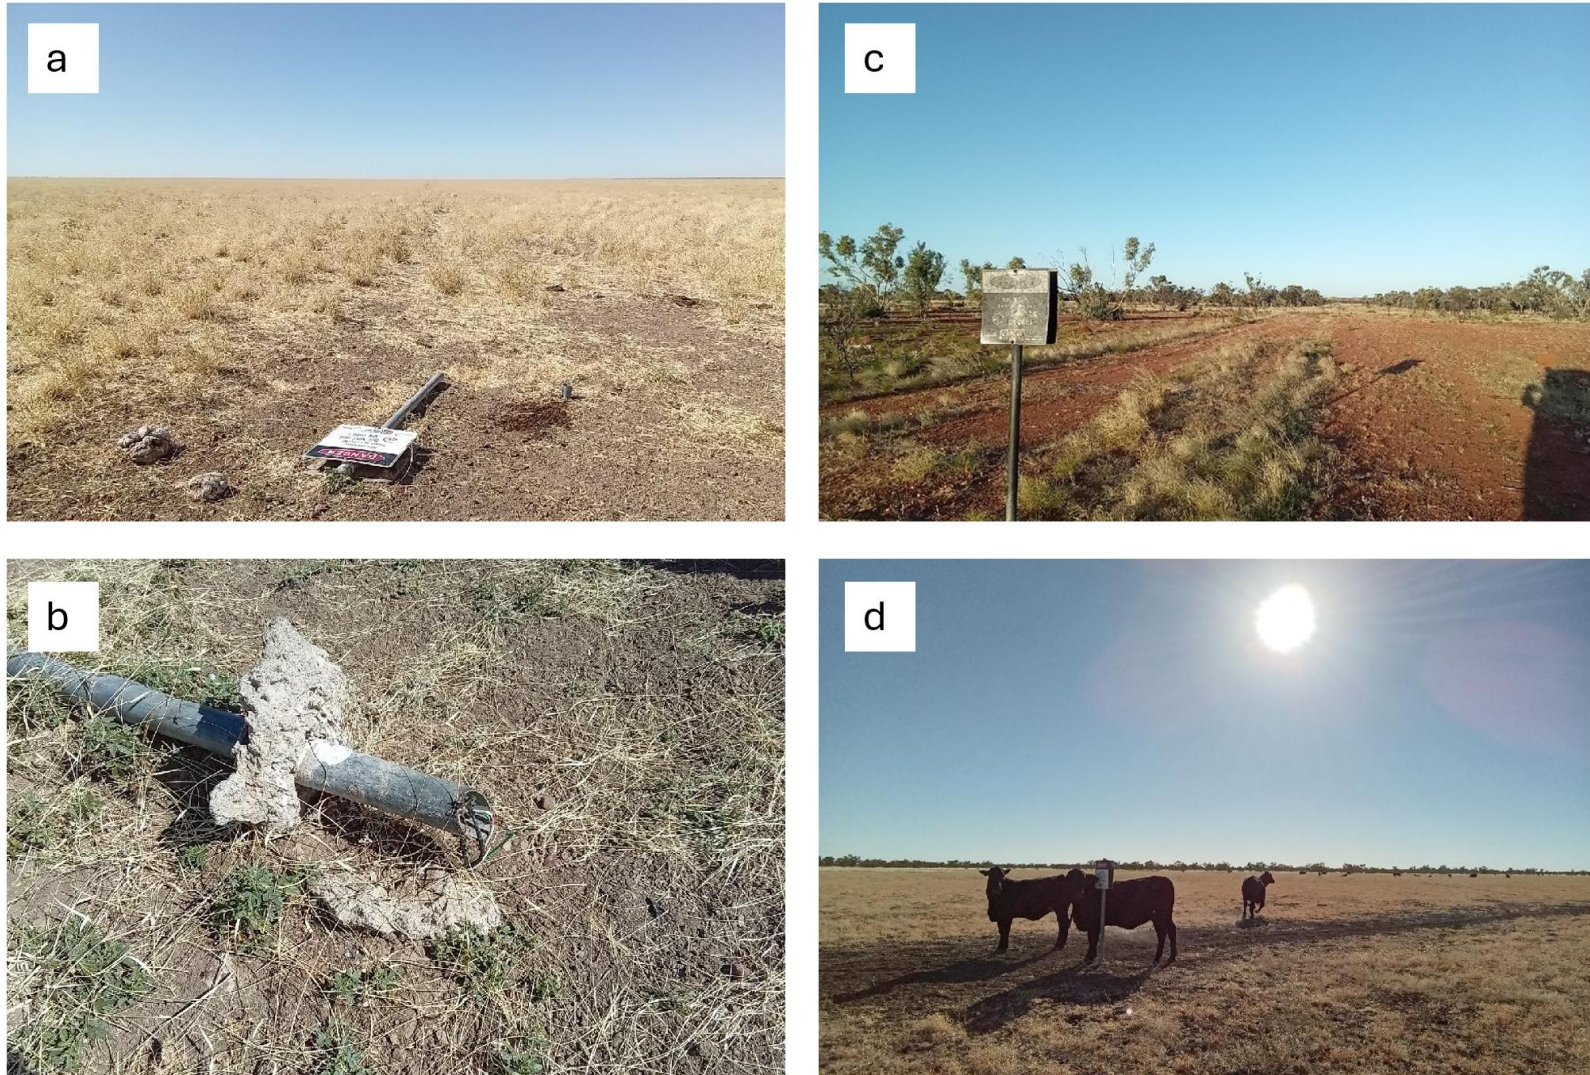
Figure 4-16. Images from the transitional rehabilitation assessment survey: a) fallen sign, b) damaged pole with exposed wires, c) burned sign, d) cattle using sign as scratching post.

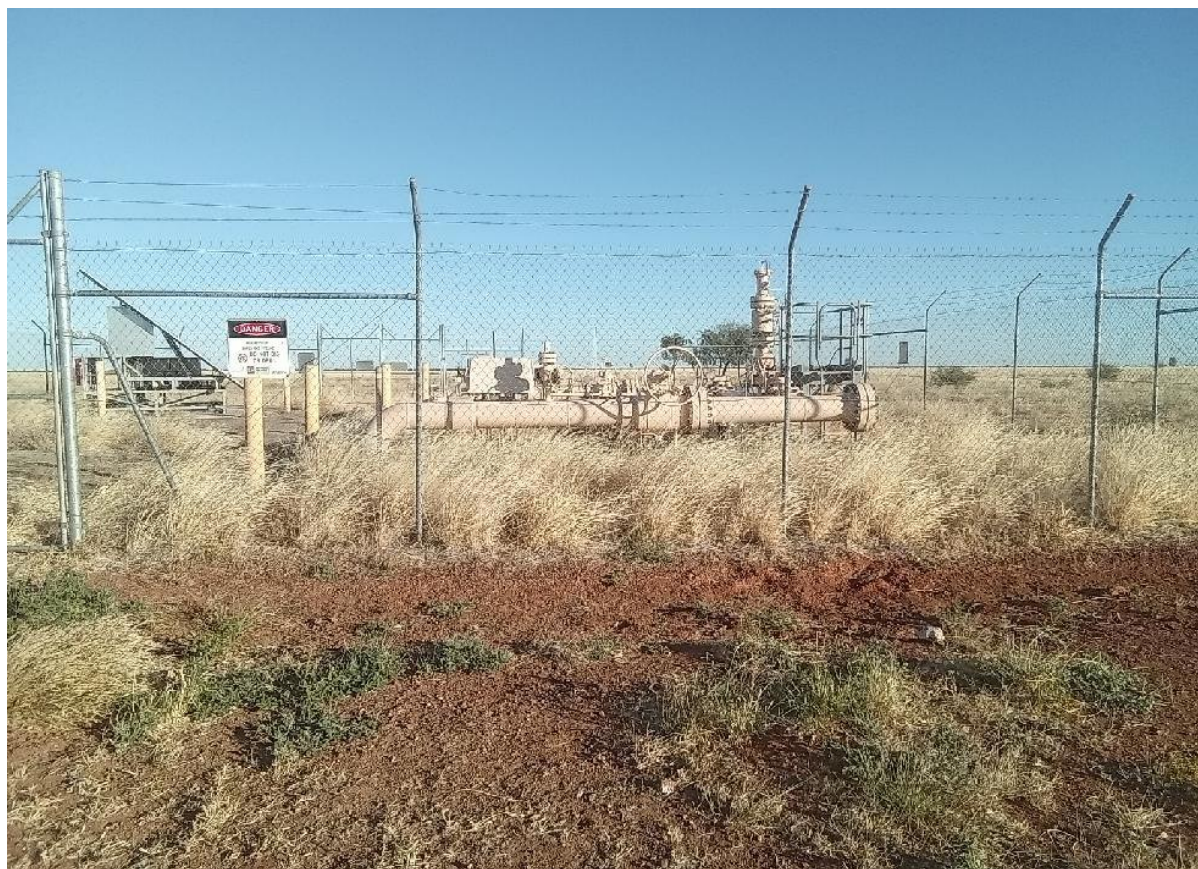
There was dense vegetation inside the fencing at Main Line Valve 3. This was reported to Jemena field staff at the completion of the field assessment (Figure 4-17).

Figure 4-17. Vegetation posing a potential fire risk inside the fencing at Main Line Valve 3.

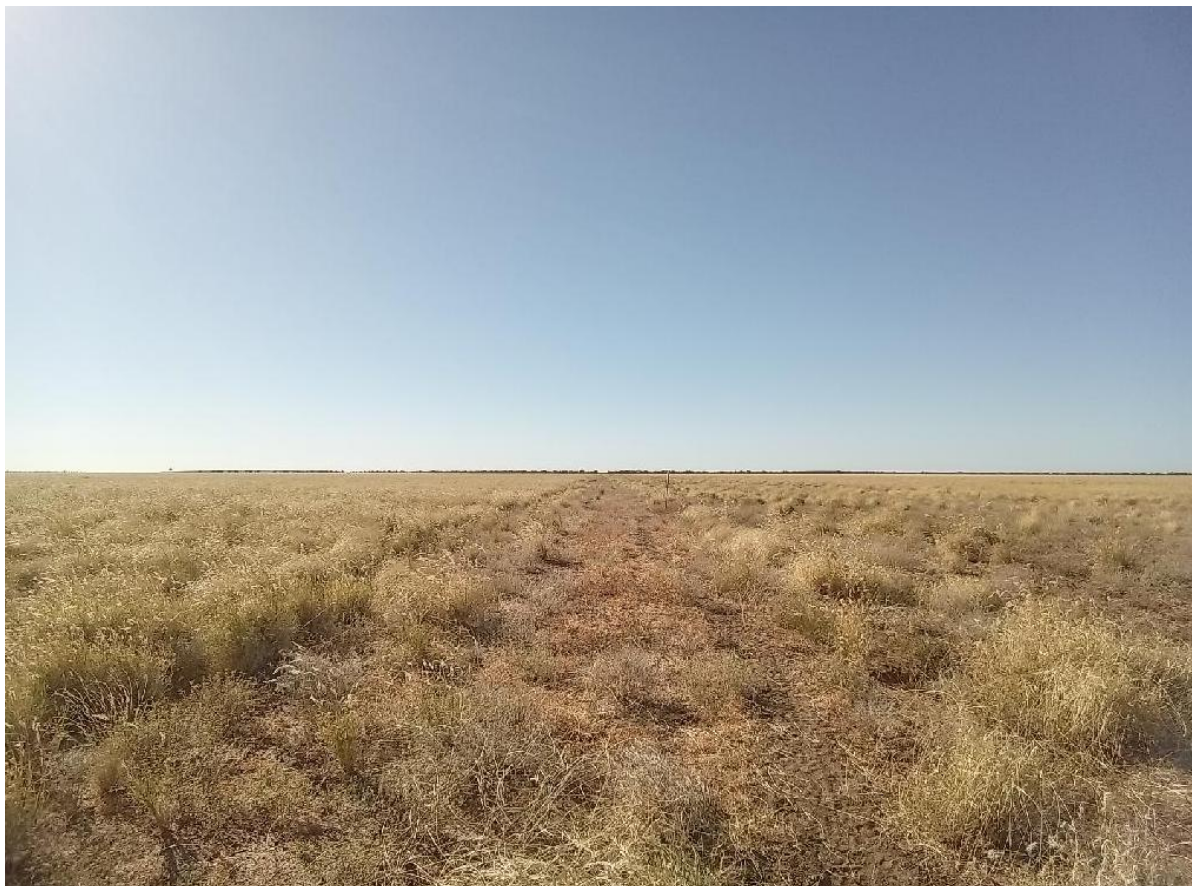
Whilst there has been good progress towards rehabilitation, RMP criteria has not yet been met.

Figure 4-18. Vegetation on the ROW similar to vegetation off the ROW but not yet meeting transition criteria.

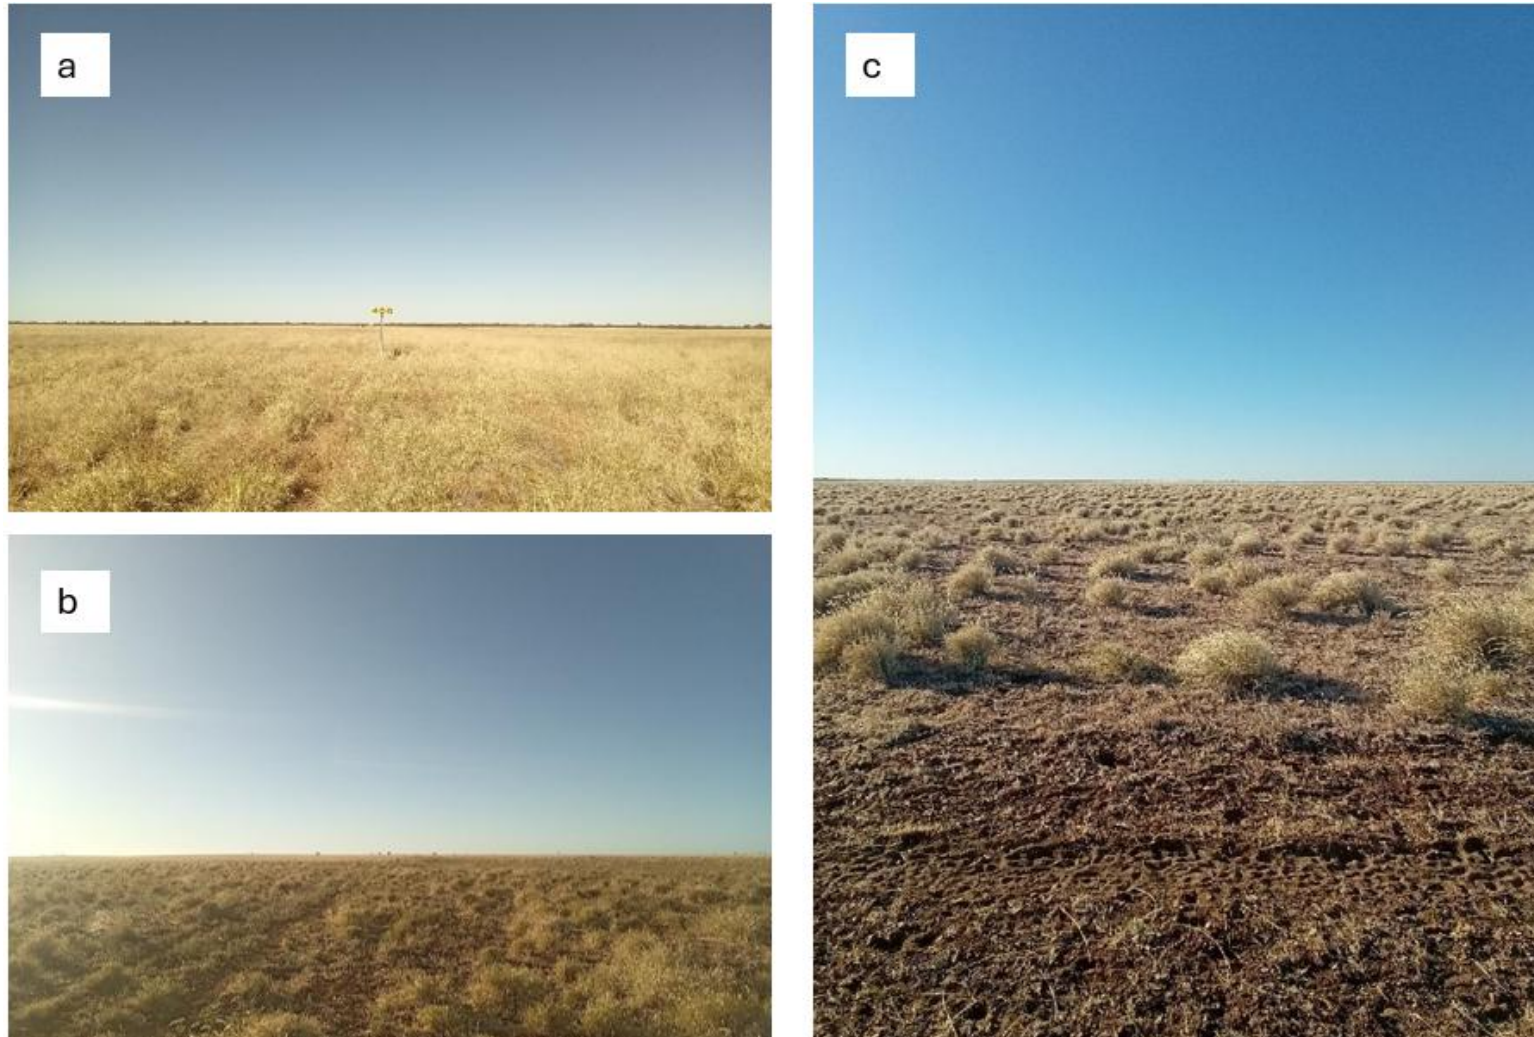
Figure 4-19. Images from assessment survey. Mitchell grasses recovering well in general. (a) KP 400 vegetation cover on the ROW representative of vegetation off the ROW, (b) cattle tracks following the ROW, impacting vegetation cover and (c) less vegetation cover on the ROW compared to off the ROW.

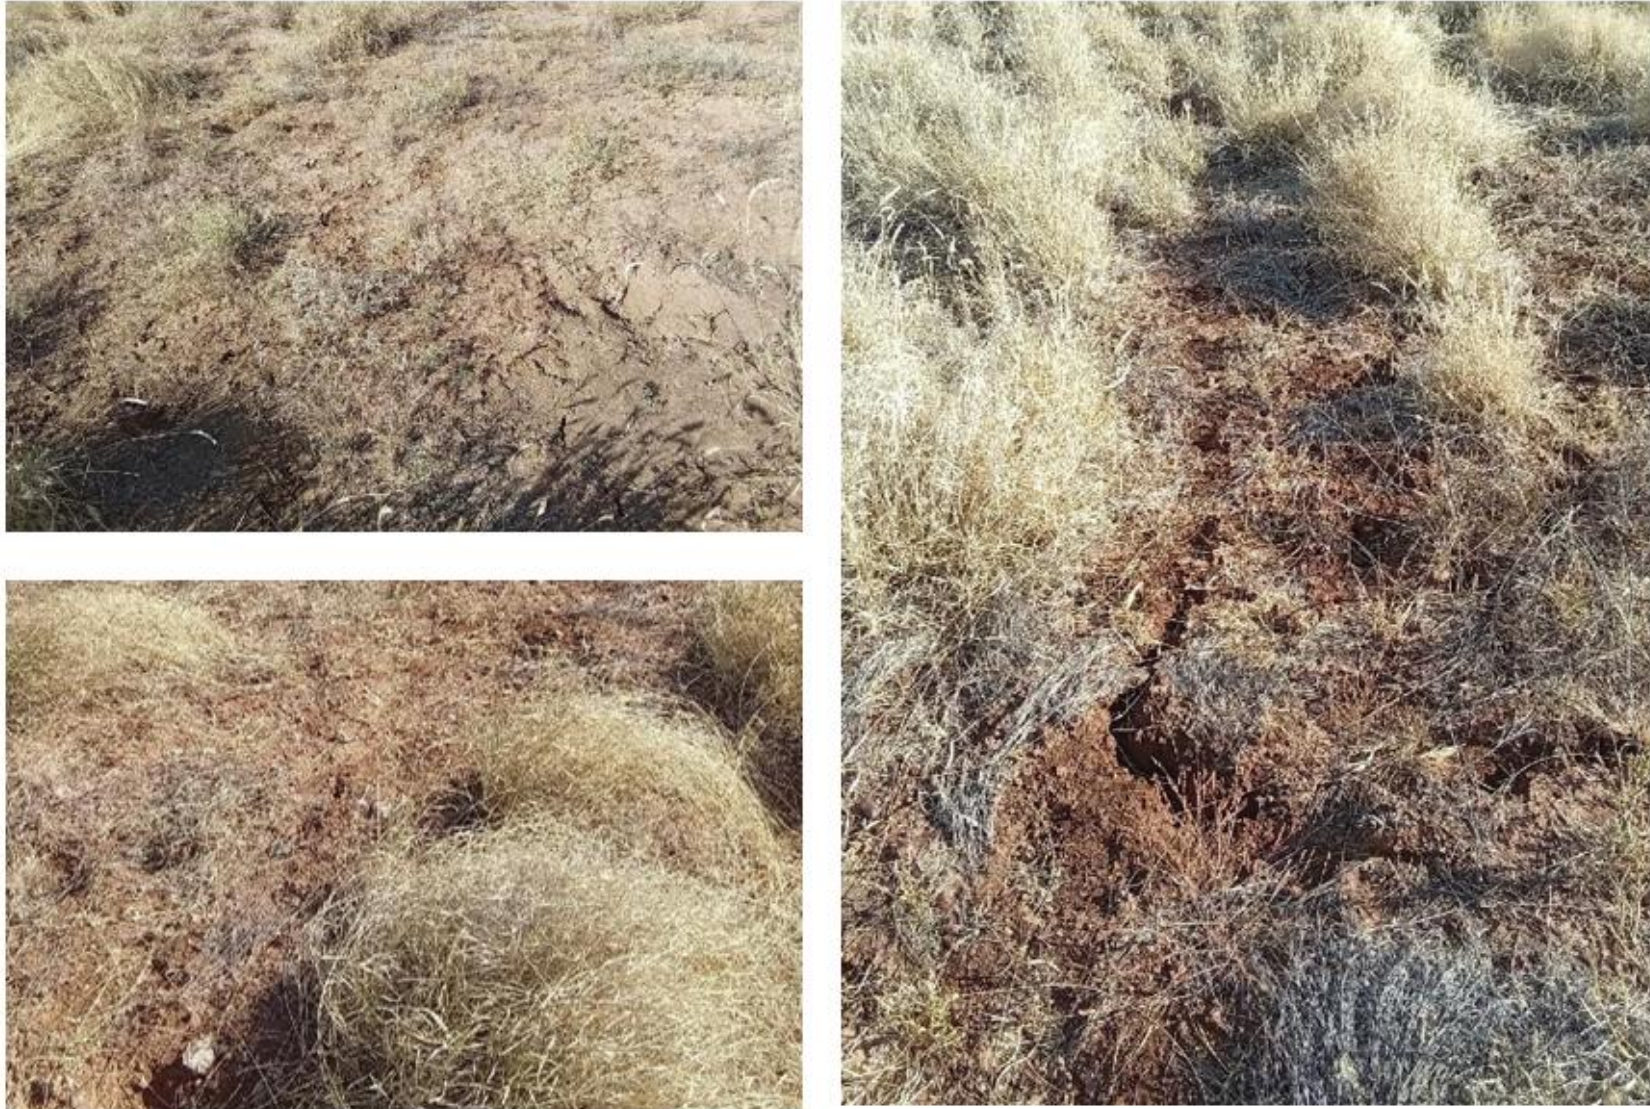
Figure 4-21. Examples of cracks and holes on the ROW.
