NGP ANNUAL COMPLIANCE REPORT - 2024

TRANSITIONAL REHABILITATION ASSESSMENT

REPORT 2024

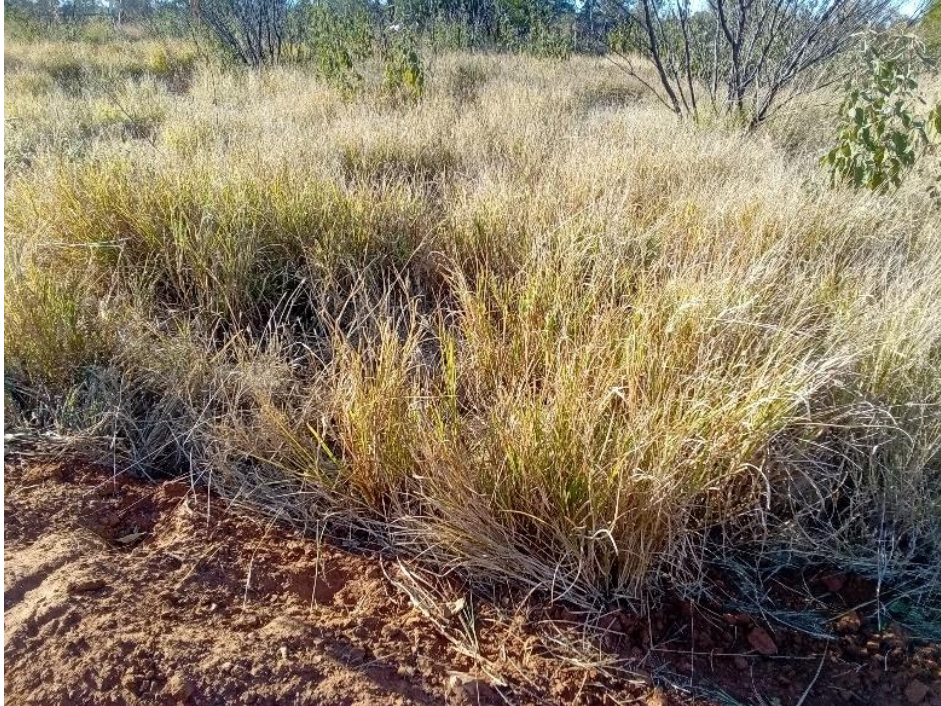
Photo 4-1. A patch of *Cenchrus ciliaris* (Buffel grass) found at KP 15.7

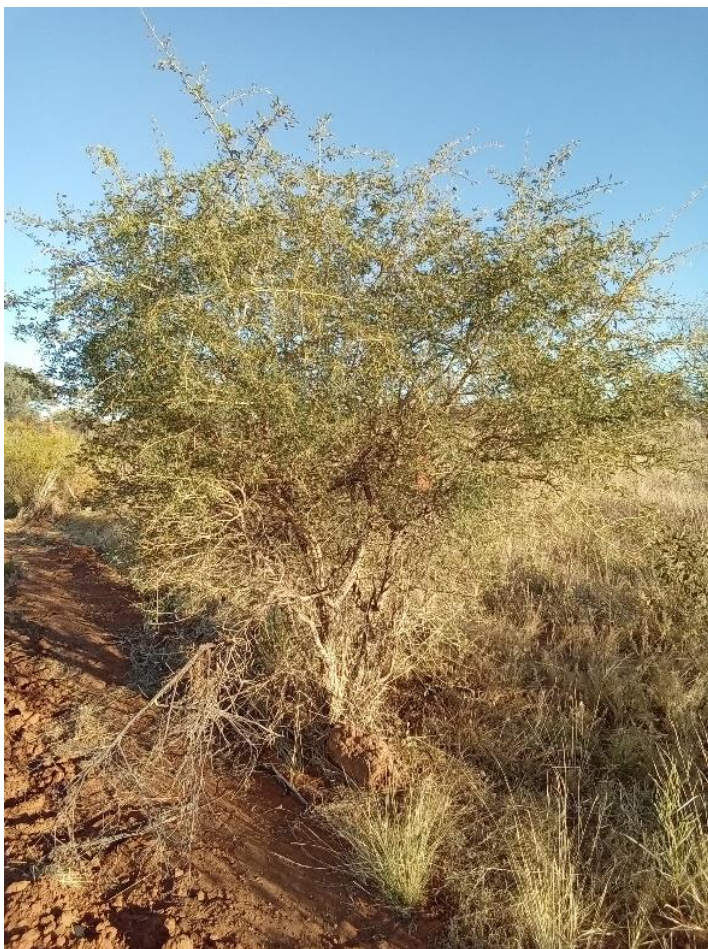
Photo 4-2. *Poposis* sp. (Mesquite) found at KP 15.6

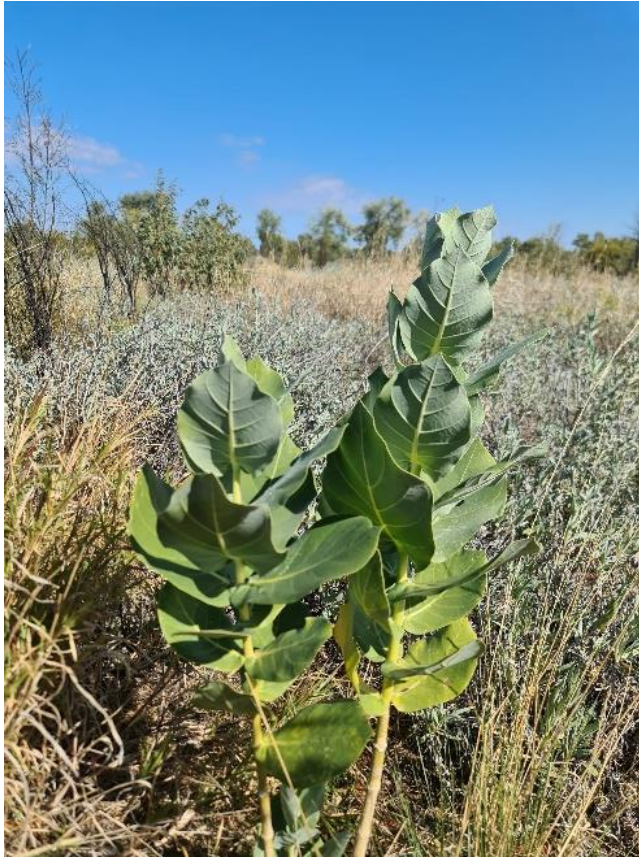
Photo 4-3. *Calotropis procera* (Rubber bush) found at KP 234

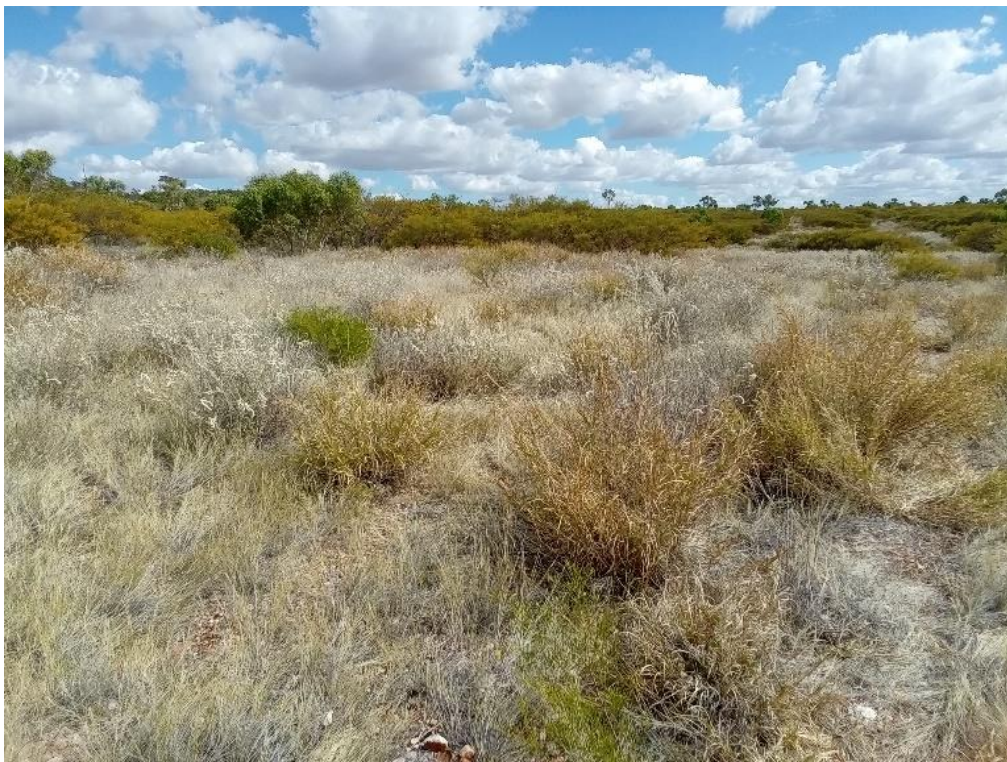
Photo 4-4. *Cenchrus ciliaris* (Buffel grass) and *Aerva javanica* (Kapok bush) within 40 km of the eastern end of the ROW.

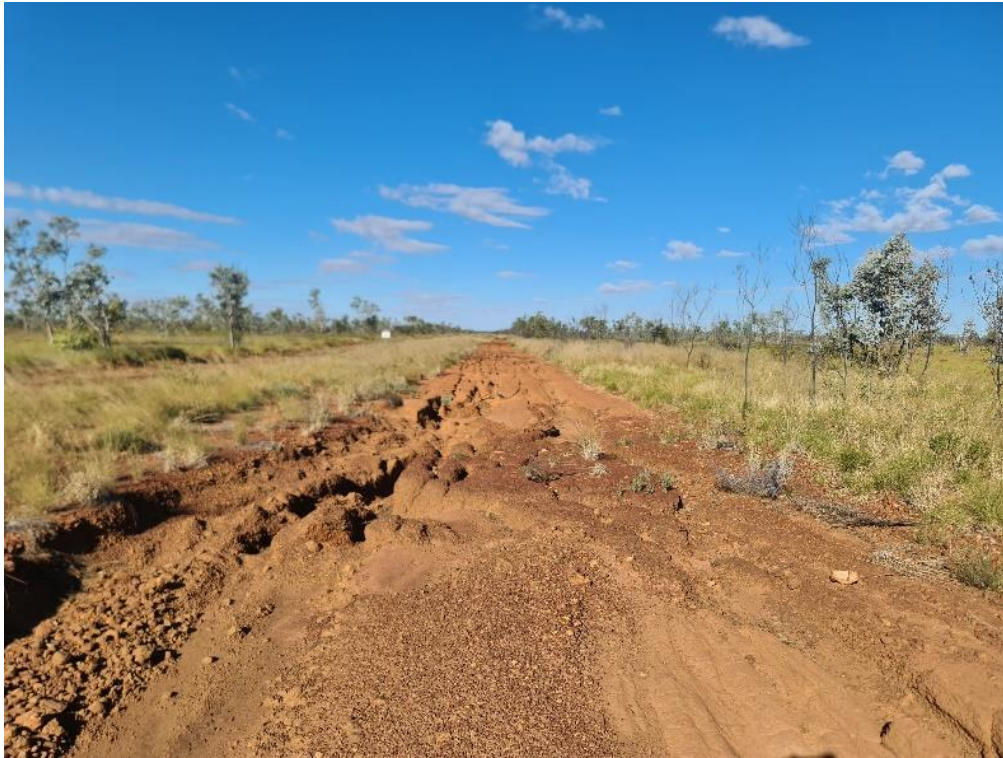
There is a particular stretch of erosion around KP 294 about 1 km long consisting of mostly Level 1 and 2 erosion, with rill and gully erosion 1 m deep and up to 4 m wide in some places. The erosion was likely caused by a lack of water diversion berms along that section and windrows along the edge and centre of the easement concentrating water flow and channelling water along the ROW. During the survey it was noted that remediation work had begun in this area in the form of erosion control berms. However, these berms were constructed of small rocks with very little soil. This may reduce the effectiveness of the berms and allow the erosion to continue. If this substrate is used further to construct berms it is recommended to use fines to create drainage to the level of the bottom of the erosion and then place berms with this gravel above to further channel the water off the affected area. Erosion control berms along KP 293 to KP 295 should be installed to help prevent the same erosion occurring again.

Photo 4-5. Rill erosion scored as the highest severity, Level 1. Erosion had a maximum depth of 1000 mm and the total length of the erosion was approximately 900 m.

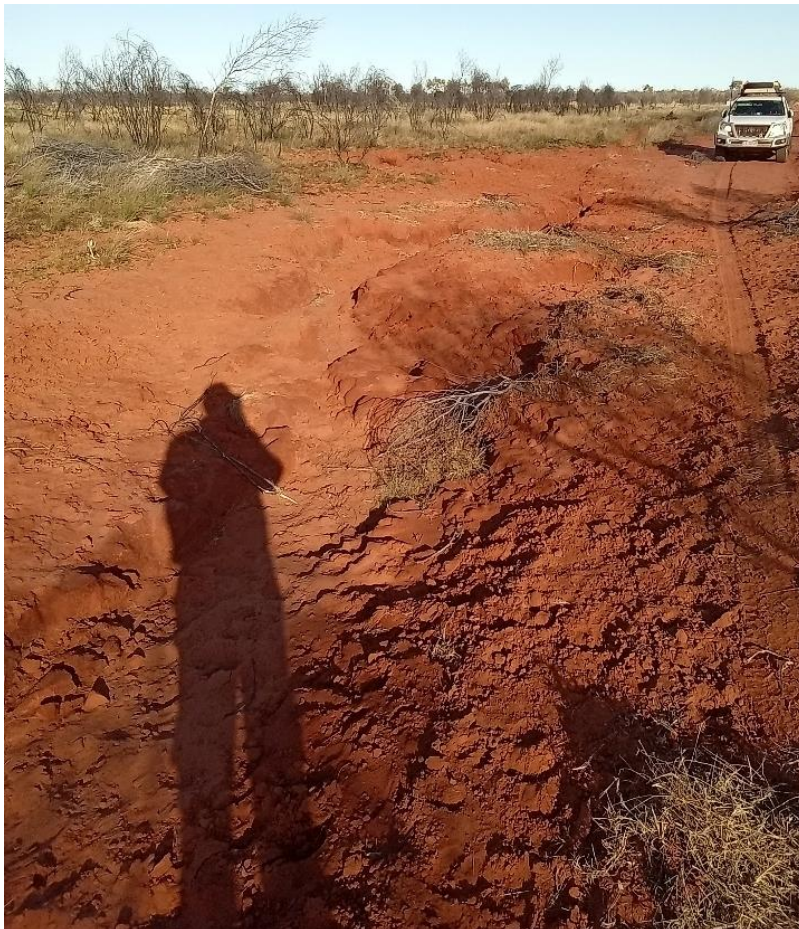
Photo 4-6. Gully erosion scored as moderate, Level 3.

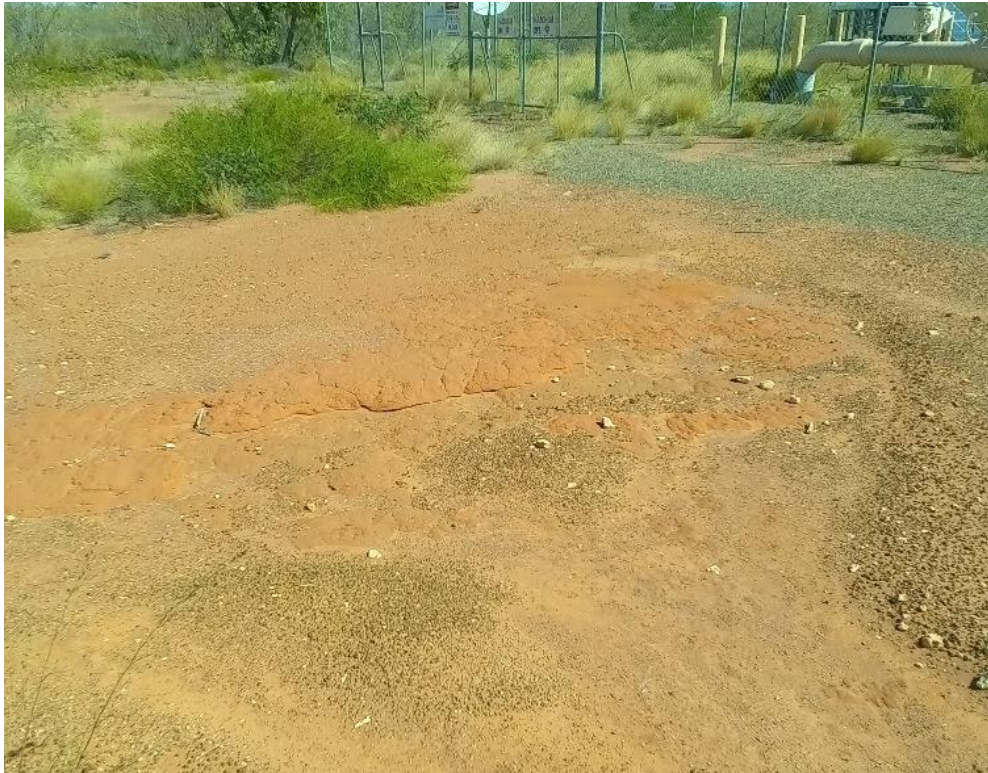
Photo 4-7. Minor wash out from the access road to the CP station at KP 211.5

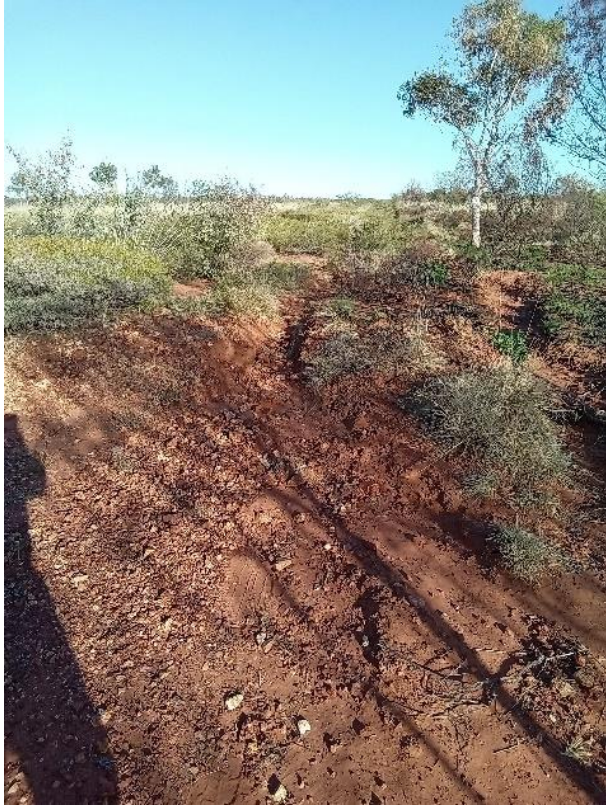
Damage was most often due to water erosion resulting in erosion channels through the berms or the berms being washed out. There were several occurrences of water flowing around the ends of berms and back onto the ROW rather than diverting outwards into adjacent land. This was often due to berms not extending far enough at the edges of the ROW. Cattle tracking has also caused erosion of berms in some instances, as well as vehicle activity along the access track of the ROW. Nine berms had been removed during grading operations for vegetation clearing. A few berms were ineffective due to their orientation on the ROW where the construction of the berm did not follow the natural lay of the land and caused water to flow directly back onto the ROW.

Photo 4-8. Erosion from water flowing around a berm and back onto the ROW.

Many of the berms would be more effective if they extended beyond the disturbed area of the ROW easement to divert and disperse water out onto adjacent undisturbed land. This may have occurred due to heritage buffers restricting the construction of berms to inside the ROW. These berms that do not extend beyond the ROW do not divert water off the easement completely allowing water to flow around the end of the berm and continue channelling downslope along the ROW increasing the risk of erosion.

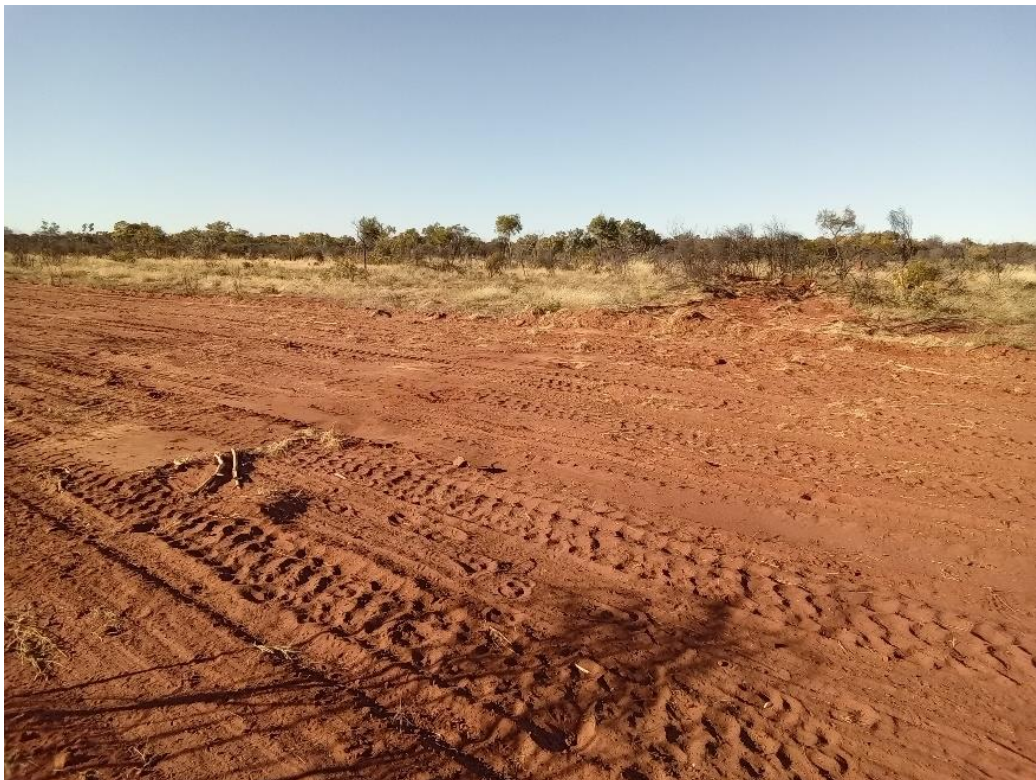
Photo 4-9. Berm removed from grading activities to clear overstory growth off the ROW.

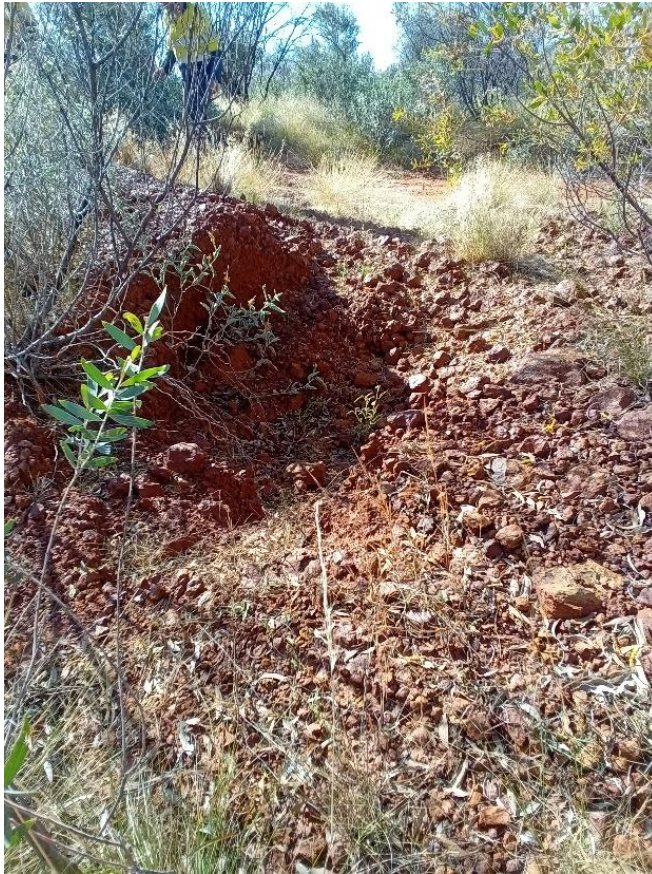
Photo 4-10. Erosion has washed out the middle of a berm at KP 307.5

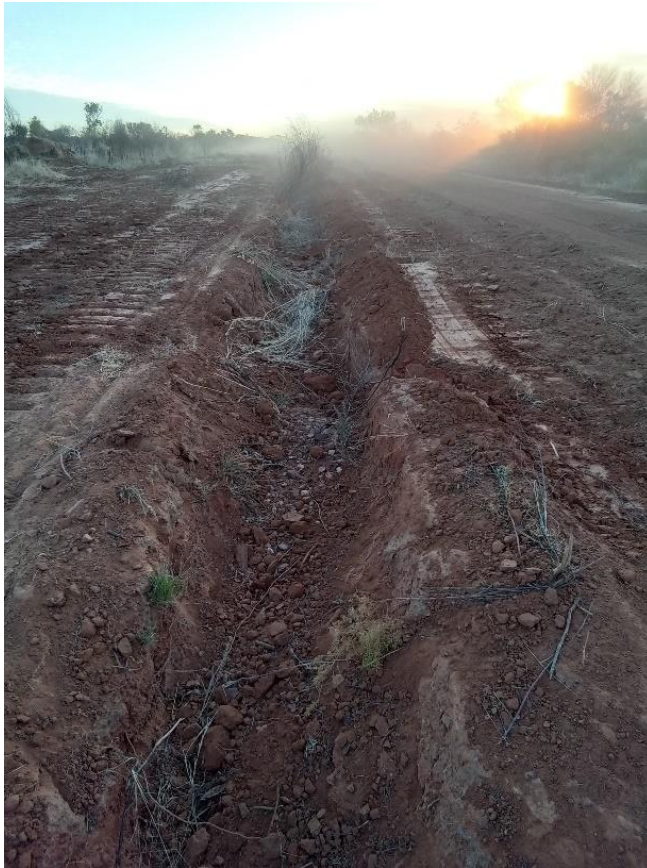
Photo 4-11. Significant subsidence which has not been repaired during grading KP 7

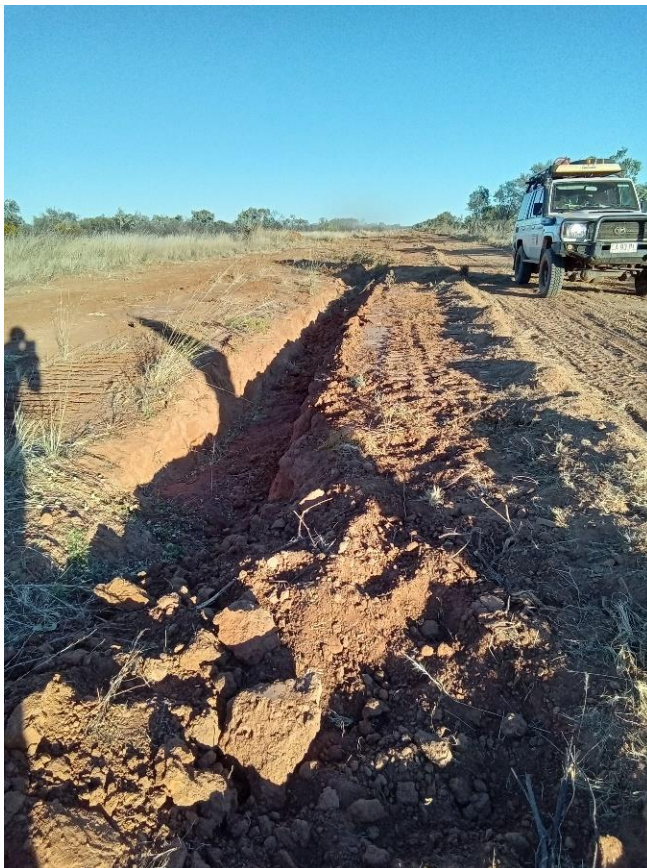
Photo 4-12. Significant subsidence has not been repaired during grading at KP 7.4

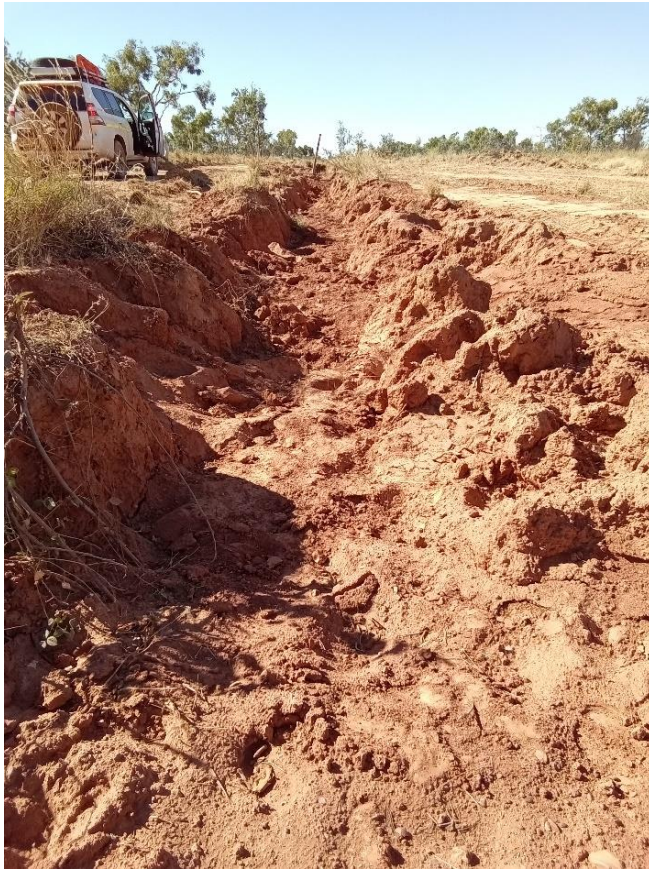
Photo 4-13. Moderate to significant subsidence which has affected a pipeline monitoring pole. KP 5.6

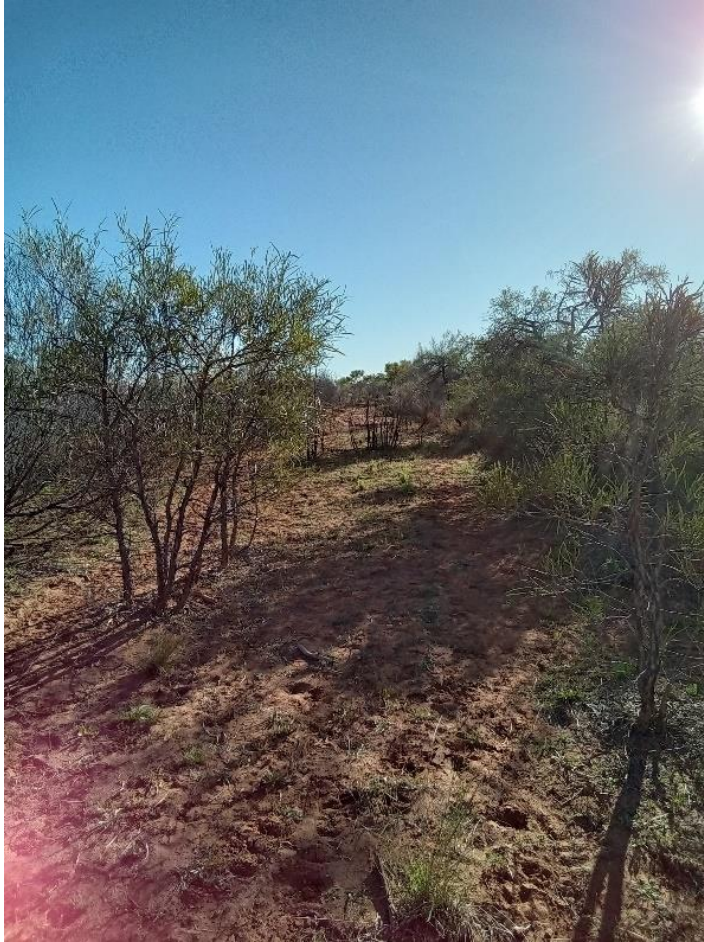
Photo 4-14. Growth of woody shrubs and trees along the ROW.

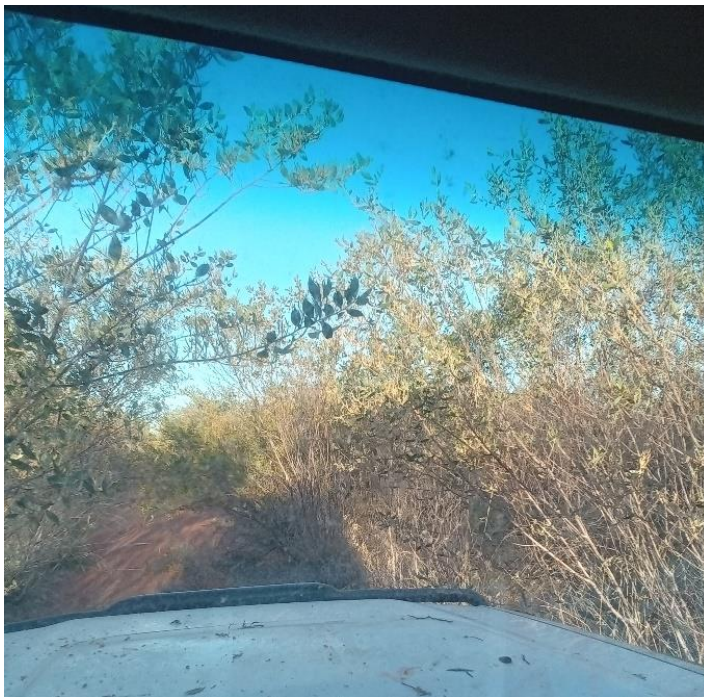
Photo 4-15. Overgrowth of overstory and ground cover restricting assessment of the ROW condition. Ground cover requires slashing.

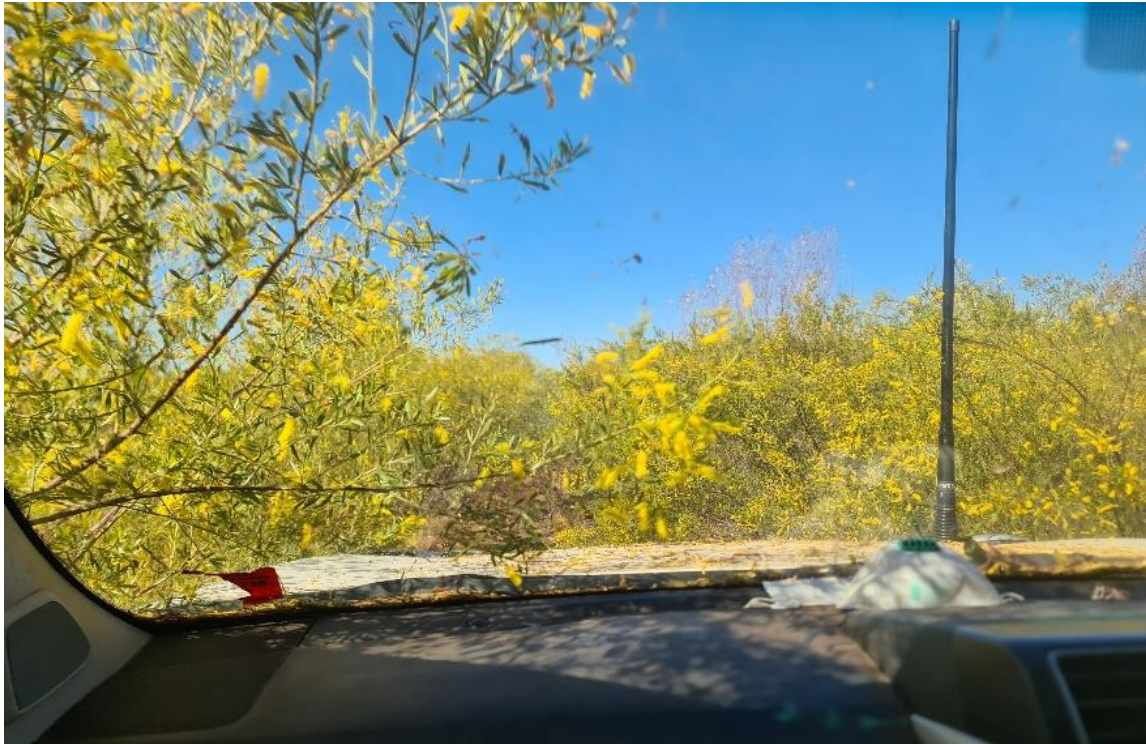
Photo 4-16. Overstory reducing vision of the condition of the ROW.

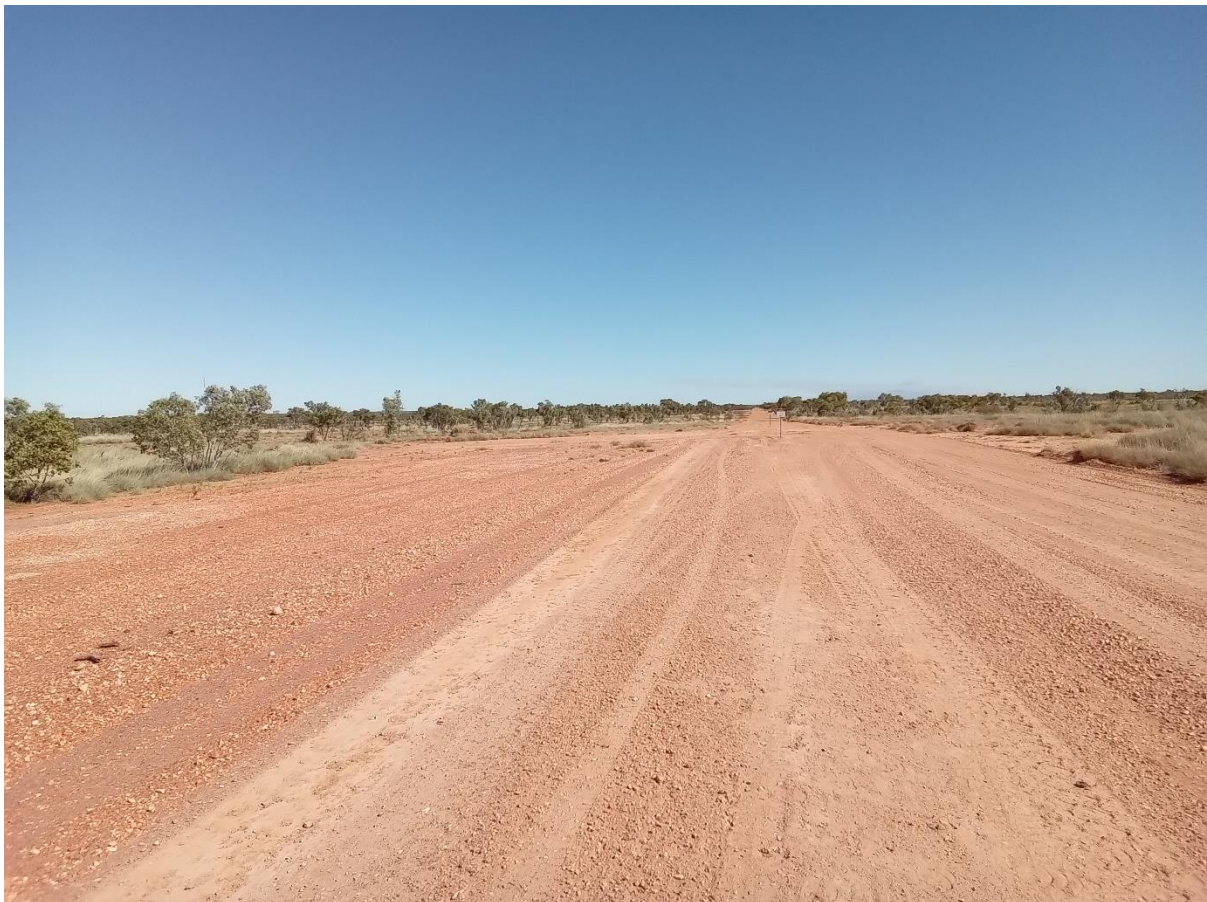
Photo 4-17. Area of low rehabilitation score due to lack of vegetation growth. Topsoil is still present, and vegetation will likely grow given time.

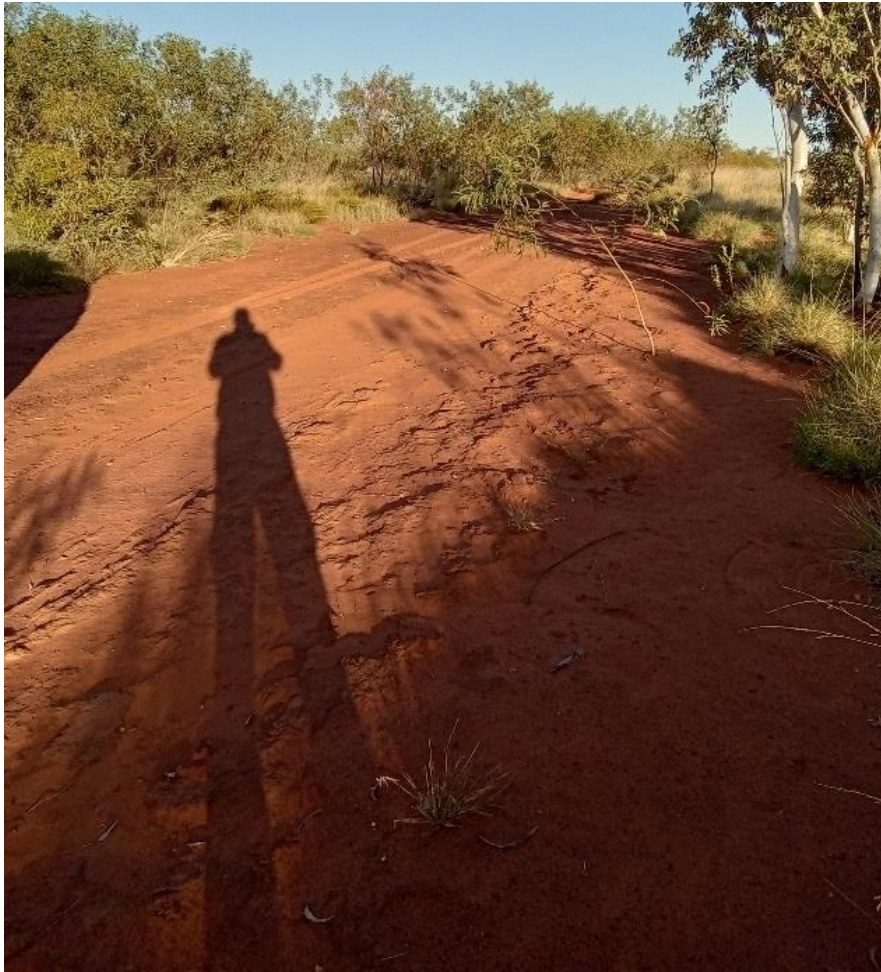
Photo 4-18. Erosion has removed topsoil from this area. Topsoil will need to be replaced and managed to encourage rehabilitation.

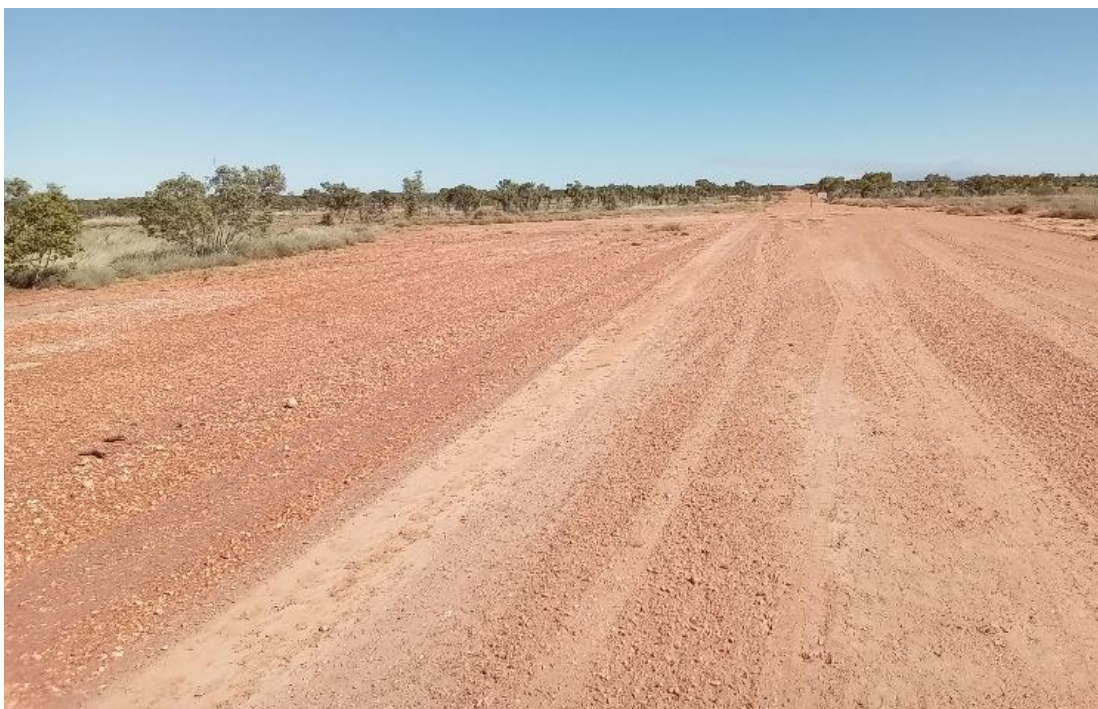
Photo 4-19. Laydown area of low rehabilitation score due to lack of vegetation growth. Topsoil is still present, and vegetation will likely grow given time.

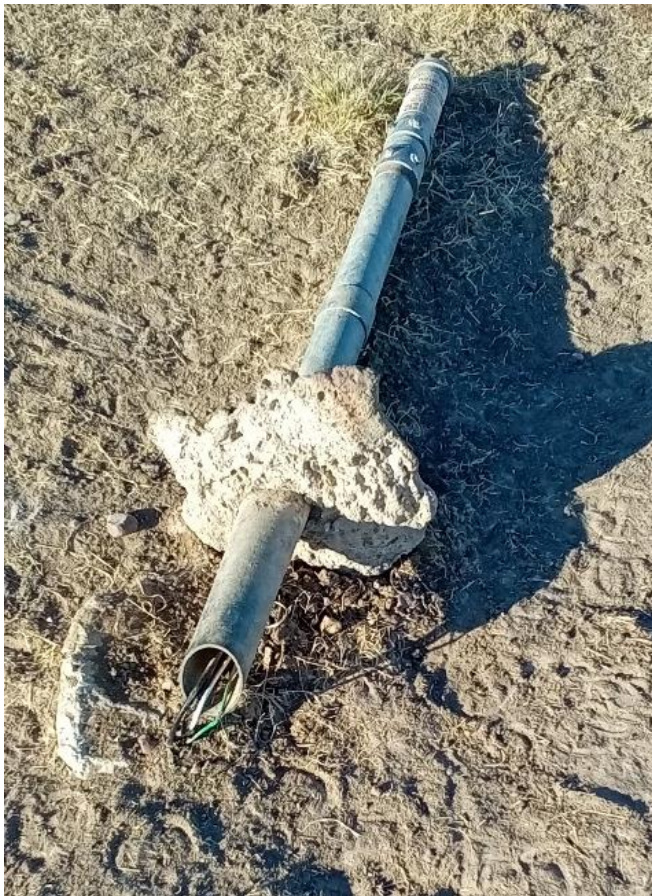
Occasionally the monitoring poles were damaged or had fallen due to land stability issues or cattle damage. Frequently, if these poles had fallen, wires were exposed at the base of the pole (Photo 4-20).

Photo 4-20. Fallen monitoring pole with exposed wires.
