# NGP ANNUAL COMPLIANCE REPORT - 2026

# JEMENA NORTHERN GAS PIPELINE TRANSITIONAL REHABILITATION ASSESSMENT REPORT 2026

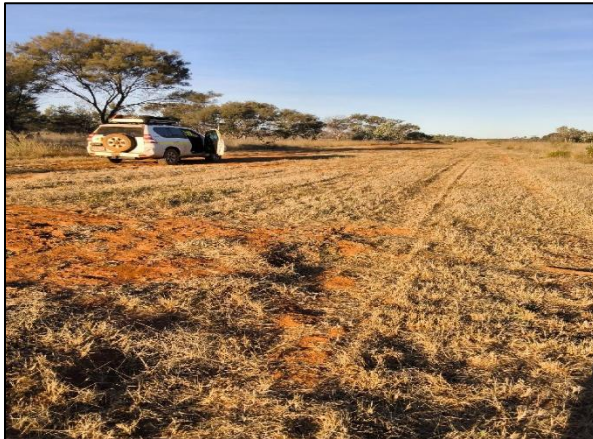
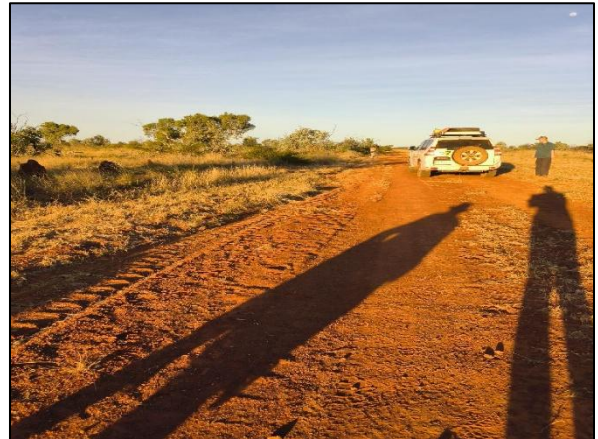
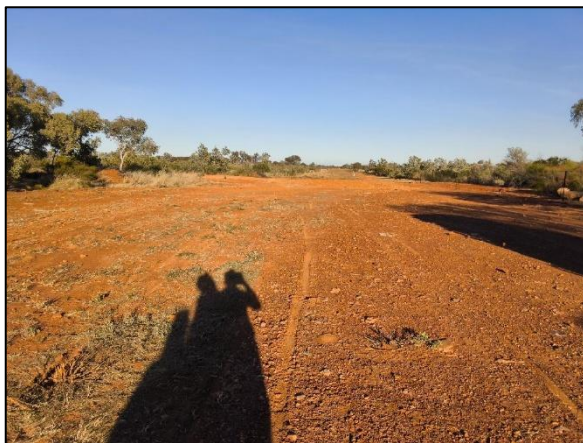
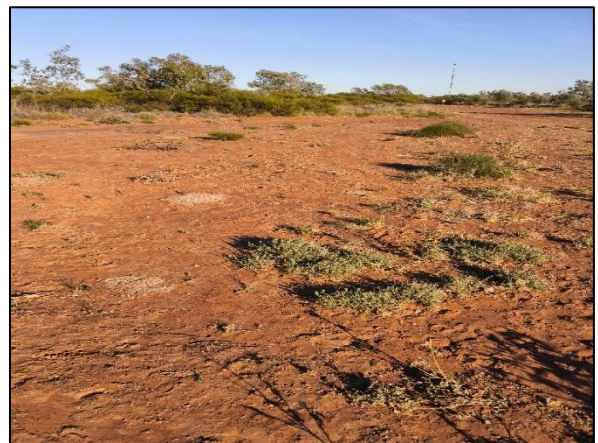
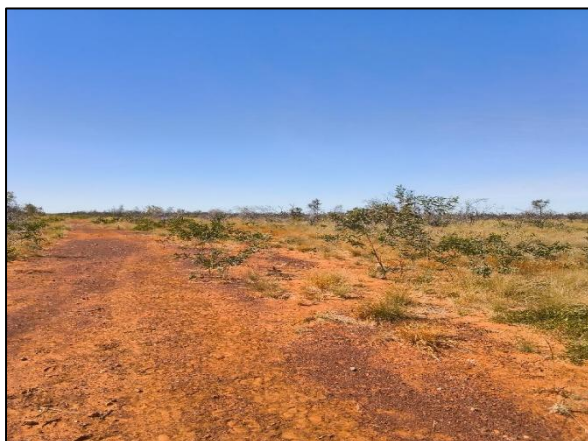
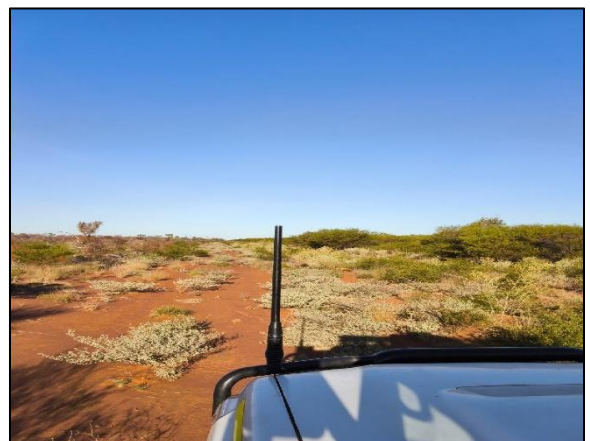
**Photo:** Representative views of the NGP ROW in NT showing established vegetation and stable ground conditions.

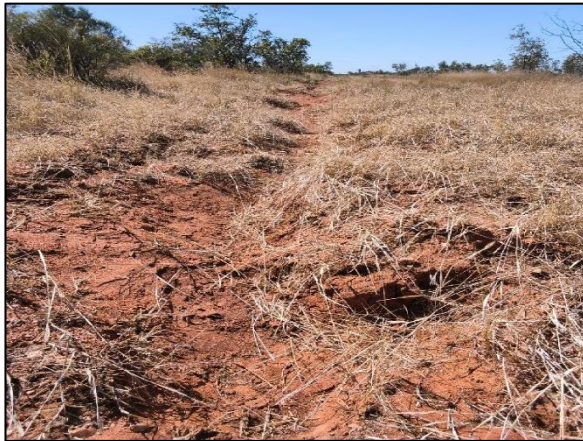
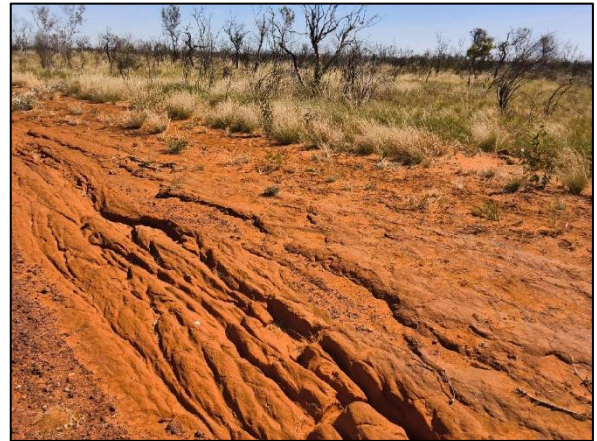
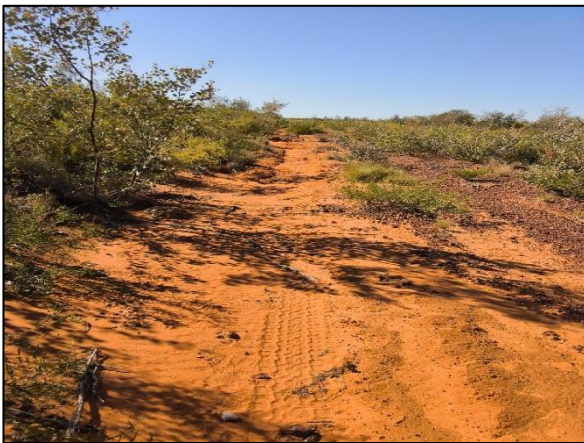
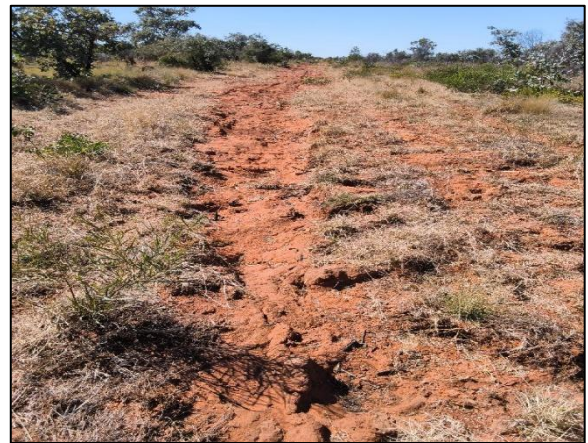
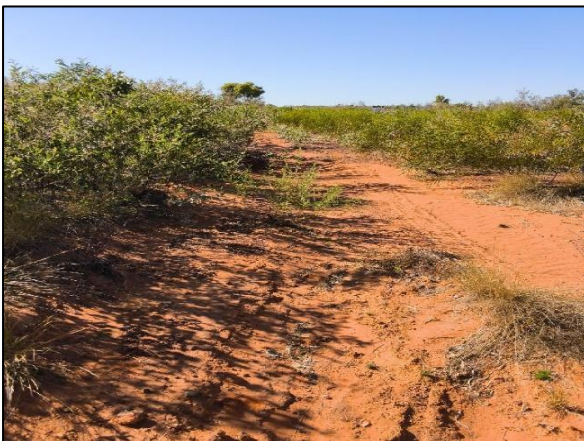
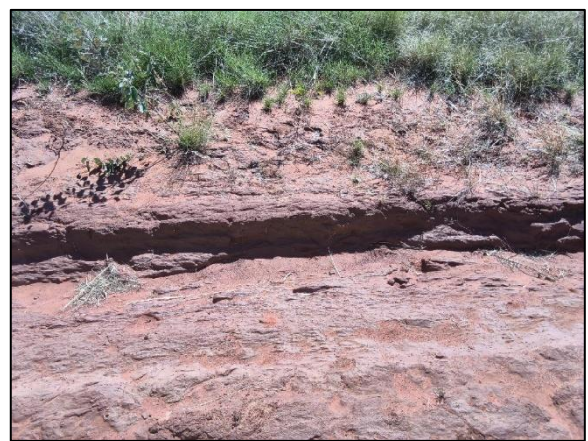
**Photo:** Level 1 & 2 erosion showing a moderate land-stability issue with potential to become significant.

All Level 1 and Level 2 erosion areas should be prioritised for remediation, including filling and levelling where appropriate and the installation or reinstatement of erosion-control berms to manage surface-water flow. Attention should be given to the identified erosion locations at KP 265–266, KP 303–308 and KP 423–424. Level 3 erosion should also be remediated, particularly where earthmoving equipment is already operating nearby or where there is potential for erosion to progress. Level 4 and Level 5 erosion should continue to be monitored and managed with erosion-control measures where required. This approach is consistent with the management hierarchy applied during the 2025 assessment. Attention should continue to be given to erosion associated with drainage lines and watercourse crossings, as concentrated surface flows can increase the likelihood of erosion progression. Vehicle movements should remain confined to established access tracks as far as practicable to minimise additional disturbance to rehabilitating areas of the ROW. Locations of erosion issues are presented in **Appendix C**. Representative photographs of erosion conditions, including significant and moderate erosion areas requiring remediation, are provided in **Appendix J**.

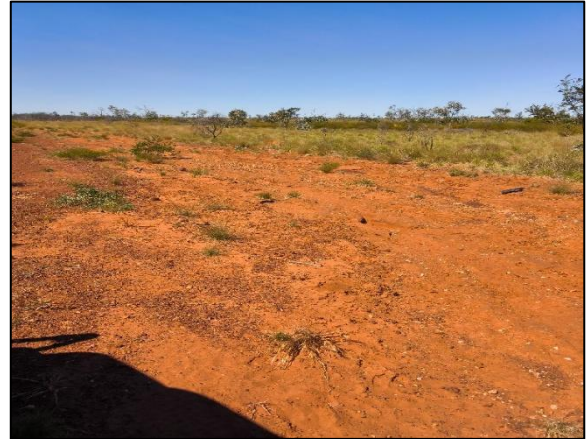
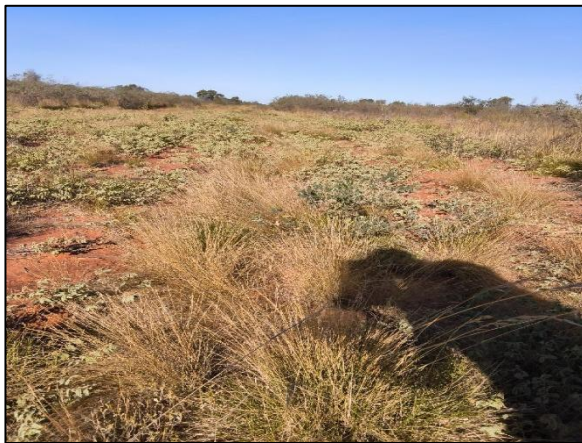
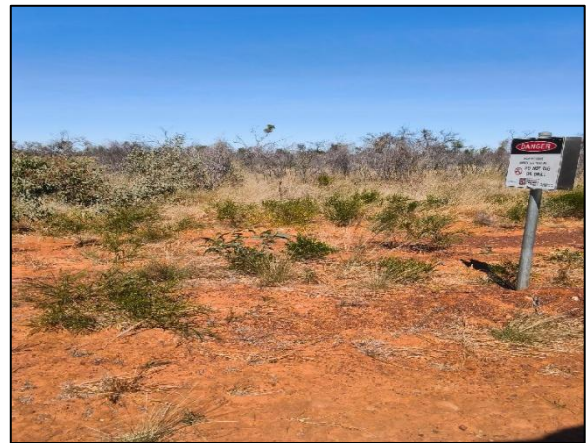
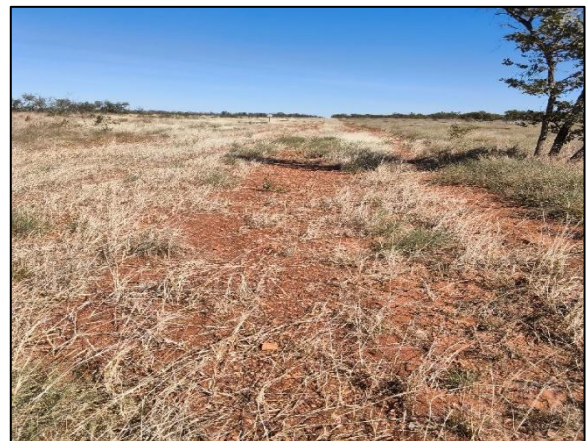
**Photo:** Level 3, 4, 5 erosion showing erosion showing a very minor and locally stable erosion feature.

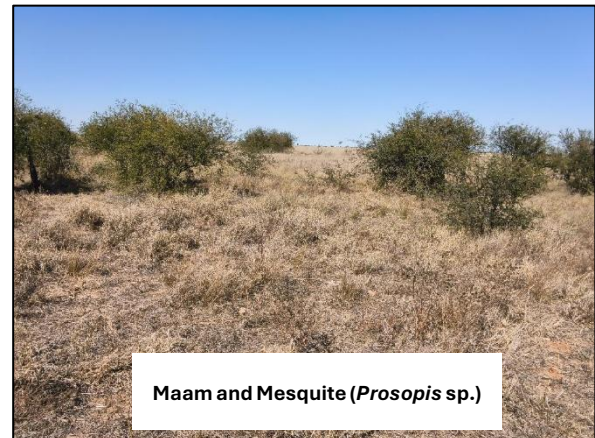
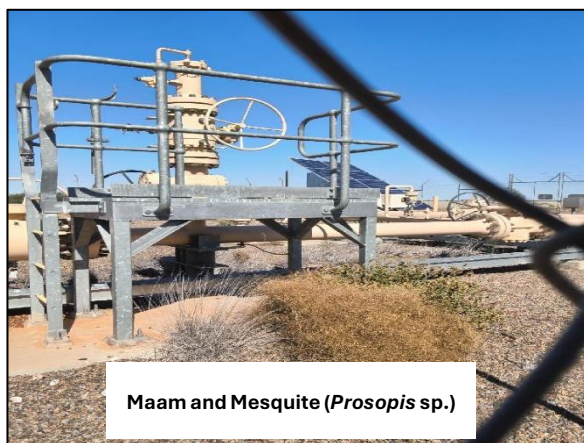
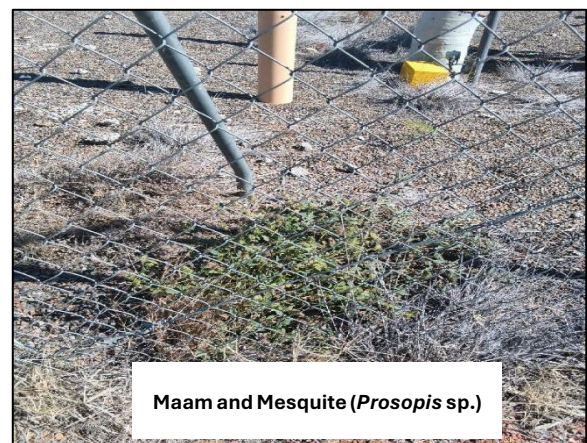
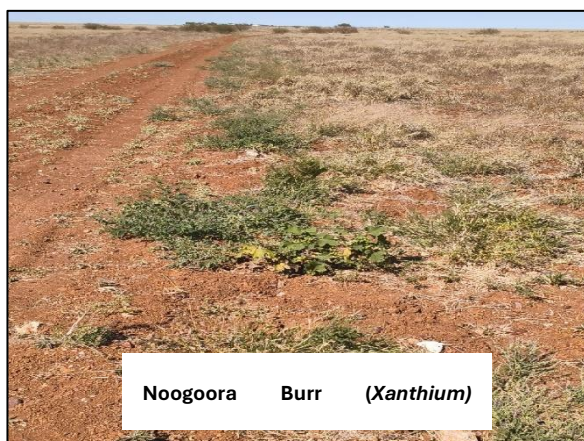
**Photo:** Representative weeds recorded within the eastern section of the NT ROW.

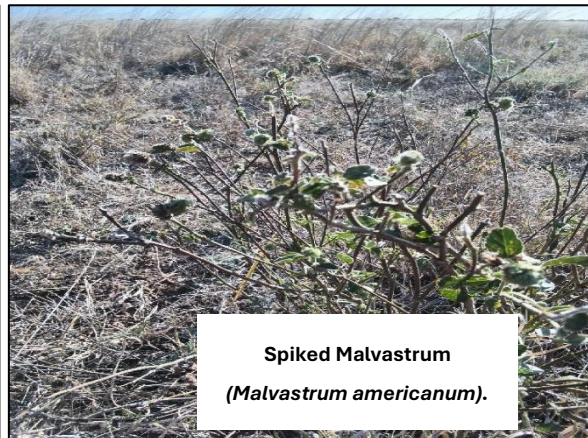
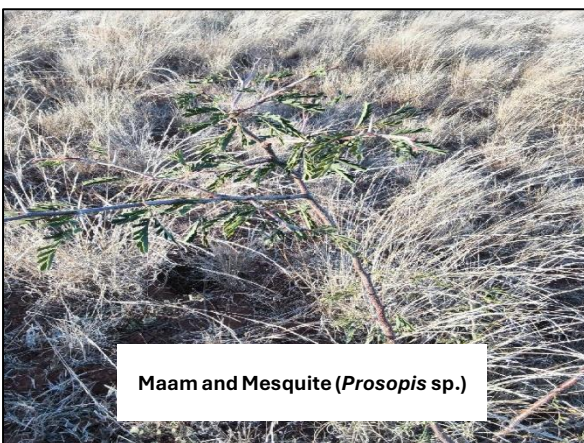
**Photo:** Representative weeds recorded within the eastern section of the NT ROW.

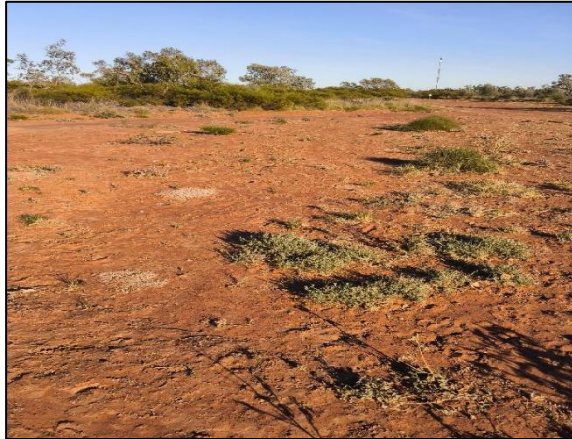
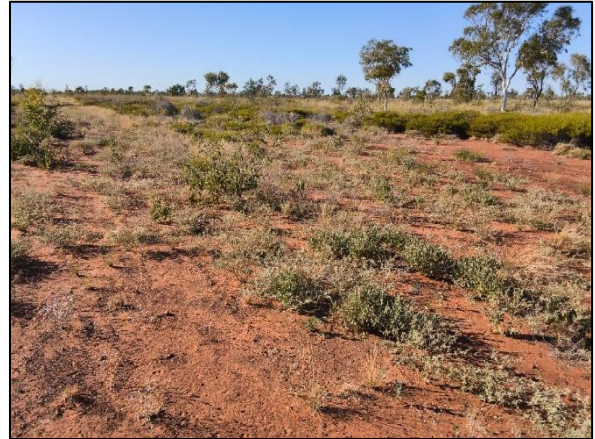
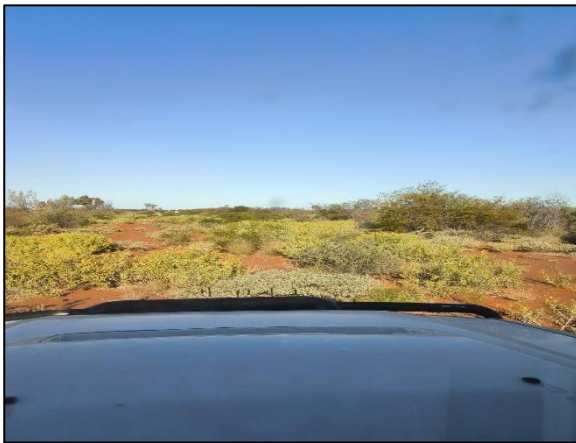
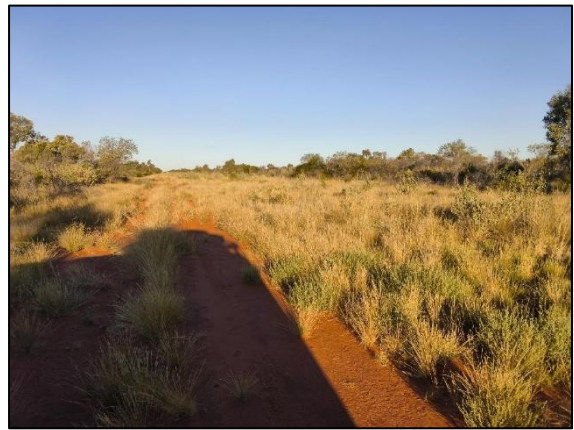
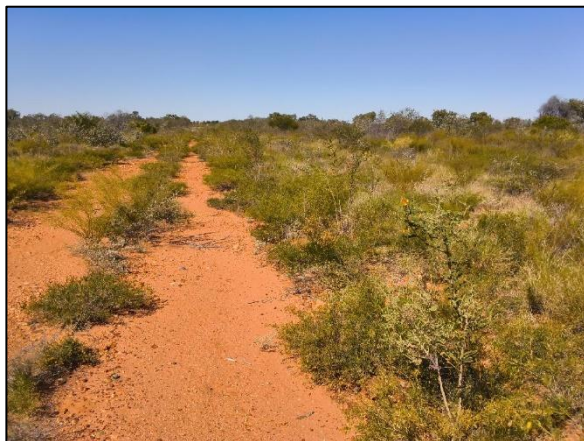
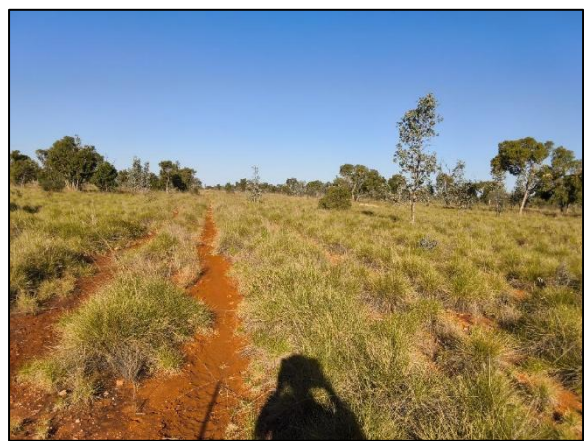
**Photo:** Vegetation Condition Level 1-5 showing dense and well-established vegetation across the ROW.

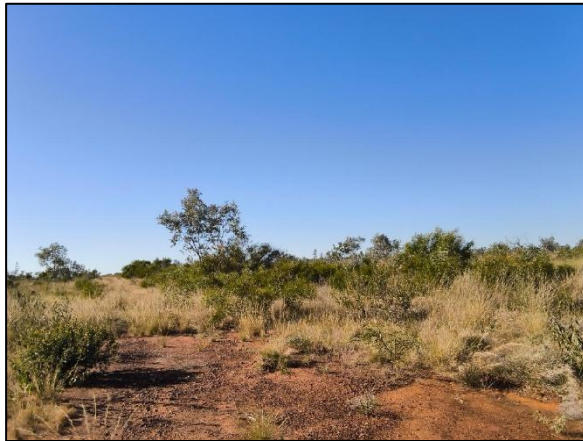
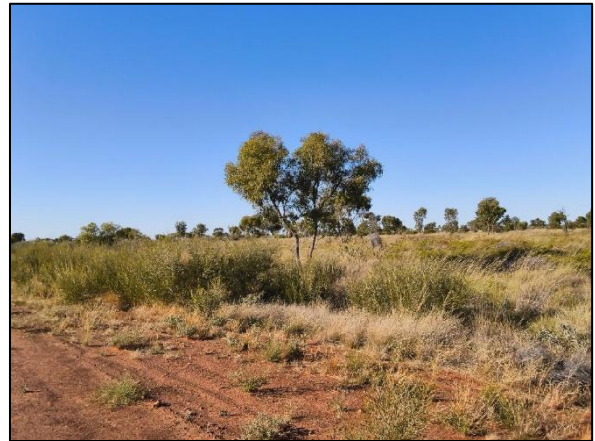
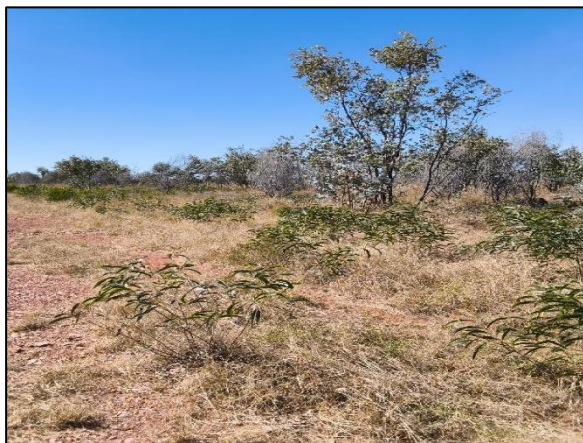
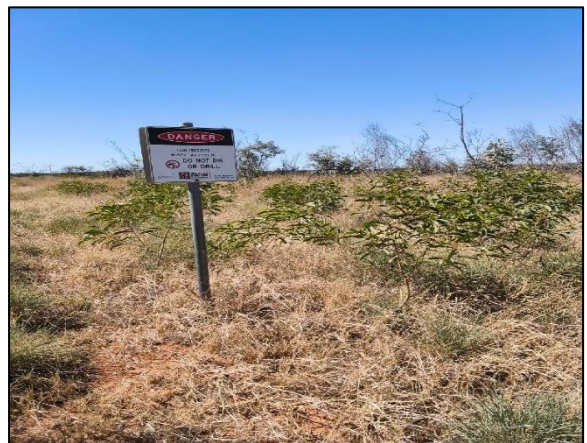
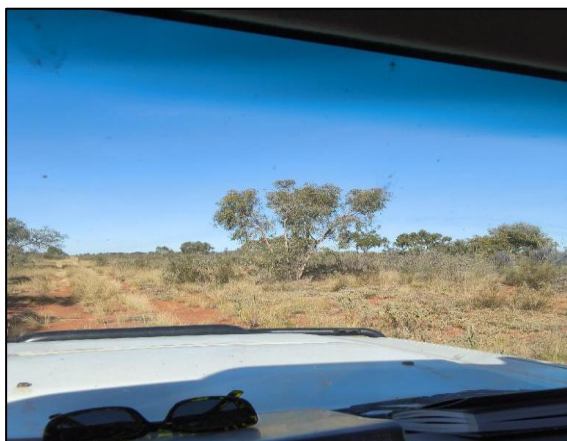
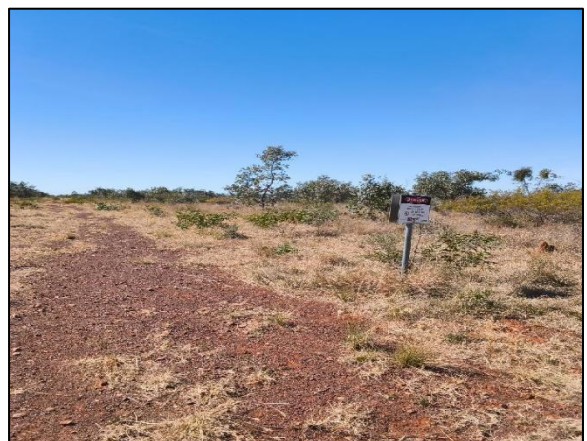
**Photo:** Representative vegetation overgrowth within the NT ROW.

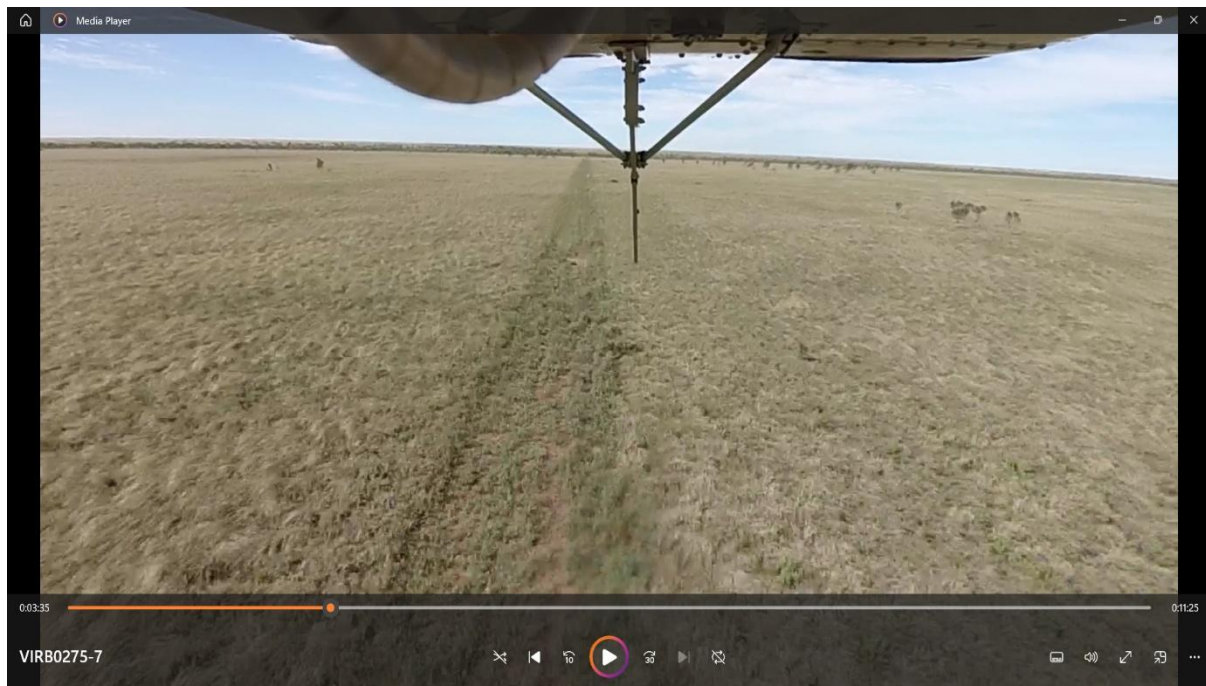
**Photo:** Example of vegetation 5 on QLD side of Pipeline. (3.35s) (KP450-475, Video: VIRB0275-7)

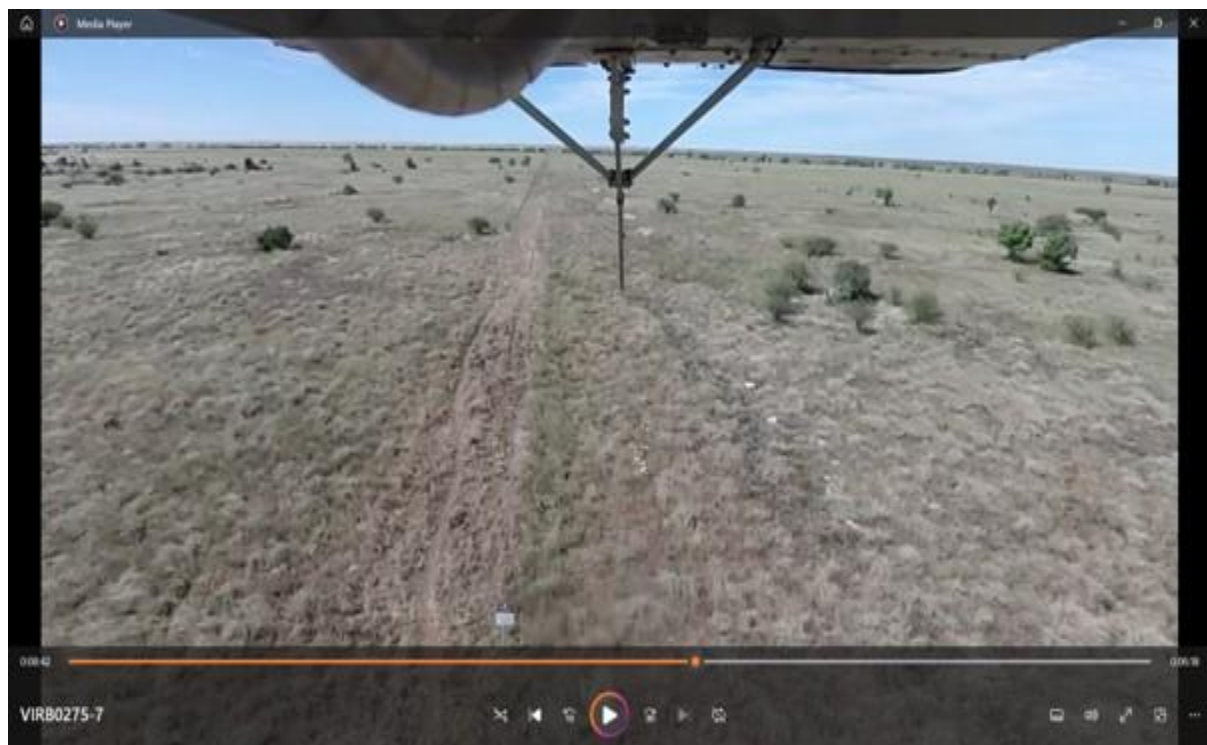
**Photo:** Cattle related erosion along NGP (8.42s). (KP450-475, Video: VIRB0275-7)

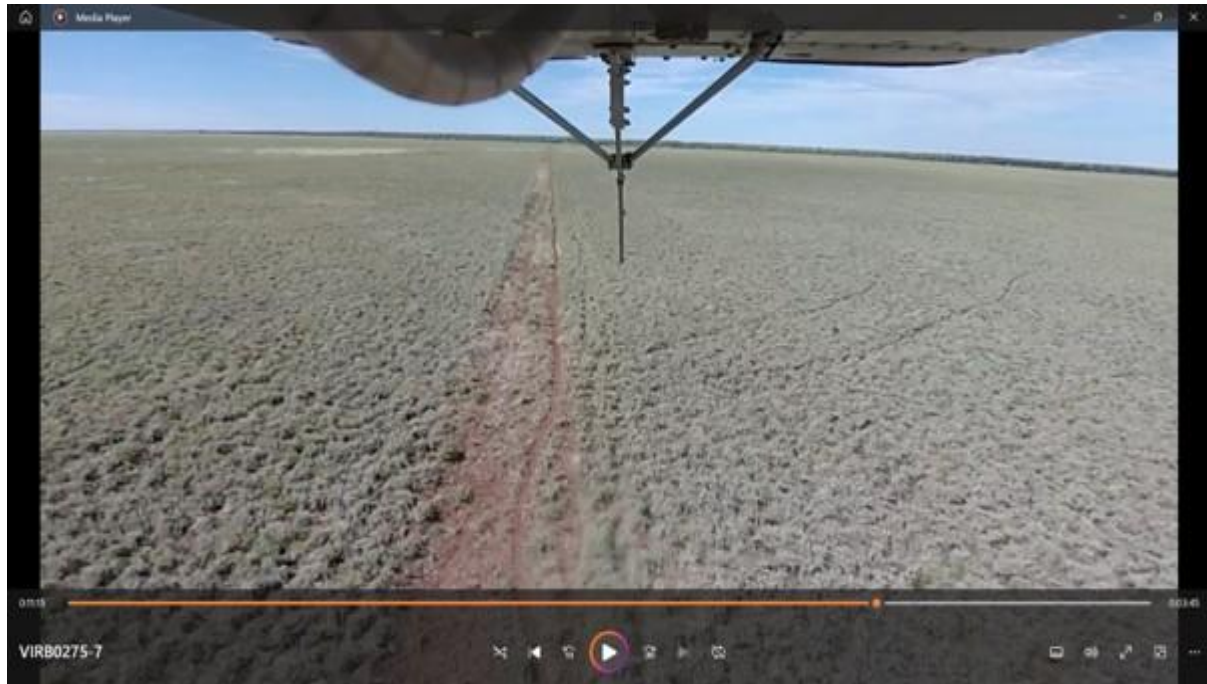
**Photo:** Example of vegetation 5 with cattle tracks which may lead to erosion (11.15s)  
(VIRBO275-8, KP480-KP500)

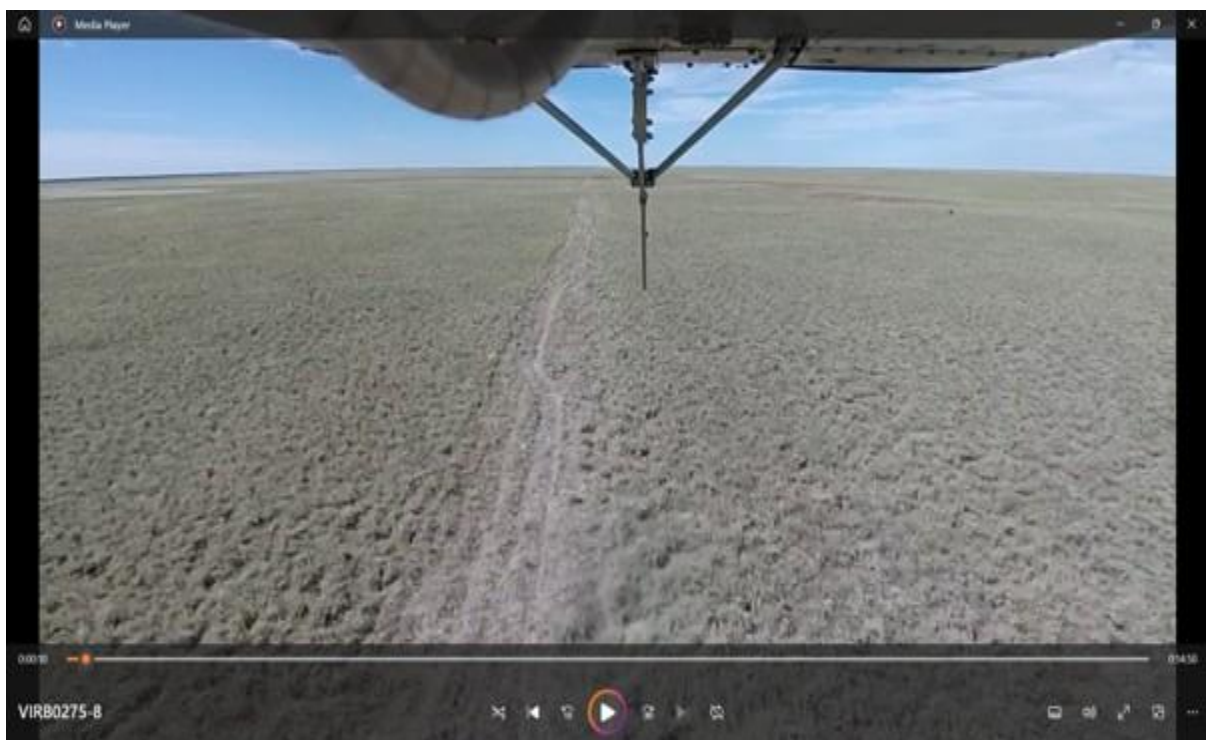
**Photo:** Vegetation 5 no erosion, cattle tracks (0.10s), (VIRBO275-8, KP480-KP500)

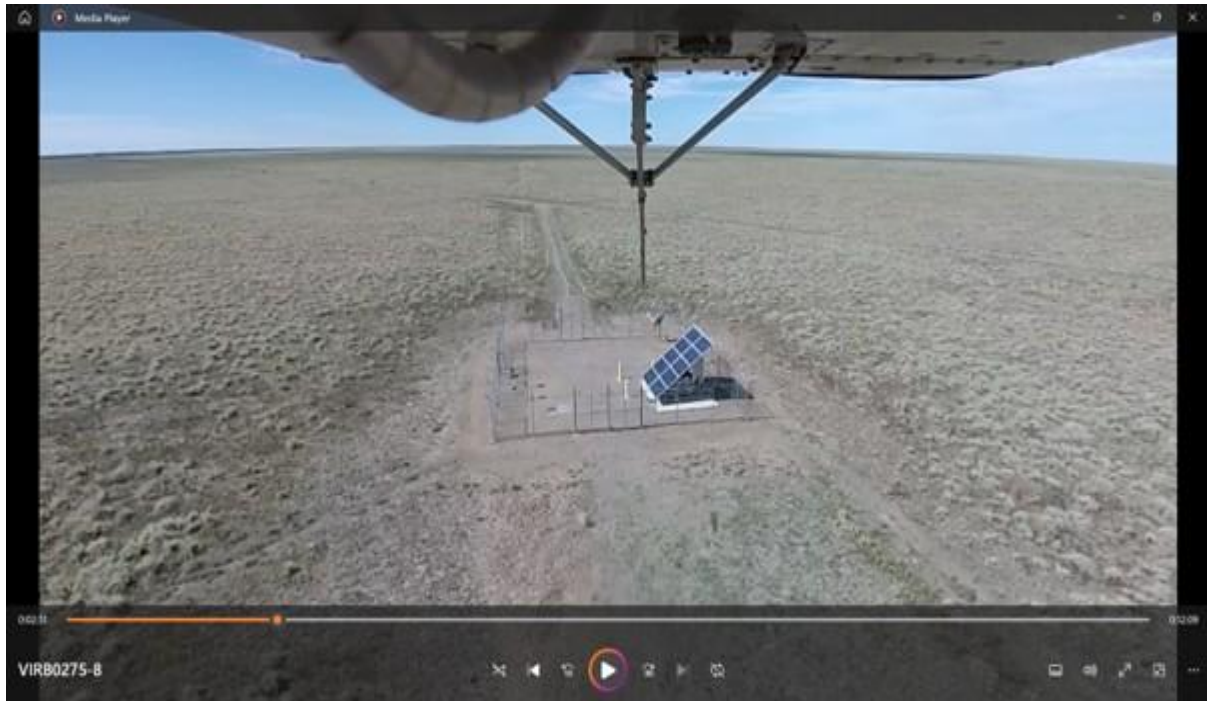
**Photo:** Cathodic protector – no weeds inside of infrastructure (2.51s)

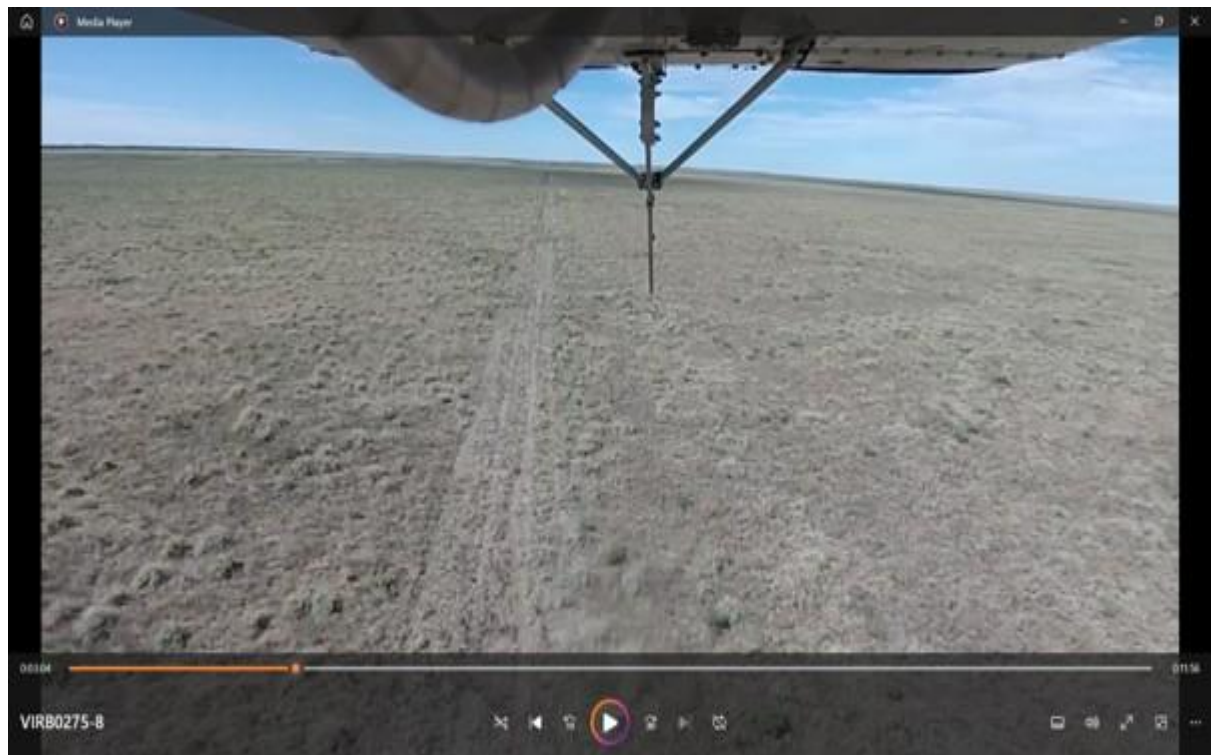
**Photo:** Vegetation 5 (3.04s)

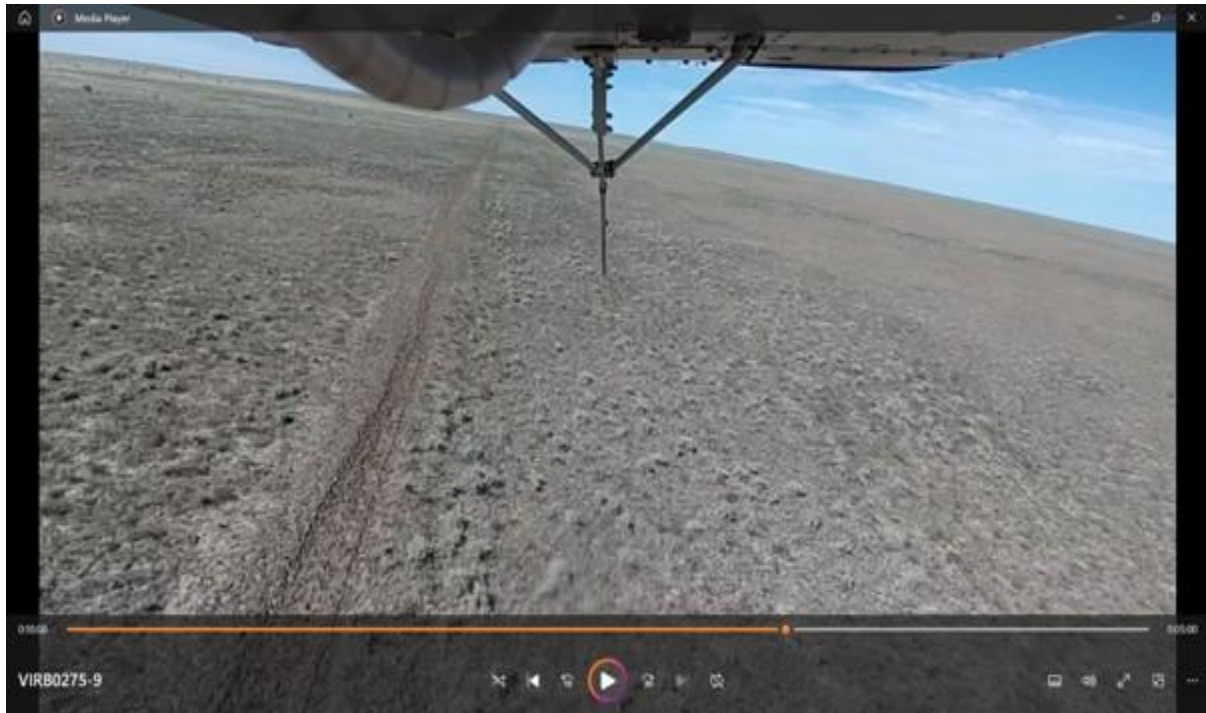
**Photo:** Example of vegetation 5 on QLD side of Pipeline.

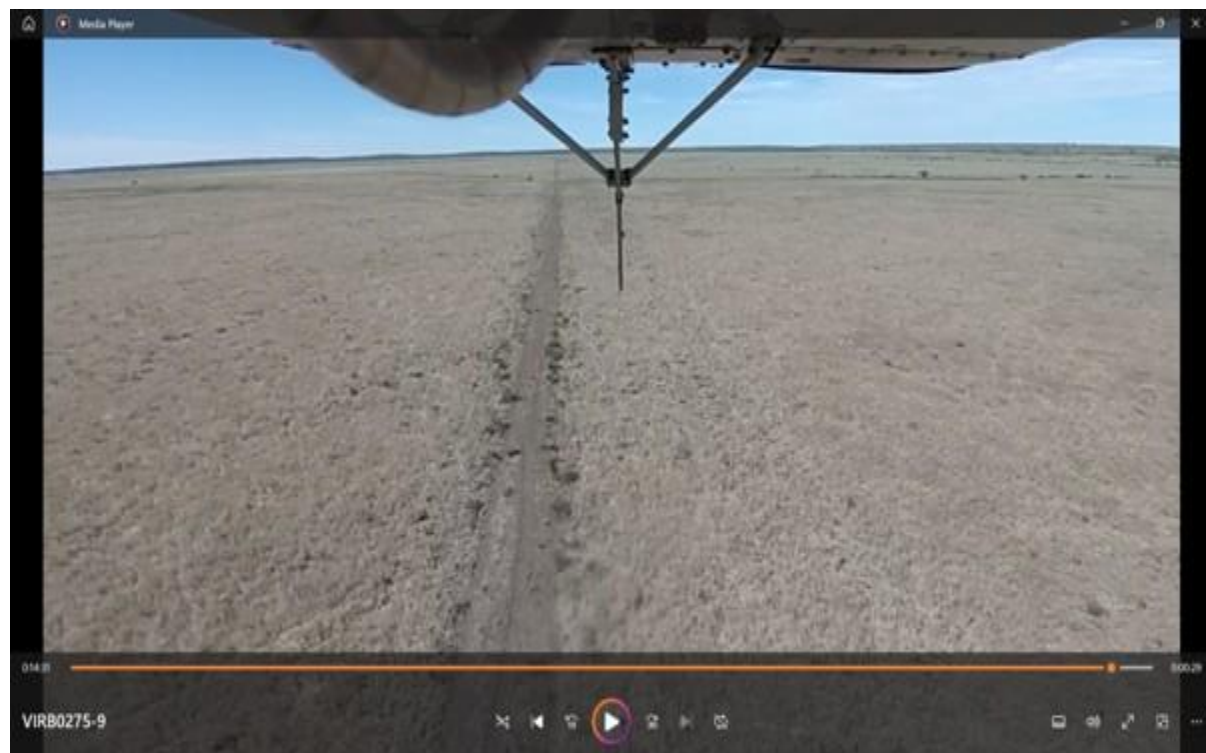
**Photo:** Example of vegetation 5 on QLD side of Pipeline.

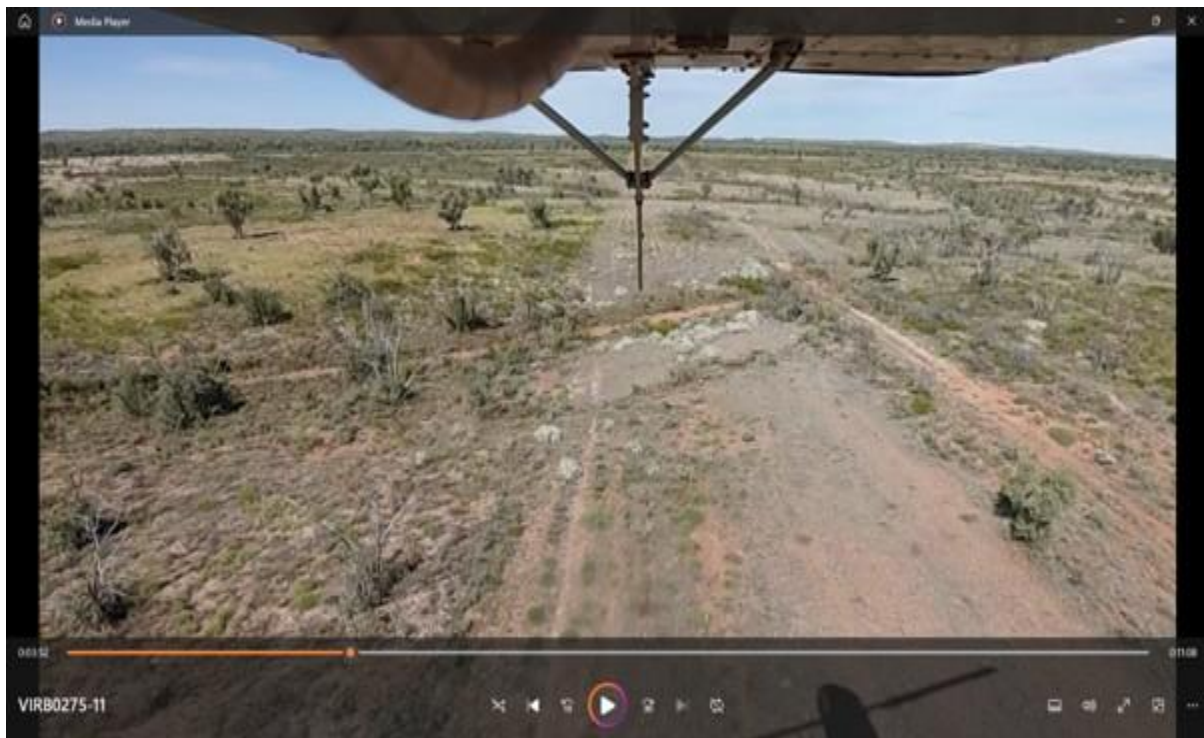
**Photo:** Example of kapok infestation that continues along pipeline until Mt Isa Compression station (3.52s)

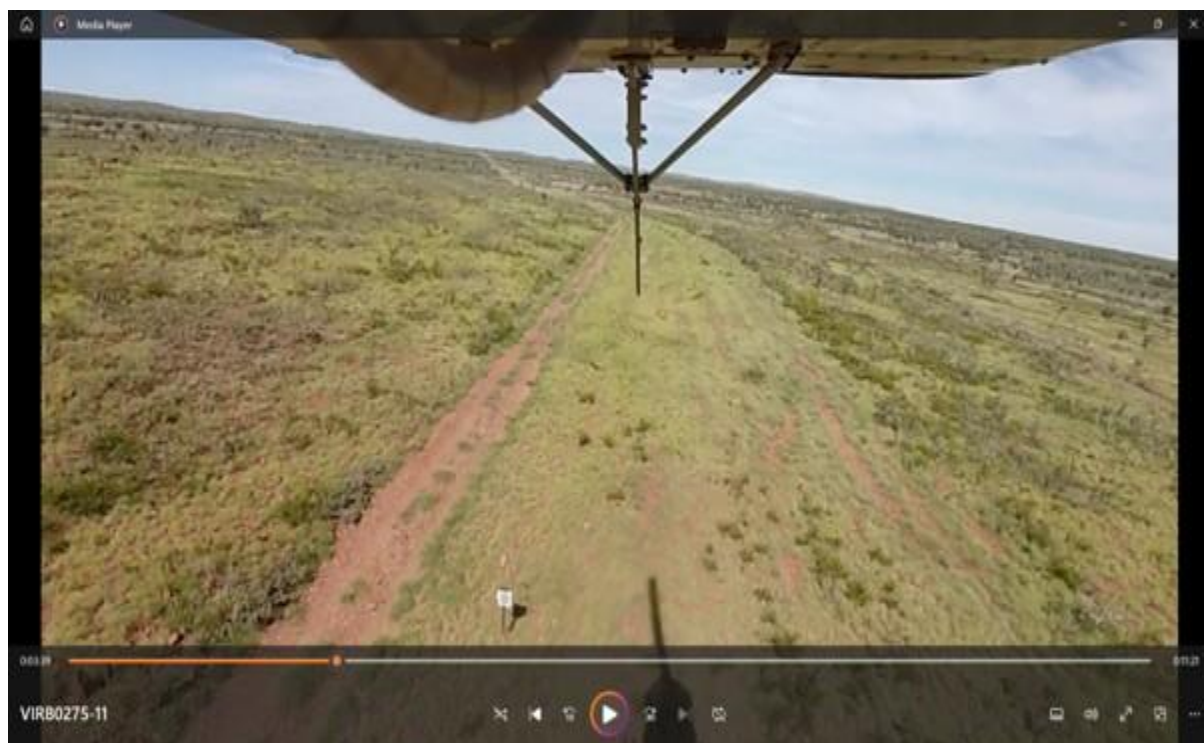
**Photo:** Example of vegetation 4 on QLD side of Pipeline.

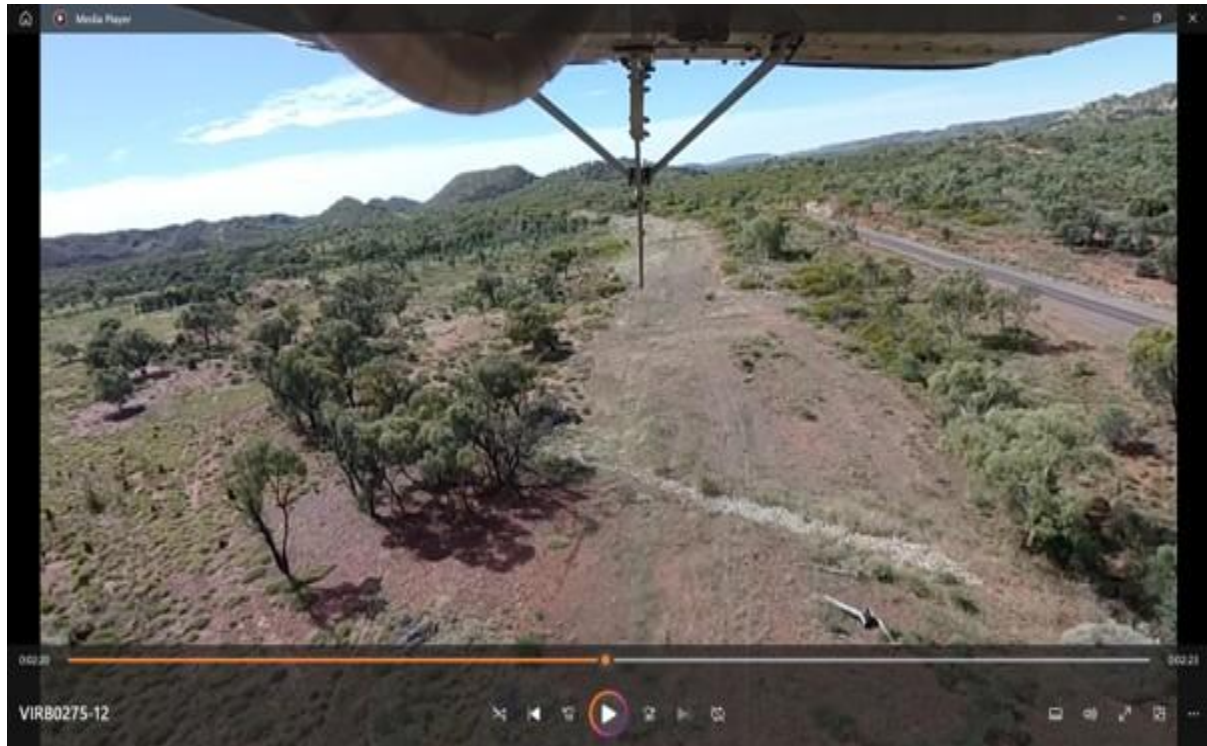
**Photo:** Rehabilitation work completed to prevent further erosion in waterways (2.20s)

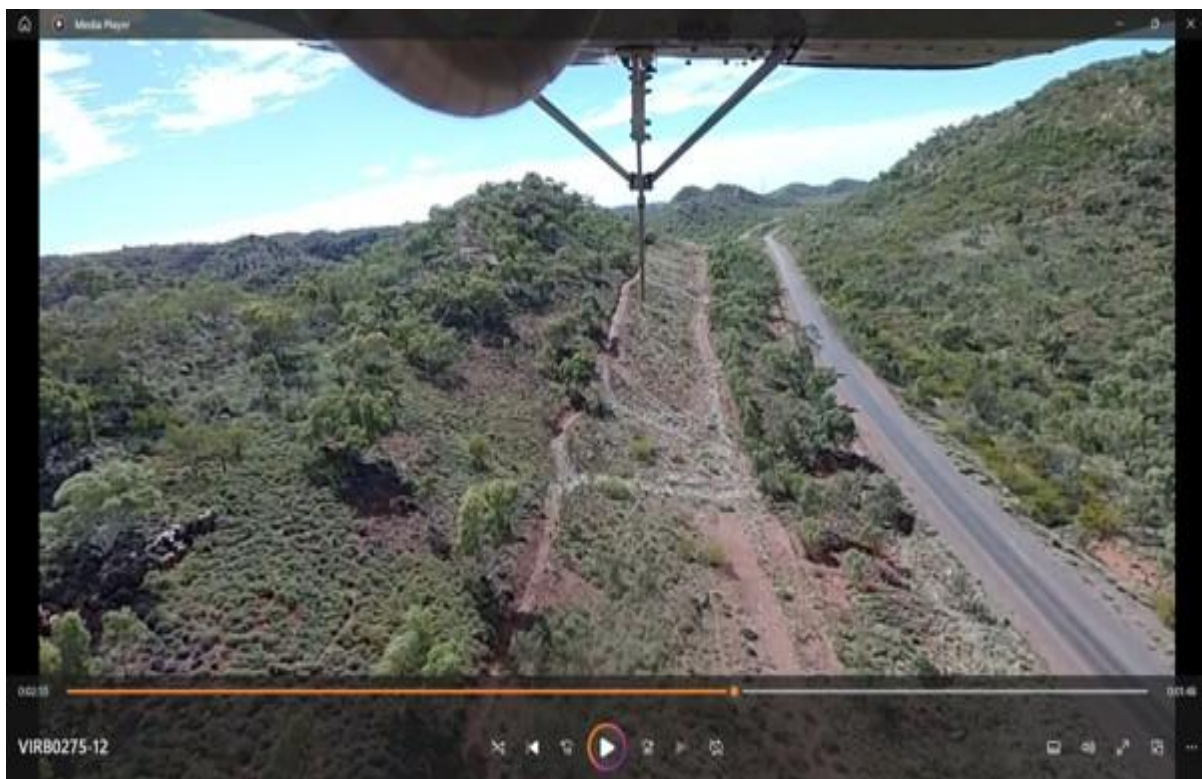
**Photo:** Rehabilitation work completed to prevent further erosion down slopes (2.55s)

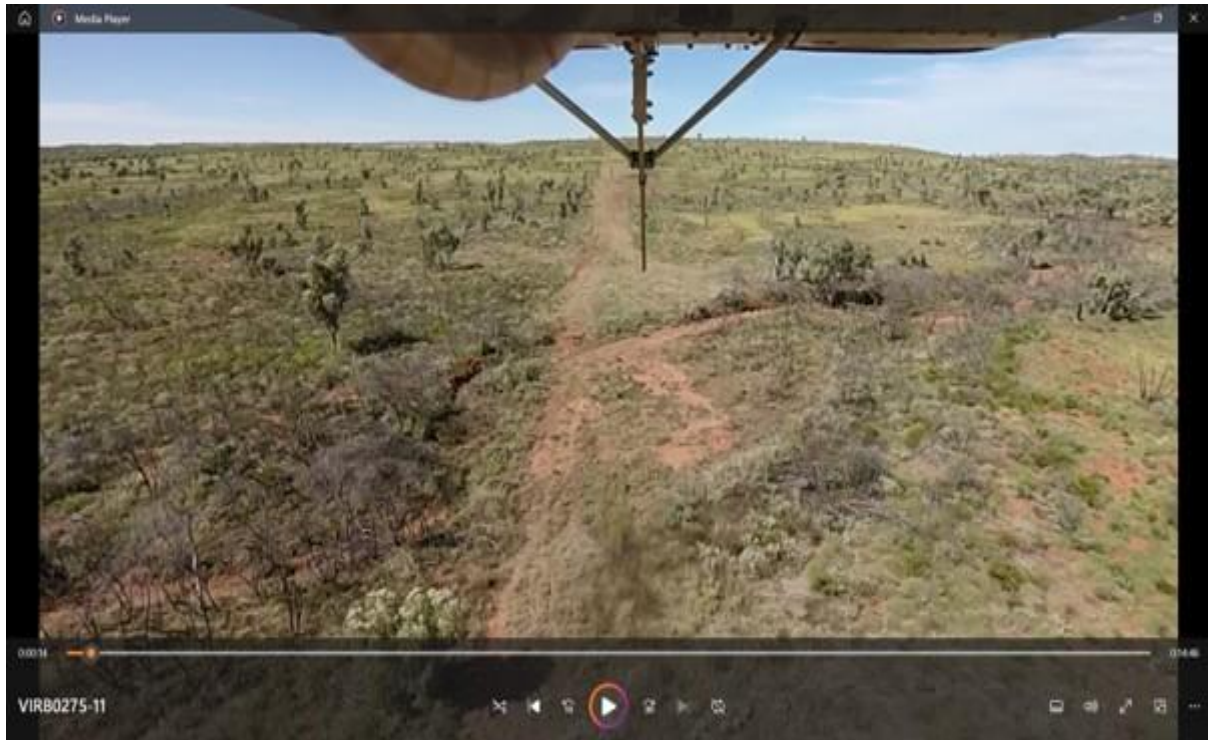
**Photo:** Light erosion on either side of riverbed crossing erosion 2 (0.14s) (VIRB0275-1, KP570-KP600)

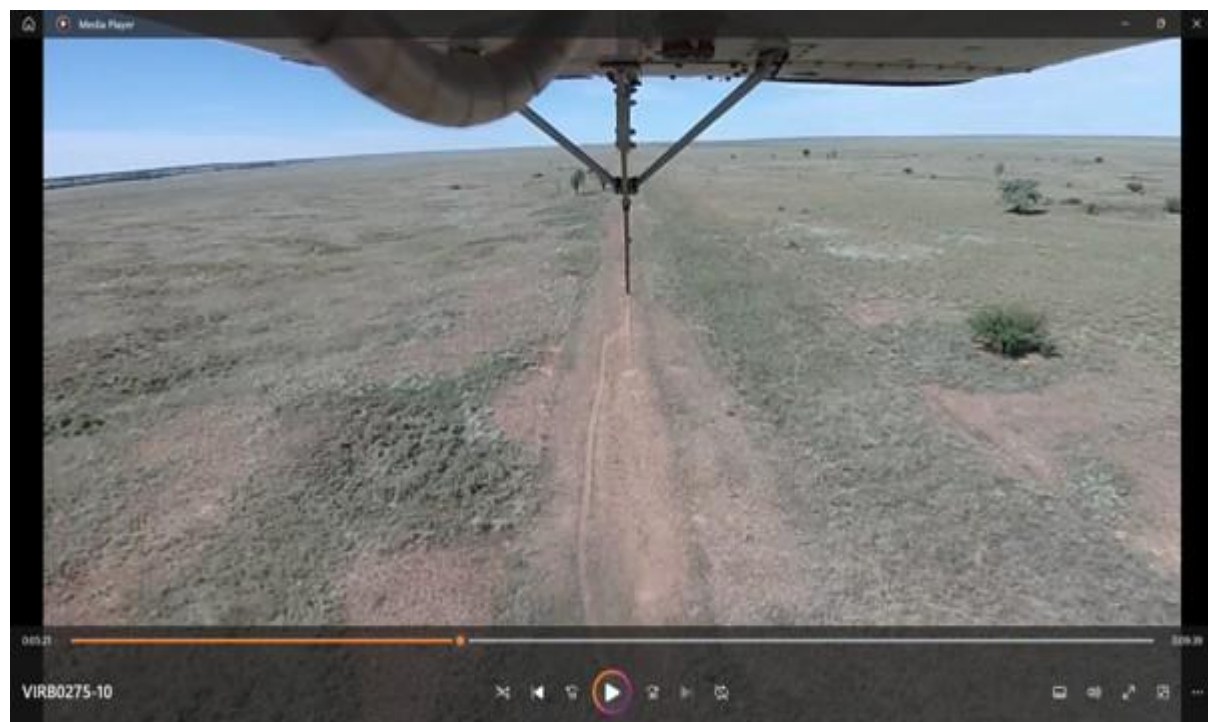
**Photo:** Vegetation 3 patches of non-vegetated areas, prickly acacia can be seen to the right of the ROW. Prickly acacia is a Weed of national significance and must be removed (5.21s)
