NGP ANNUAL COMPLIANCE REPORT - 2025

| Project Name | Jemena Northern Gas Pipeline |
| Approved Action | Construct and Operate a buried 622 km high-pressure gas pipeline from Tennant Creek (Northern Territory) to Mount Isa (Queensland) |

JEMENA NORTHERN GAS PIPELINE TRANSITIONAL REHABILITATION ASSESSMENT REPORT 2025

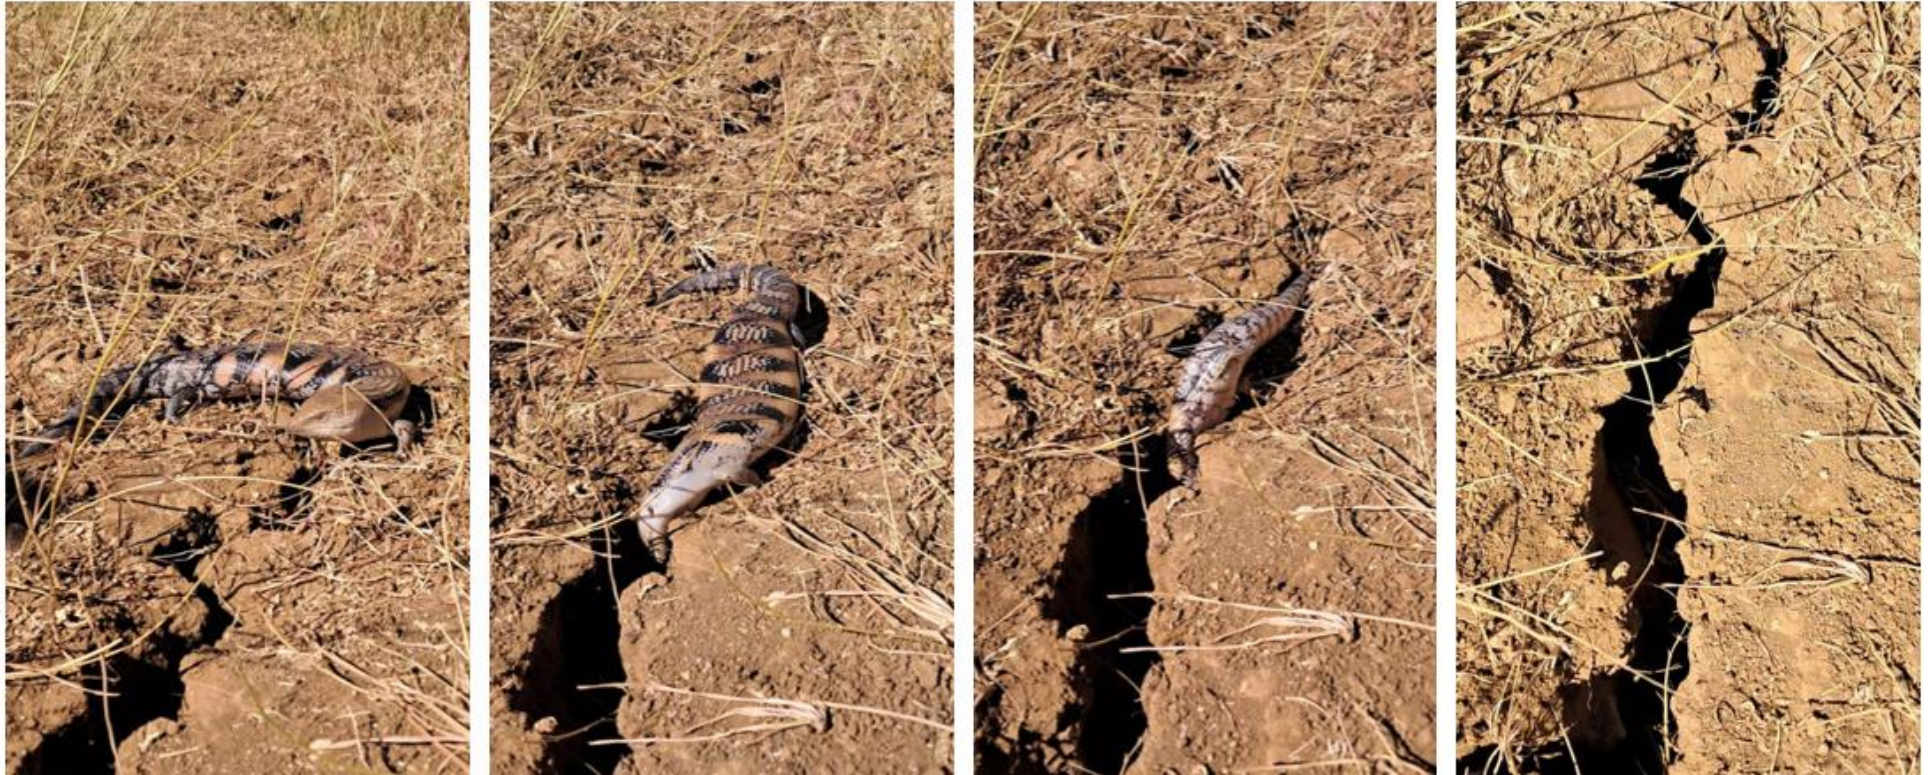
The number of cracks and holes on the ROW compared to off the ROW was deemed to be representative at most sites. See Figure 4-20/Figure 4-21 for examples of cracks and holes formed on the ROW.

Figure 4-20. Blue tongue lizard using crack formed on the ROW.
