NGP ANNUAL COMPLIANCE REPORT - 2024

TRANSITIONAL REHABILITATION ASSESSMENT

REPORT 2024

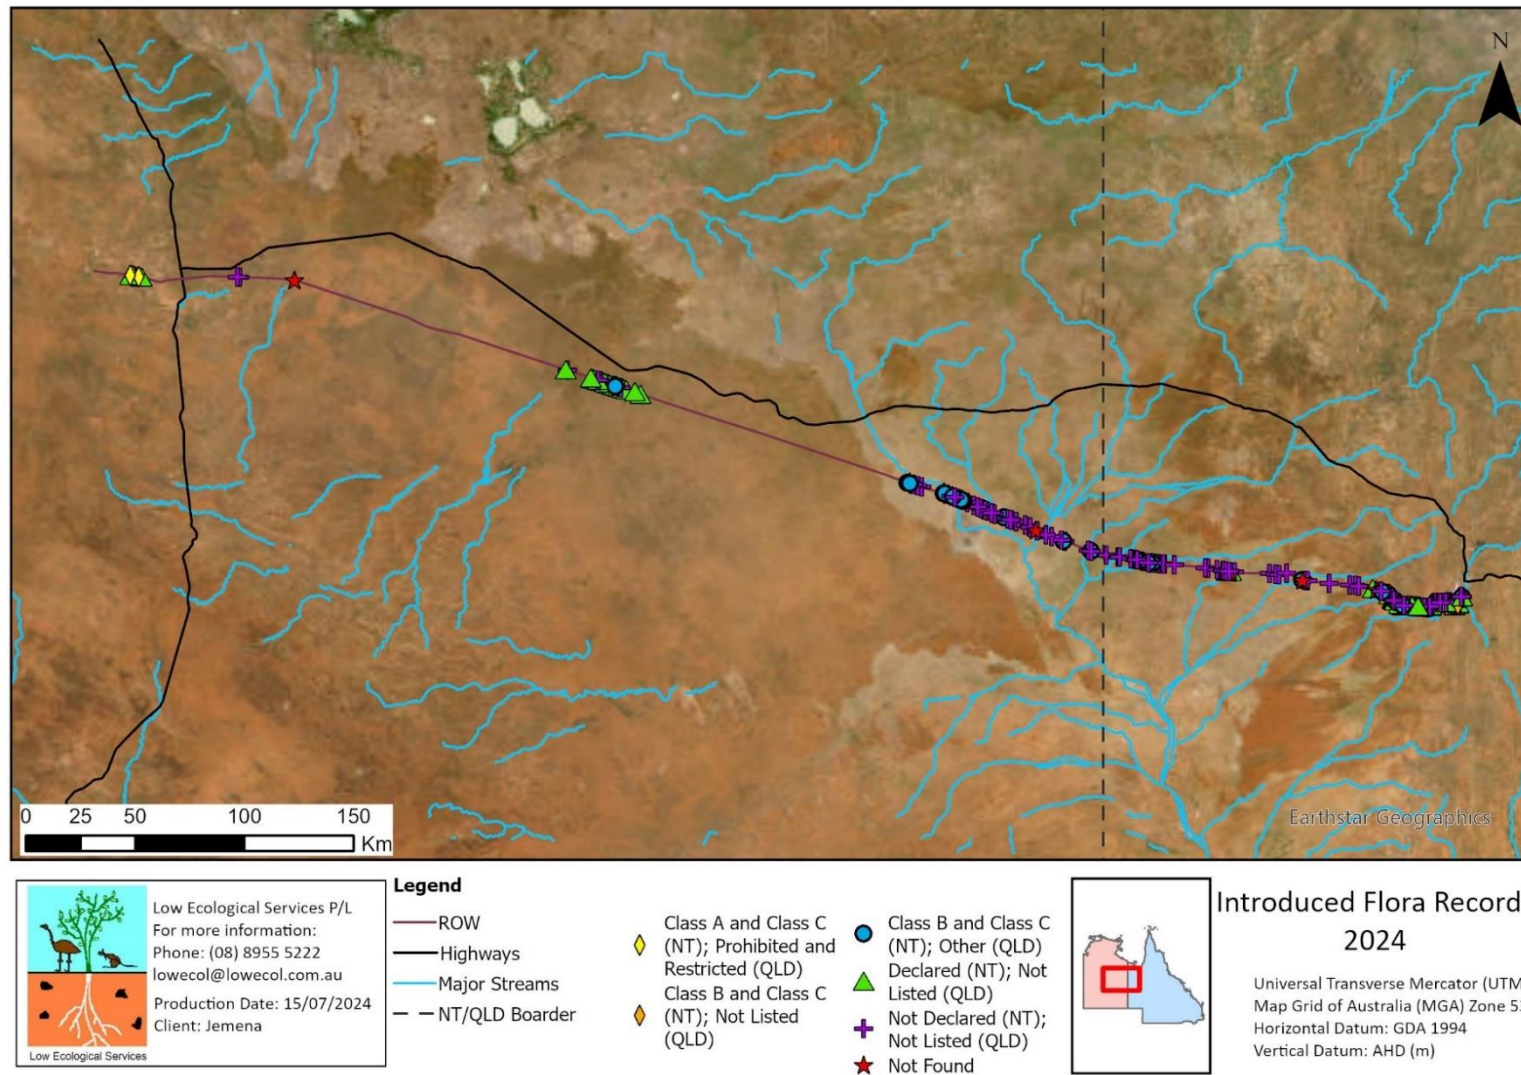
The assessment of weeds along the pipeline easement was similar to the 2023 assessment. On a few occasions the presence of weeds recorded in 2023 could not be found in 2024 and these may have been removed during grading of the ROW or fires. Several new areas were identified with weeds that were not recorded in 2023, *Parkensonia aculeata* (Parkensonia) and *Caltropis procera* (Rubber Bush) were weeds observed within the ROW this year compared to 2023. Observations of *Hyptis suaveolens* (Horehound) and *Trichodesma zeylanicum* (Cattle Bush) were not made this year but were noted in 2023. A map of the introduced flora species observed during the survey is presented in Figure 4-1, and refer to Appendix A, Table 9-3 for weed locations.

Figure 4-1. Introduced flora species observed during the survey displayed by weed classification. Refer to Table 4-1 for state and territory categories. Weeds designated 'Not Found' were identified in 2023 but were not found in this survey (2024).

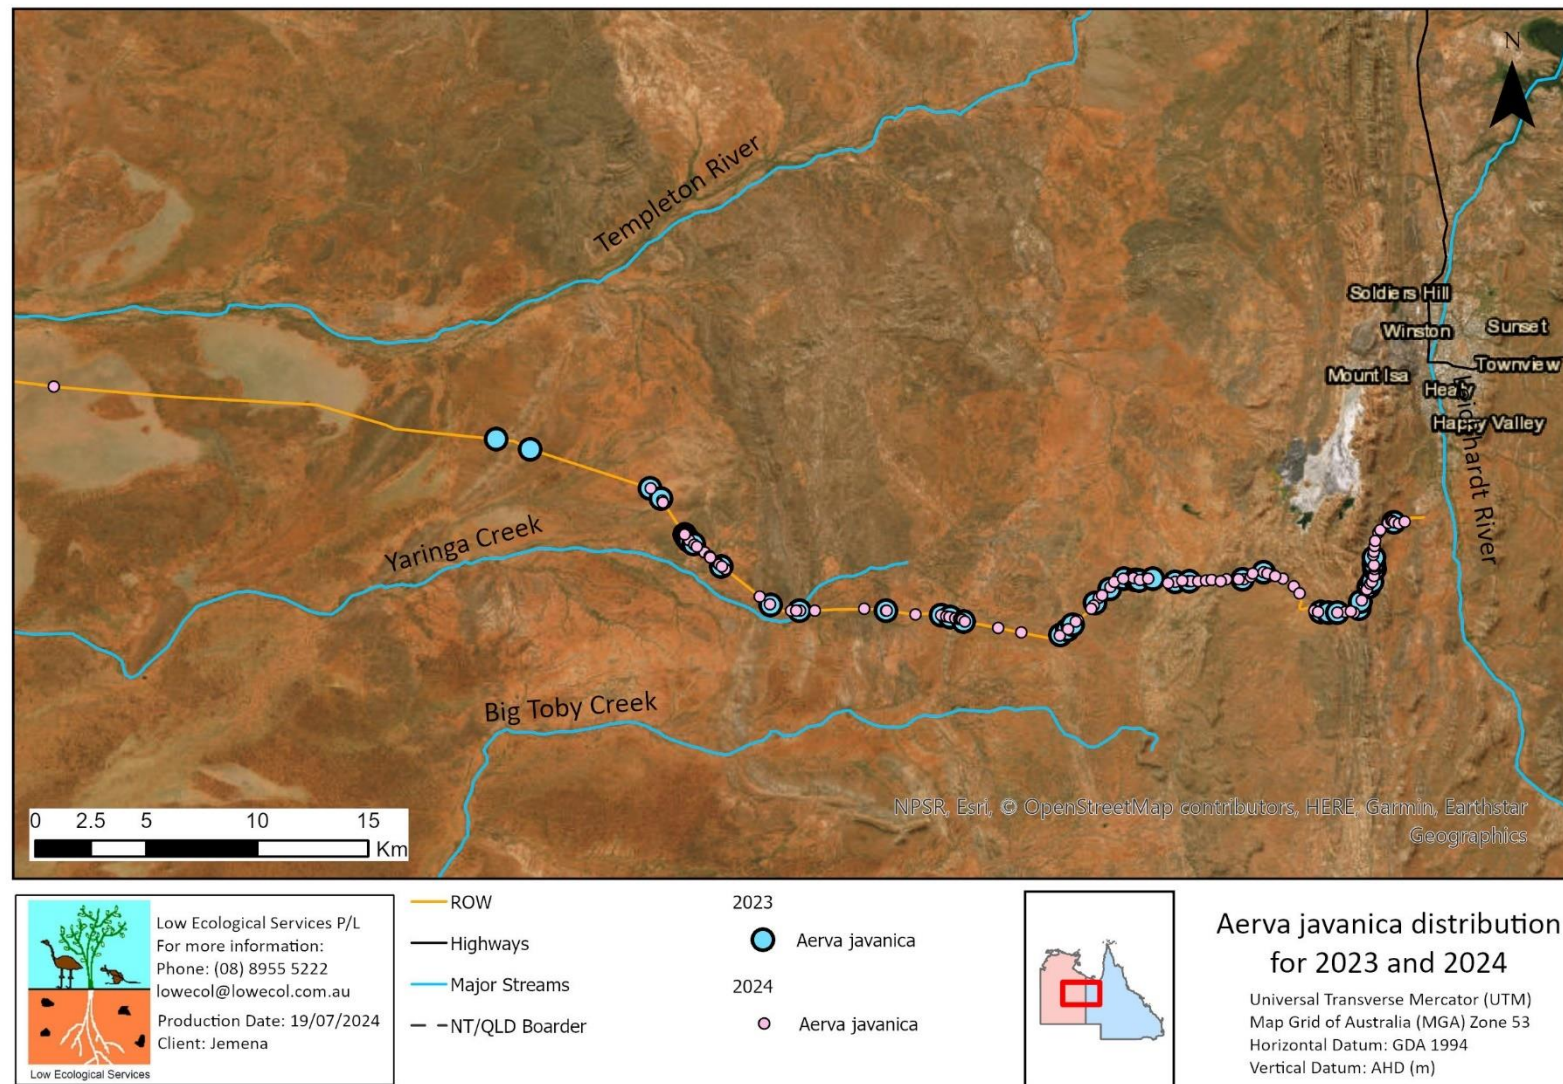
Figure 4-2. Comparison of *Aerva javanica* (Kapok bush) distribution along the NGP ROW 2023 vs 2024.

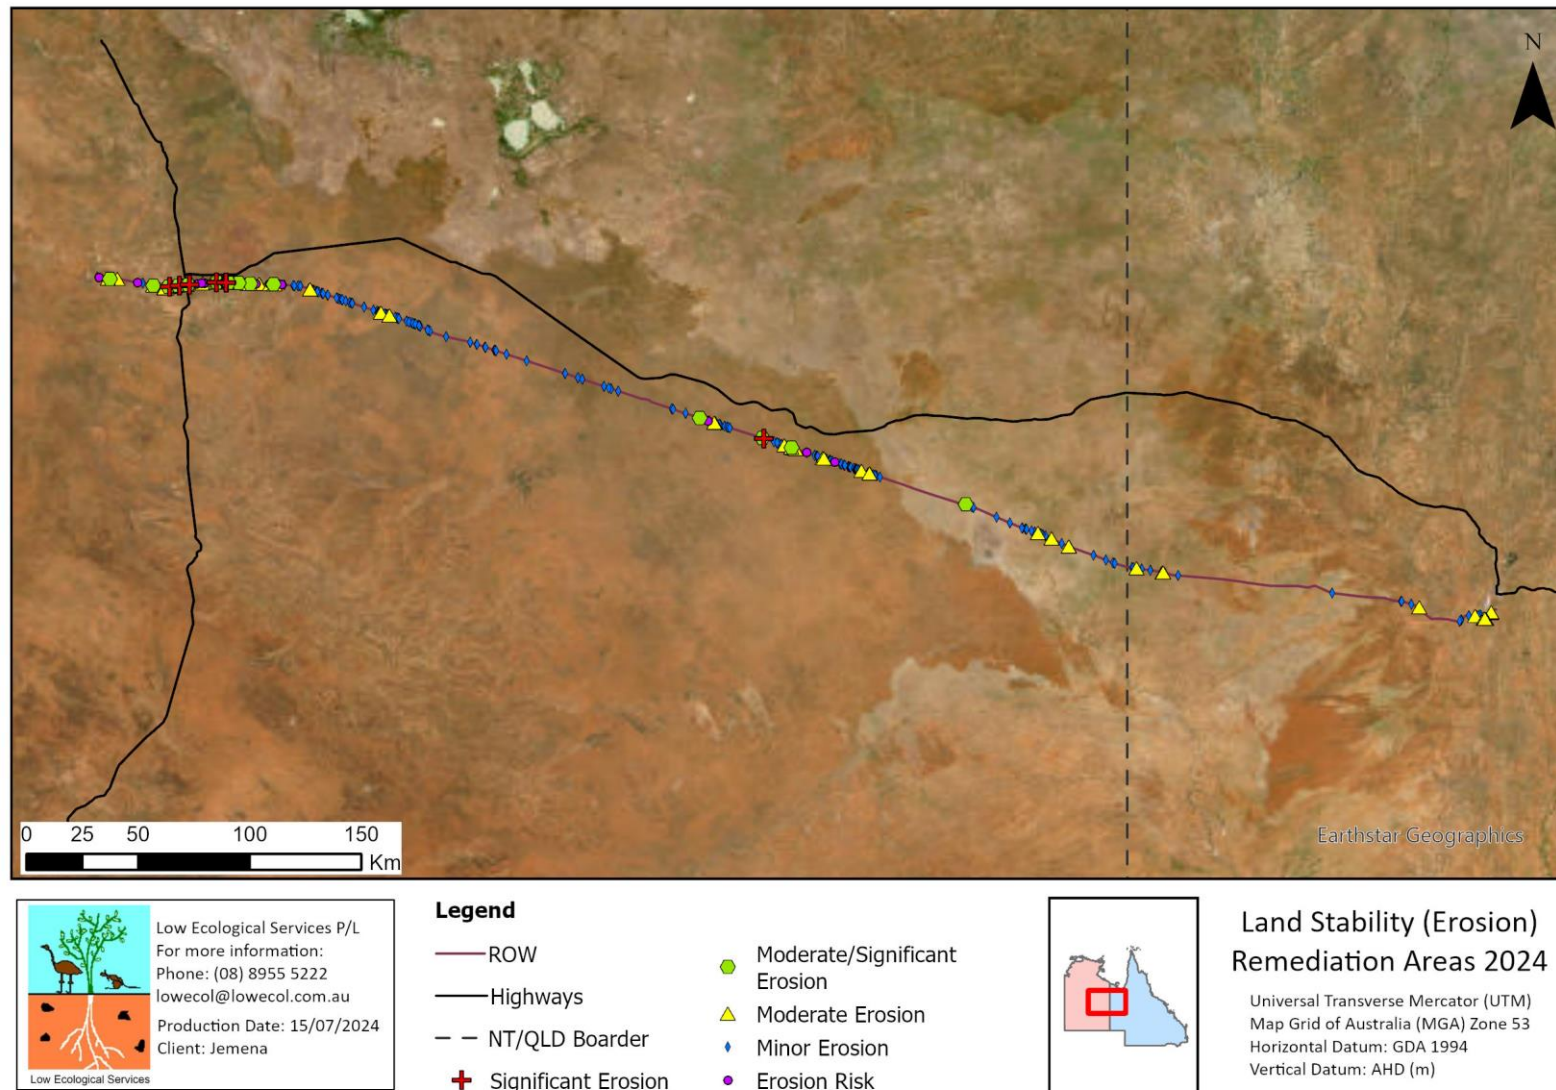
Just after KP 272, there is an unmarked access track (unknown use) that seems to have diverted water along it, causing a large amount of sheet flow onto and down the ROW, causing Level 3 erosion. Erosion control berms along that access road would help to prevent future erosion.

Between KP 620 and KP 621 the ROW runs along the side of a steep slope, next to the Boulia Mt Isa Highway, with many naturally occurring drainage gullies. Some of these gullies have erosion matting laid on them which are starting to deteriorate in places, and two of the gullies are starting to erode above and underneath the matting. These have been classified as Level 3 erosion due to the potential of increased erosion. Deteriorated matting should be replaced and extended up the slope to prevent it from flowing under the matting.

Figure 4-3. Location of significant, moderate/ significant, moderate, and minor erosion along the NGP ROW.

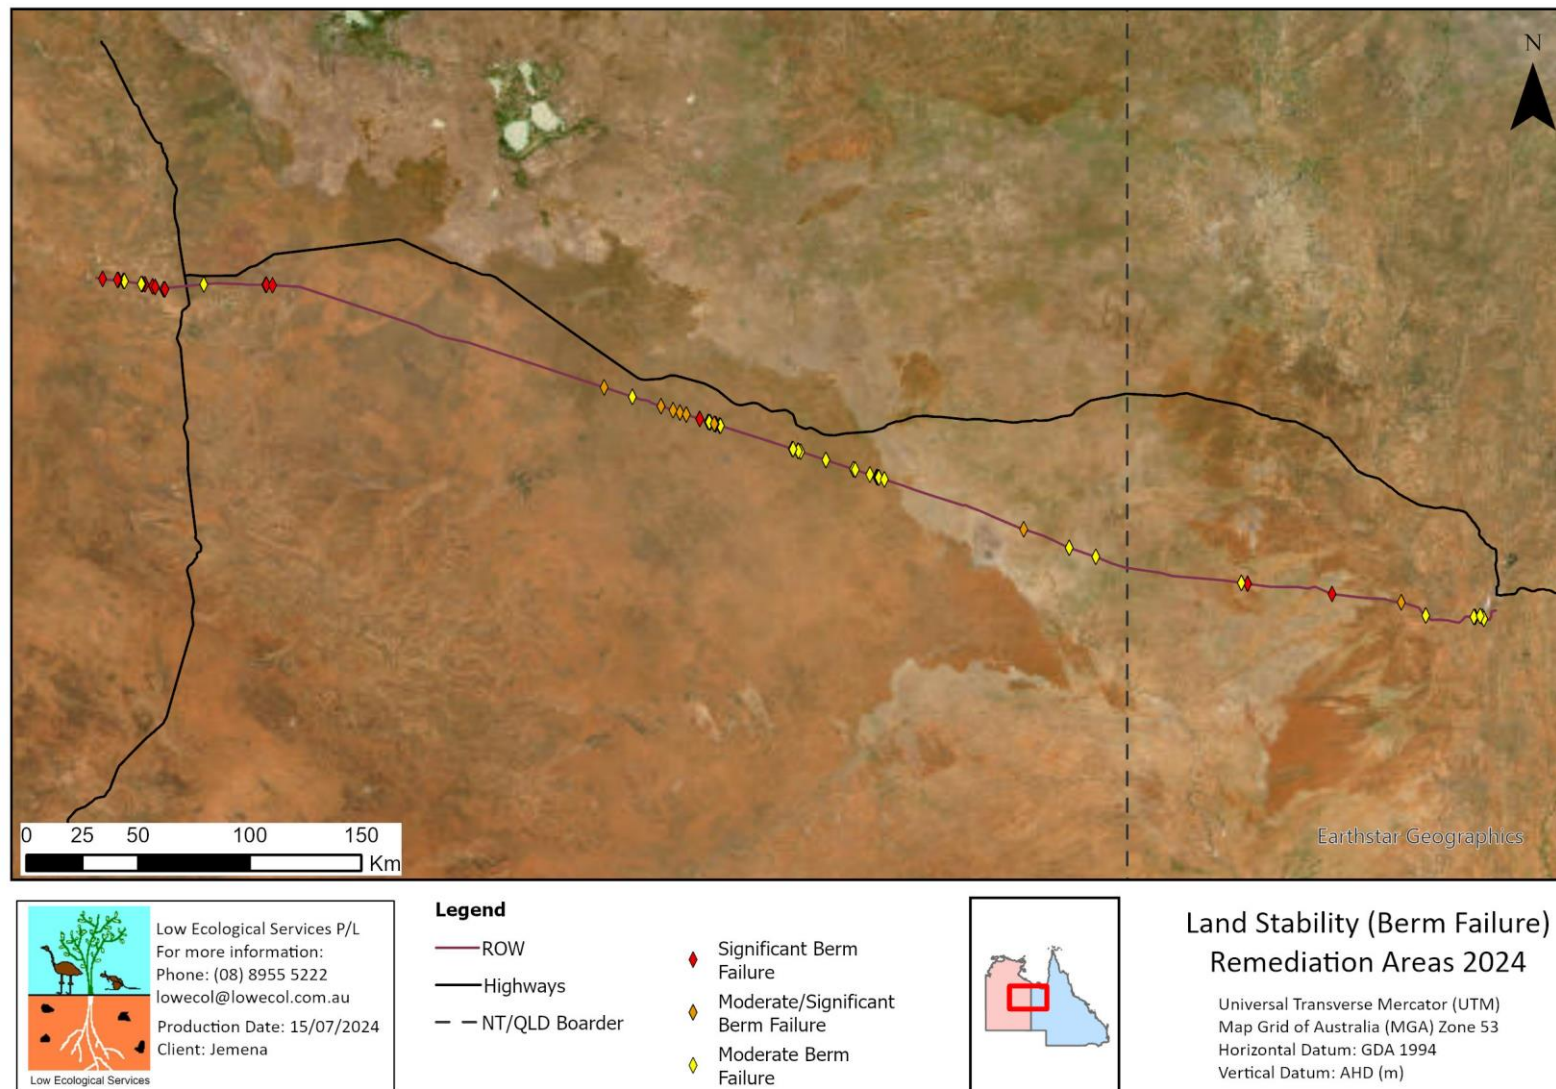
Damage was most often due to water erosion resulting in erosion channels through the berms or the berms being washed out. There were several occurrences of water flowing around the ends of berms and back onto the ROW rather than diverting outwards into adjacent land. This was often due to berms not extending far enough at the edges of the ROW. Cattle tracking has also caused erosion of berms in some instances, as well as vehicle activity along the access track of the ROW. Nine berms had been removed during grading operations for vegetation clearing. A few berms were ineffective due to their orientation on the ROW where the construction of the berm did not follow the natural lay of the land and caused water to flow directly back onto the ROW.

Figure 4-4. Locations of observed compromised berms along the NGP ROW.

Many of the berms would be more effective if they extended beyond the disturbed area of the ROW easement to divert and disperse water out onto adjacent undisturbed land. This may have occurred due to heritage buffers restricting the construction of berms to inside the ROW. These berms that do not extend beyond the ROW do not divert water off the easement completely allowing water to flow around the end of the berm and continue channelling downslope along the ROW increasing the risk of erosion.

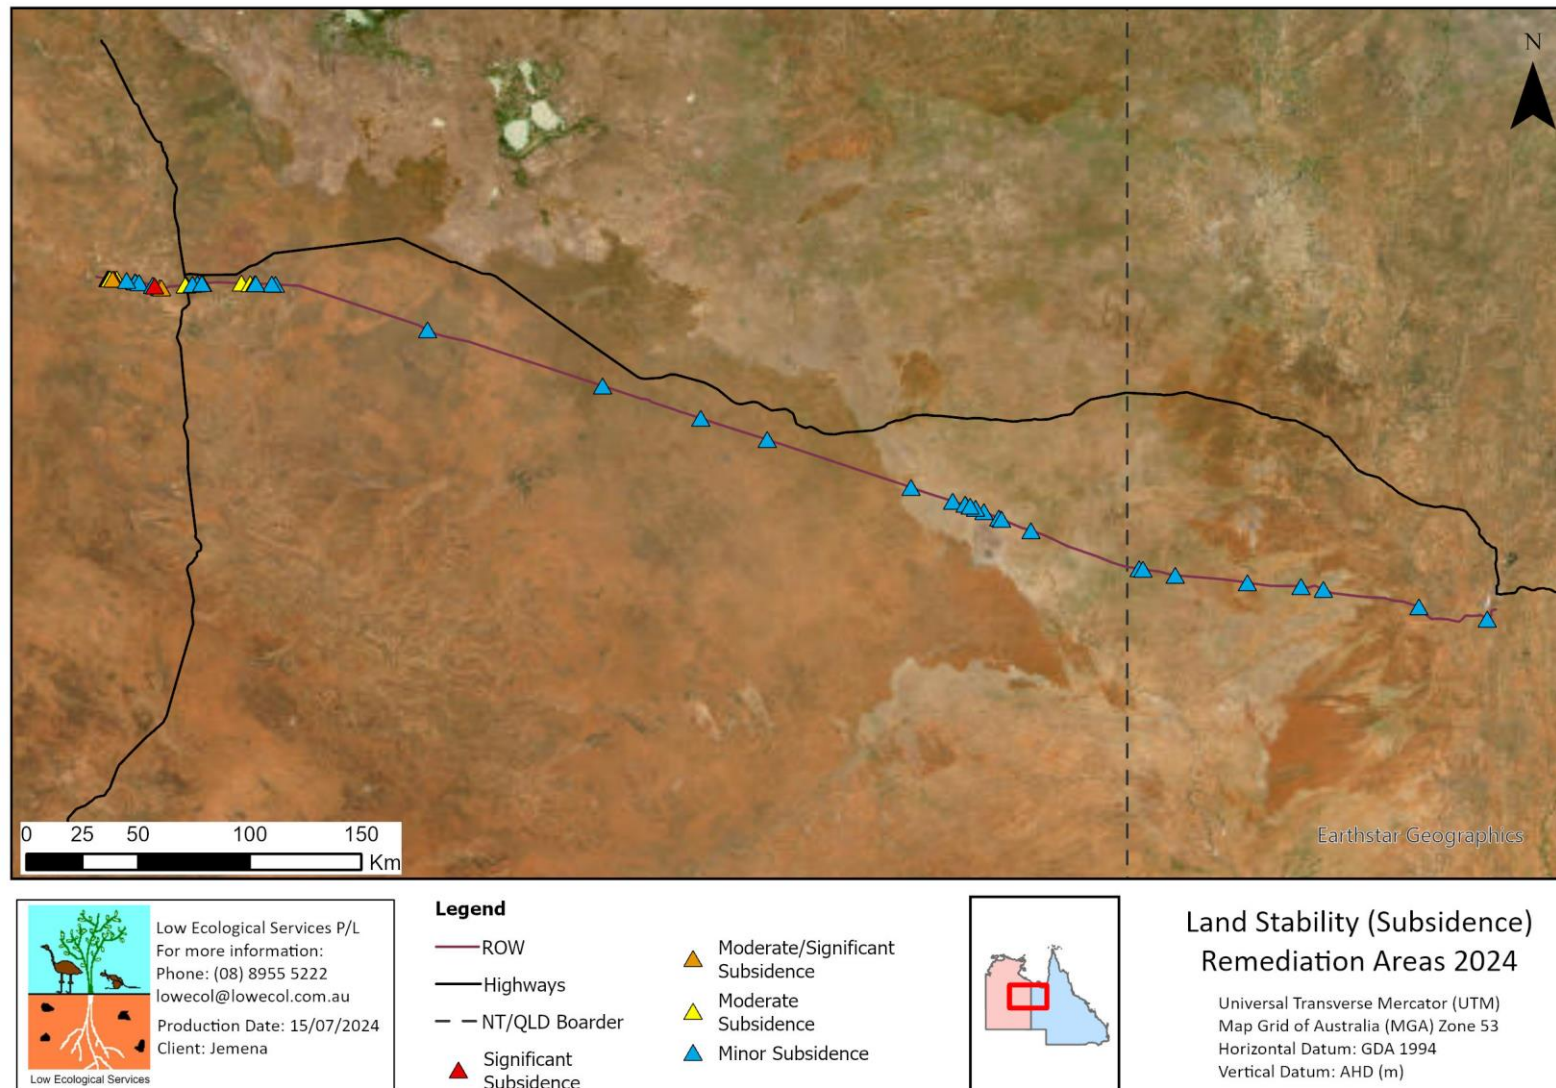
Subsidence issues were assessed as significant (2 instances), significant/moderate (9 instances), moderate (7 instances) and minor (39 instances), ranging from 100-500 mm in depth. Filling in of subsidence is recommended in all instances of significant, significant/moderate and moderate subsidence issues, with monitoring recommended for minor subsidence issues.

Figure 4-5. Locations of observed subsidence along the NGP ROW

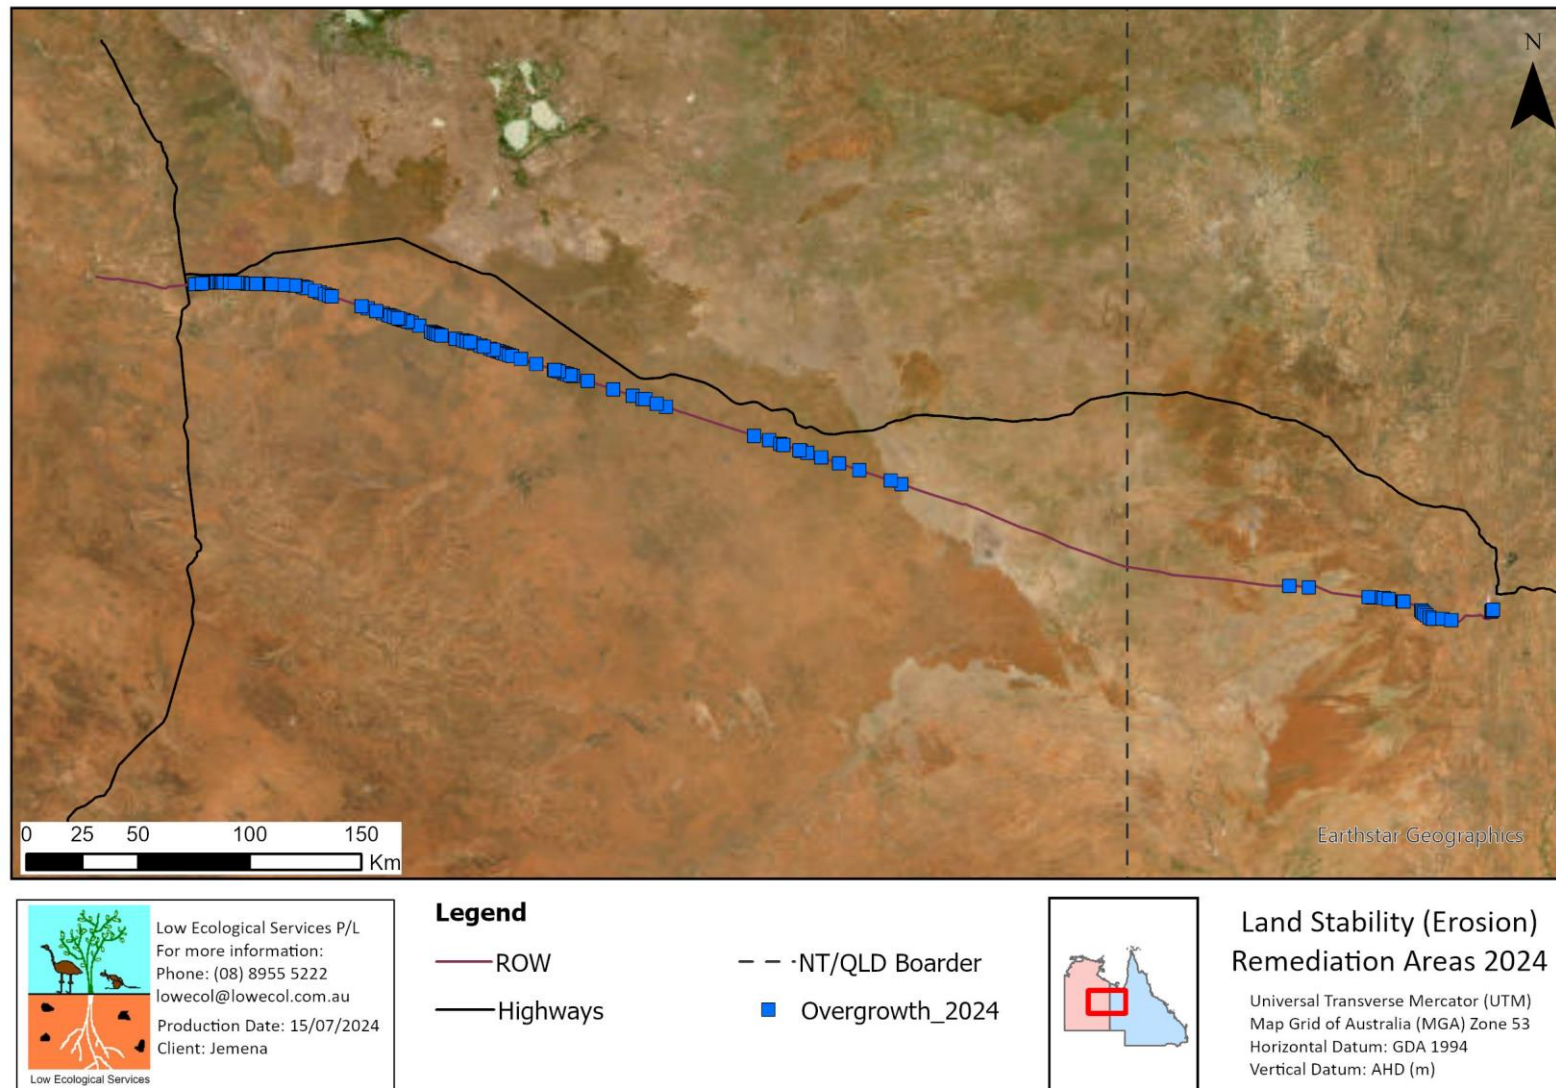
The ROW between KP 356 - KP 526 and KP 535 - KP 560 crossed the Barkley, Georgina, Wonardo, Austral, Wonorah-Barkley and Kalalla land systems of the Barkley Tablelands. This section is characterised by open grass plans with very little woody vegetation growth. No overstory growth was observed along the ROW and the ground cover does not obstruct vision or impact on pipeline infrastructure, therefore can and should be maintained. All other areas consisted of an overstorey which needs to be removed and continually discouraged from establishing through regular slashing.

Figure 4-6. Overgrowth along the NGP ROW.

Clearing and grading will be required in these areas, currently, to remove the undesirable vegetation which has grown. This will likely remove most ground cover and reduce the overall rehabilitation condition. While not ideal for the purposes of rehabilitation, it is required to protect Jemena's assets and enable further management. The current ground cover has shown resilience and the ability to establish quickly in the right conditions (refer to Section 7.3) and therefore recovery should be rapid.
