# NGP ANNUAL COMPLIANCE REPORT - 2026

# JEMENA NORTHERN GAS PIPELINE TRANSITIONAL REHABILITATION ASSESSMENT REPORT 2026

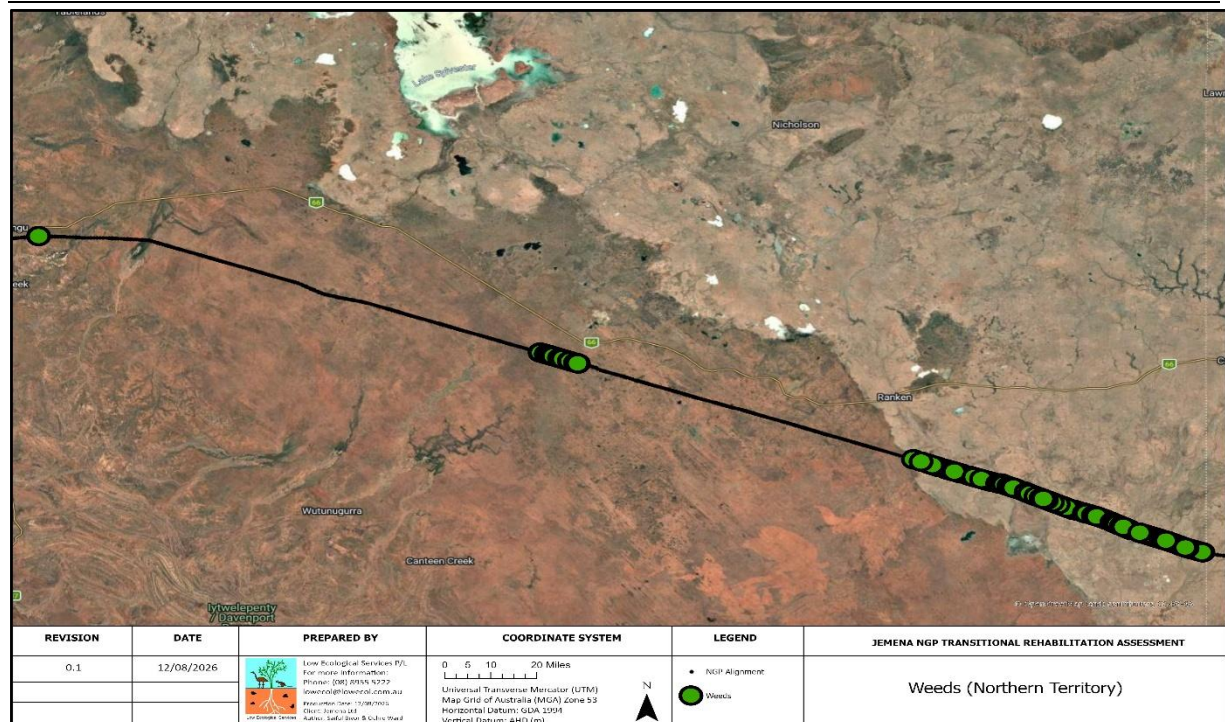
**Figure 5-1: Weed Species Recorded During the 2026 NGP Transitional Rehabilitation Assessment (NT)**

Introduced flora species remained common along sections of the Northern Territory portion of the NGP ROW during the 2026 transitional rehabilitation assessment. Species recorded included Buffel Grass (*Cenchrus ciliaris*), Kapok Bush (*Aerva javanica*), Spiked Malvastrum (*Malvastrum americanum*), Mesquite (*Prosopis* sp.), Prickly Acacia (*Vachellia farnesiana*), Noogoora Burr (*Xanthium strumarium*) and Parkinsonia (*Parkinsonia aculeata*). Spiked Malvastrum was the most frequently recorded introduced species, followed by Prickly Acacia, Buffel Grass and Mesquite.

Previous assessments found that weeds occurring on the ROW may originate from a combination of surrounding pastoral land, cattle movement, vehicle traffic and disturbance associated with construction and maintenance of the pipeline. In 2025, weed occurrences were generally reported at low density and were considered largely associated with encroachment from adjacent pastoral land, although the ROW and vehicle access were also recognised as potential pathways for weed establishment and dispersal. The GPS location for each weed record is provided in **Appendix A**. Representative photographs of weed infestations and weed conditions observed during the 2026 field assessment are provided in **Appendix J**.

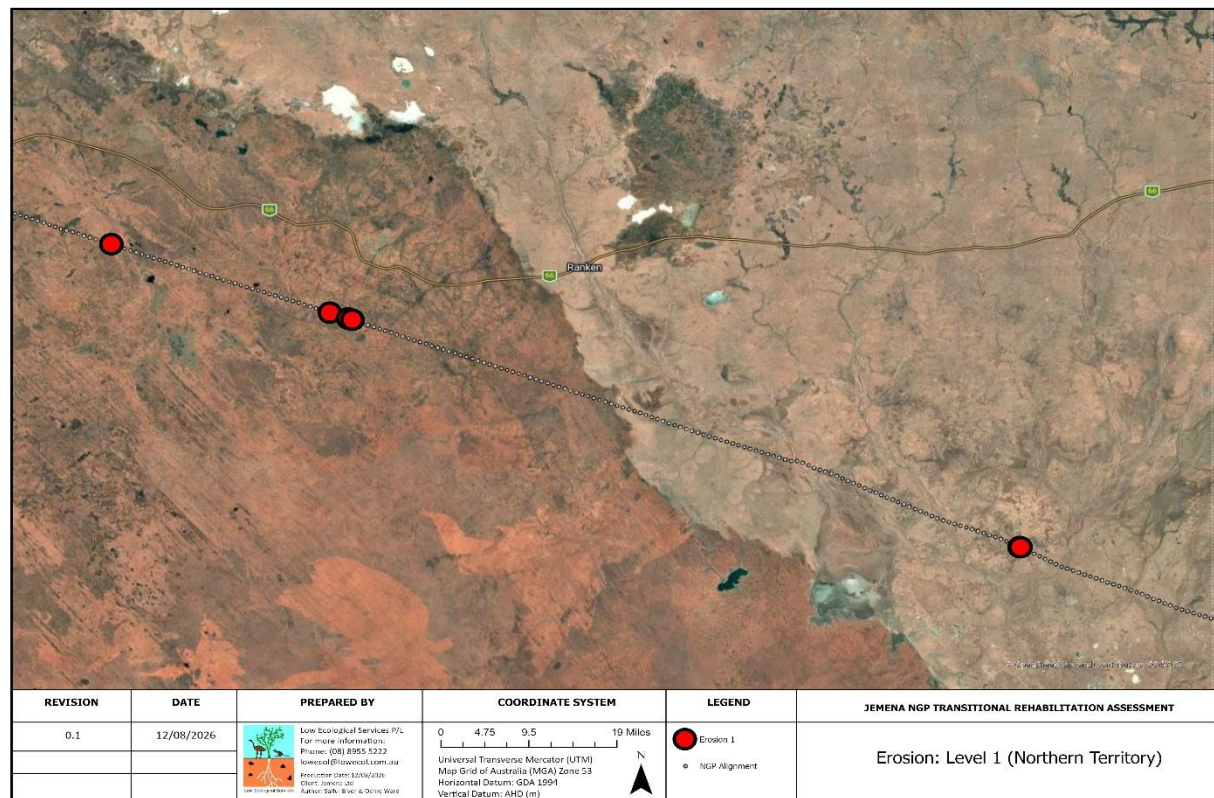
**Figure 5-2: Level 1 Erosion Locations Recorded along the Northern Territory Section of the NGP ROW, 2026**

Level 1 erosion represented only a small proportion of the total. Four Level 1 erosion areas were identified along the NT section of the ROW, comprising one between KP 265–266, two between KP 303–308, and one between KP 423–424. Two Level 2 erosion areas were also identified, comprising one between KP 50–54 and one between KP 303–304.

All Level 1 and Level 2 erosion areas should be prioritised for remediation, including filling and levelling where appropriate and the installation or reinstatement of erosion-control berms to manage surface-water flow. Attention should be given to the identified erosion locations at KP 265–266, KP 303–308 and KP 423–424. Level 3 erosion should also be remediated, particularly where earthmoving equipment is already operating nearby or where there is potential for erosion to progress. Level 4 and Level 5 erosion should continue to be monitored and managed with erosion-control measures where required. This approach is consistent with the management hierarchy applied during the 2025 assessment. Attention should continue to be given to erosion associated with drainage lines and watercourse crossings, as concentrated surface flows can increase the likelihood of erosion progression. Vehicle movements should remain confined to established access tracks as far as practicable to minimise additional disturbance to rehabilitating areas of the ROW. Locations of erosion issues are presented in **Appendix C**. Representative photographs of erosion conditions, including significant and moderate erosion areas requiring remediation, are provided in **Appendix J**.

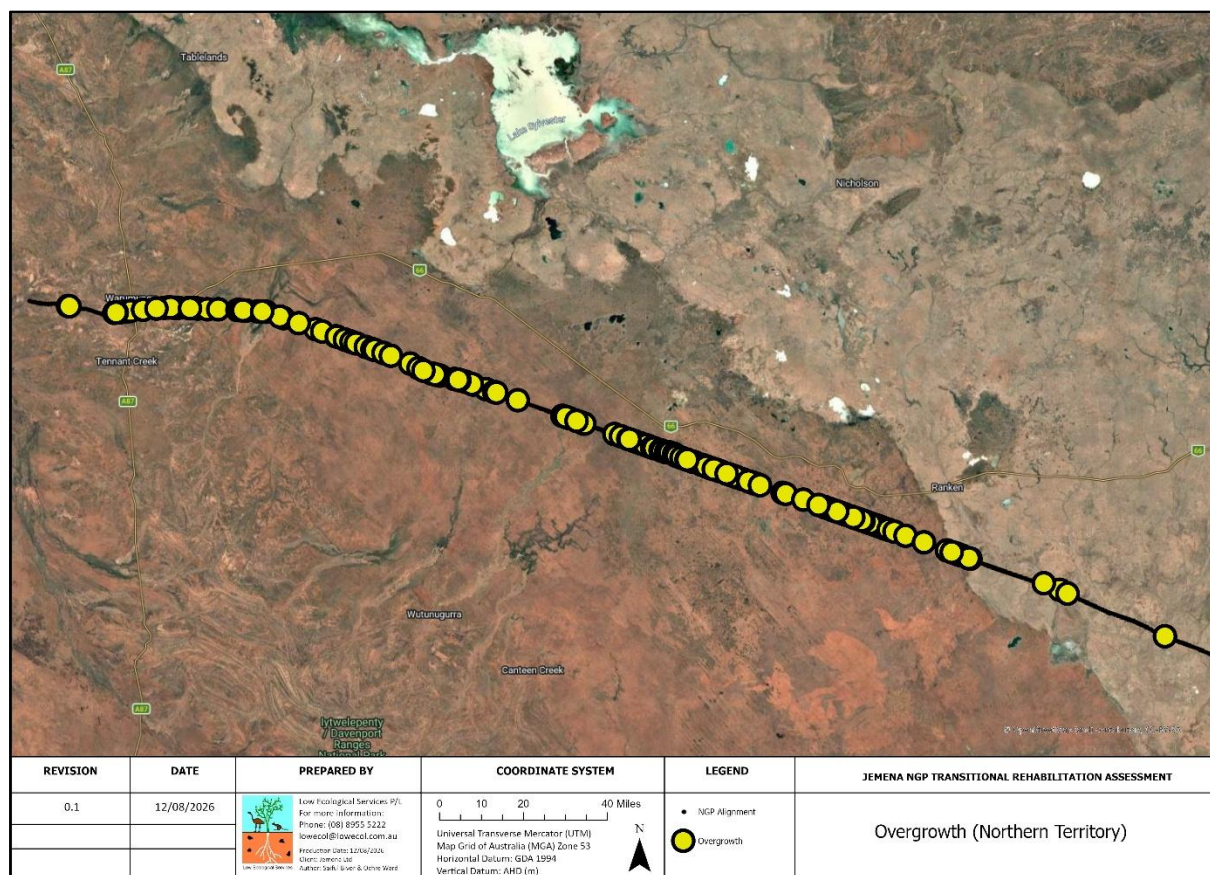
**Figure 5-12: Vegetation overgrowth Locations Recorded along the Northern Territory Section of the NGP ROW, 2026**

Areas of overgrowth were particularly evident through sections of the western and central NT portion of the ROW, including multiple clusters between approximately 134.3°E and 136.8°E. Additional occurrences were recorded farther east. The distribution of observations indicates that woody vegetation has continued to re-establish along substantial sections of the pipeline easement. The 2025 assessment found that overgrowth remained particularly evident in some sections of the ROW, although the overall extent had reduced following vegetation-clearing works. Clearing had commenced from the western end of the pipeline and had temporarily reduced ground cover in treated sections, while vegetation and topsoil removed during these works had been stockpiled adjacent to the ROW.

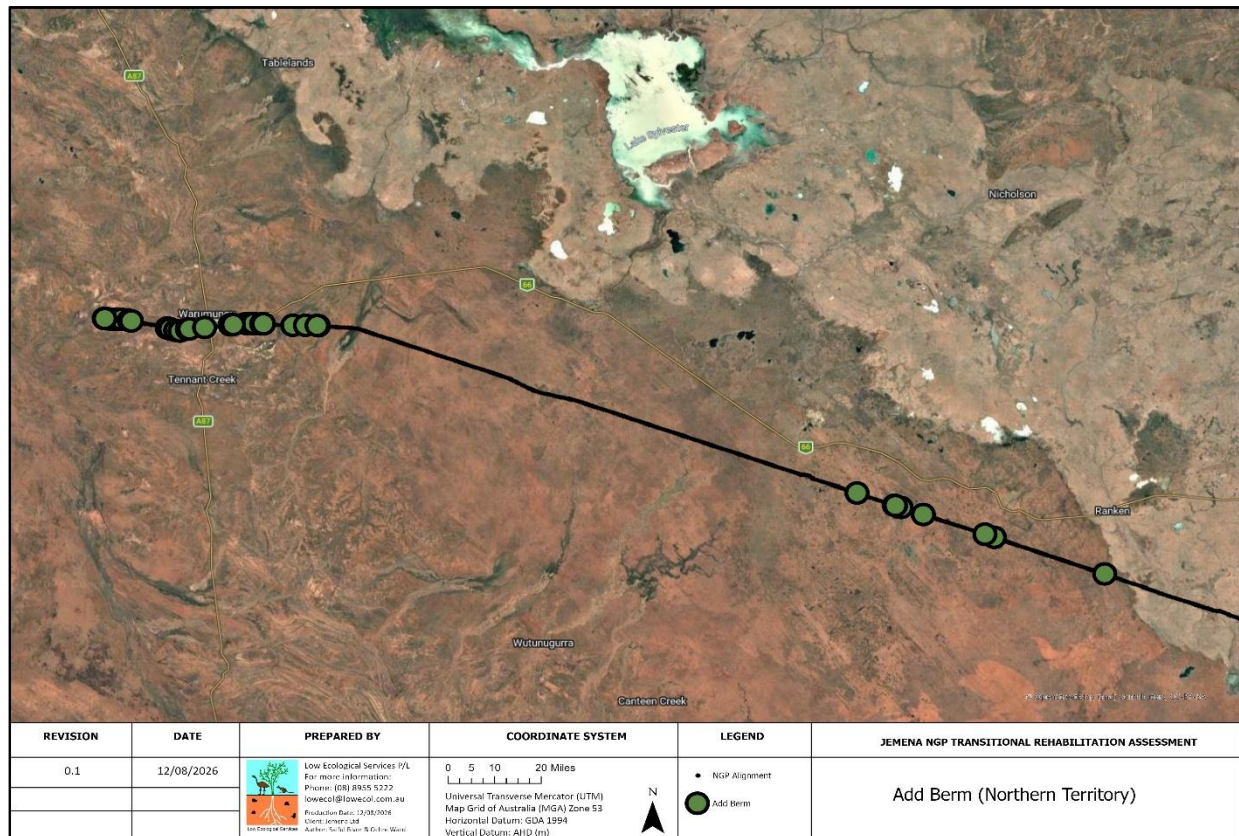
**Figure 5-13: Add Berm Locations Recorded along the Northern Territory Section of the NGP ROW, 2026**

The comparatively large number of locations requiring additional or reinstated berms indicates that runoff management remains an important land-stability issue along sections of the NT ROW. The purpose of these berms is to interrupt water flow along the easement and divert runoff away from disturbed areas before sufficient flow velocity develops to cause erosion.

Previous surveys identified several mechanisms by which berm effectiveness can be reduced, including erosion through the berm, washout, inadequate length, inappropriate orientation and removal during grading. Berms that terminate within the ROW may allow water to flow around their ends and continue downslope along the easement rather than dispersing onto stable surrounding land. Where practicable, berms should therefore be positioned and constructed to follow the natural landform and direct runoff away from the ROW. The 2025 survey also identified wide, shallow berms as preferable to tall, narrow structures where vehicle and machinery access needs to be maintained.

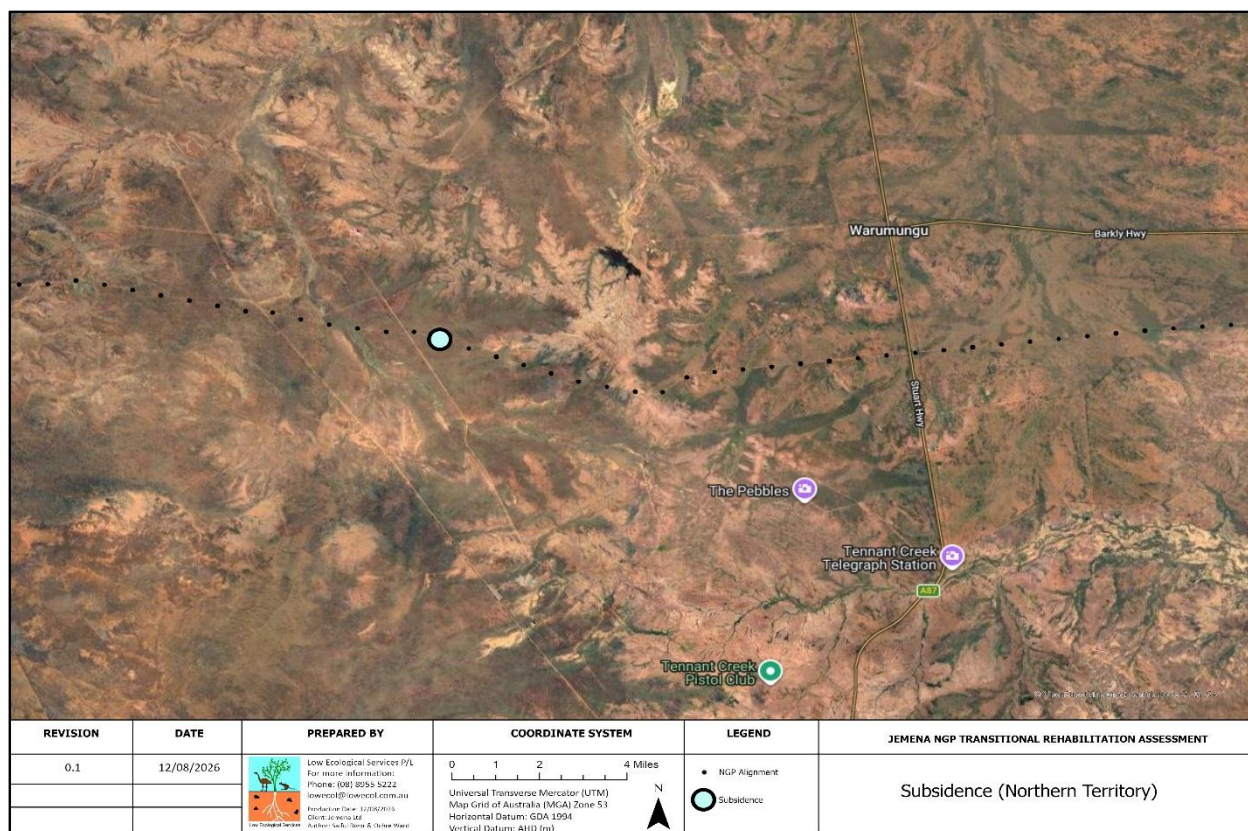
**Figure 5-15: Subsidence Locations Recorded along the Northern Territory Section of the NGP ROW, 2026**

One instance of subsidence was recorded along the Northern Territory section of the NGP ROW during the 2026 transitional rehabilitation assessment. The subsidence was classified as Level 1 (significant) and was recorded between KP 21–22, at approximately 134.0596°E, 19.4773°S. This represents a reduction in the number of subsidence issues recorded compared with the 17 locations identified along the ROW in 2025. As the subsidence recorded in 2026 was classified as Level 1, the KP 21–22 location should be prioritised for remediation. Consistent with the approach adopted in previous assessments, remediation should include filling and reinstatement of the affected area to achieve a stable surface consistent with the surrounding landform and to minimise the potential for water to concentrate within the depression and contribute to further erosion.

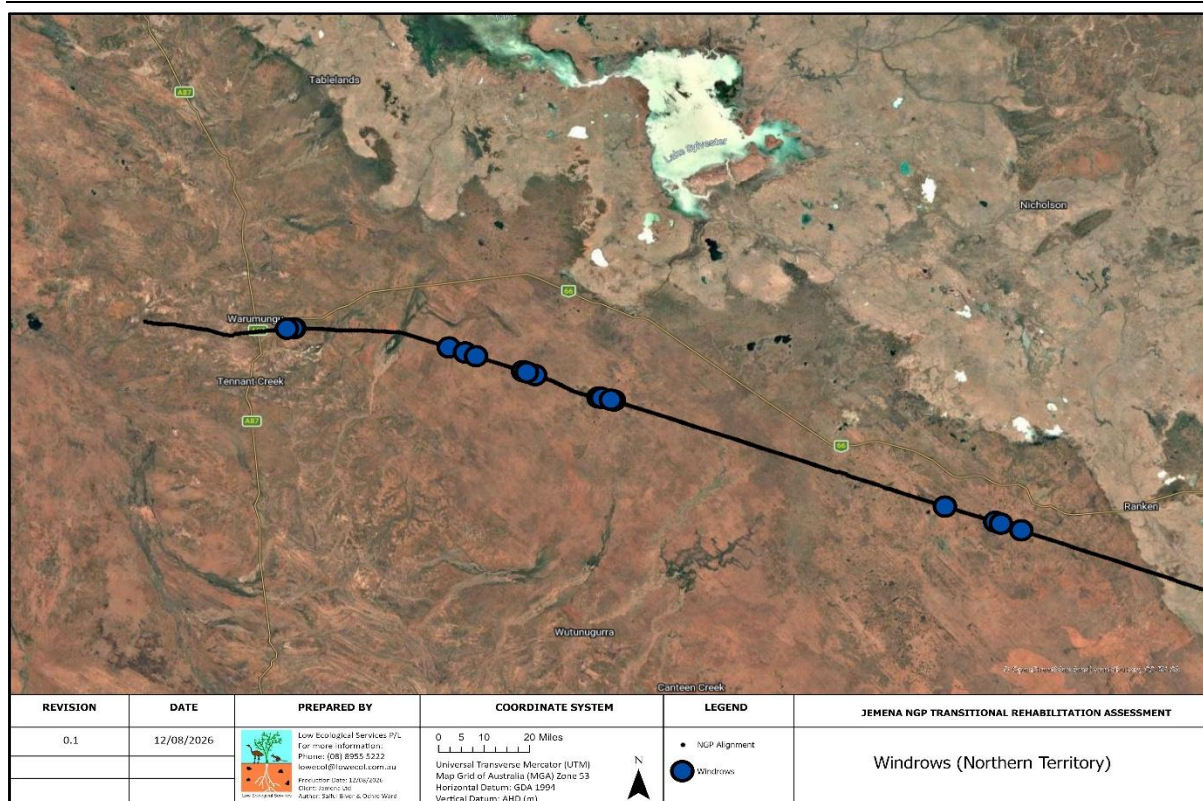
**Figure 5-16: Windrows Locations Recorded along the Northern Territory Section of the NGP ROW, 2026**

Windrows were recorded at 18 locations along the Northern Territory section of the NGP ROW during the 2026 transitional rehabilitation assessment. Windrows generally consist of soil and material pushed to the sides of the ROW during grading and other maintenance activities. Where these features remain along the easement, they can interfere with the natural movement of surface water by preventing runoff from dispersing from the ROW into the surrounding landscape. This can result in water being redirected or concentrated along the easement, increasing the potential for sheet erosion, riling and gully development.

Where windrows are restricting natural drainage or concentrating surface water, they should be pulled back, spread or appropriately breached to allow runoff to disperse into the surrounding landscape. Works should aim to restore the natural surface drainage pattern while minimising additional disturbance to established vegetation and stable ground surfaces. Where suitable, material from windrows may also be redistributed across adjacent areas affected by erosion or topsoil loss, provided the material is appropriate for rehabilitation and its removal does not create additional erosion or drainage issues. Locations of windrows recorded during the 2026 assessment are presented in Figure 5-21, with individual locations and recommended management actions provided in **Appendix H**.

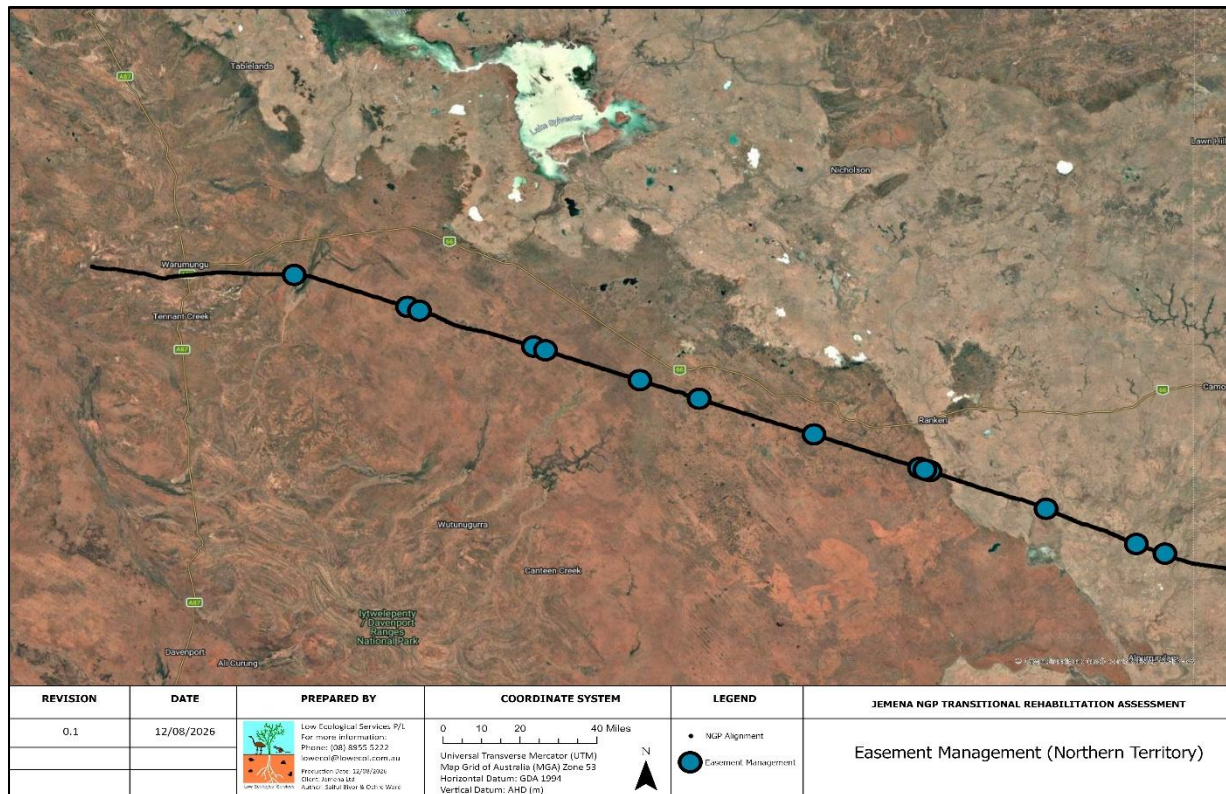
**Figure 5-17: Easement Management Locations Recorded along the Northern Territory Section of the NGP ROW, 2026**

possible vehicle tracks were recorded at approximately 135.516°E and 135.561°E. The tyre tracks at the former location were considered stable due to established vegetation. Continued monitoring of vehicle-affected areas is recommended to identify any subsequent deterioration of ground cover or development of erosion.

Vegetation maintenance requirements varied along the ROW. At approximately 135.916°E, vegetation was approximately knee height and line of sight remained adequate; slashing was therefore not considered immediately necessary but was recommended as a maintenance measure. Other sections, including areas near 134.616°E, 136.139°E and 136.570°E, were identified as requiring slashing. Where weeds occur within areas proposed for slashing, weed control should be undertaken prior to slashing to minimise the potential for weed spread. Slashing should also be undertaken in a manner that avoids scraping or unnecessarily disturbing the soil surface. Localised drainage observations were also recorded. At approximately 136.967°E, sand had accumulated on the upstream side of an existing berm, suggesting that the berm may be influencing local surface-water movement or ponding. A waterway with relatively high banks was also recorded near 137.443°E. These areas should be considered during future inspections to determine whether existing drainage and erosion-control structures are functioning as intended (**Appendix I**).

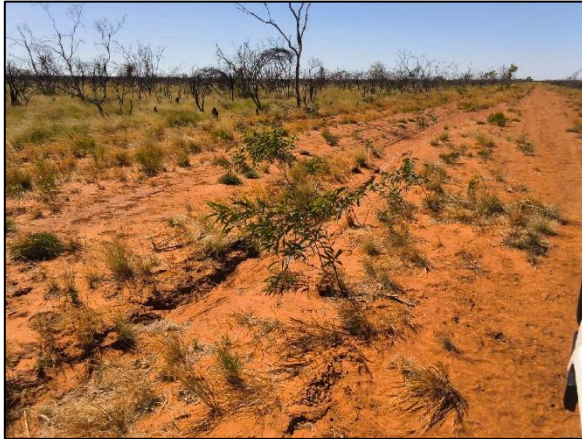
**Photo:** Level 1 & 2 erosion showing a moderate land-stability issue with potential to become significant.

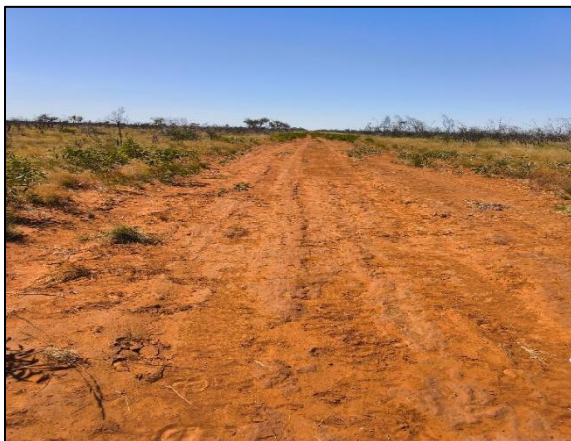
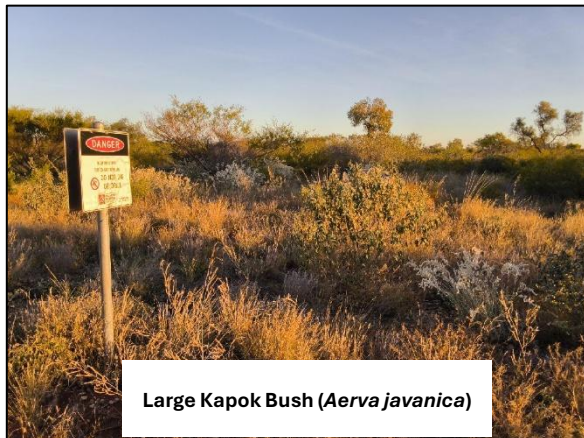
**Photo:** Level 3, 4, 5 erosion showing erosion showing a very minor and locally stable erosion feature.

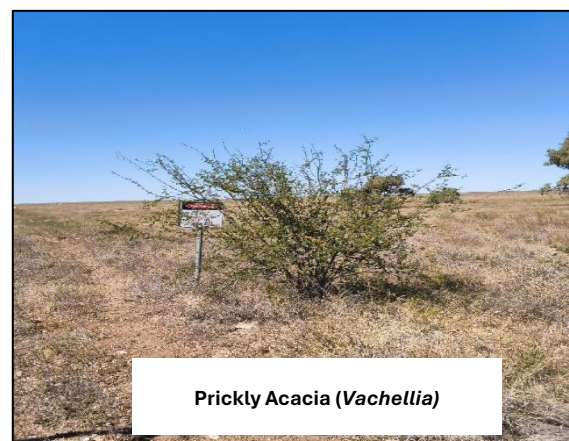
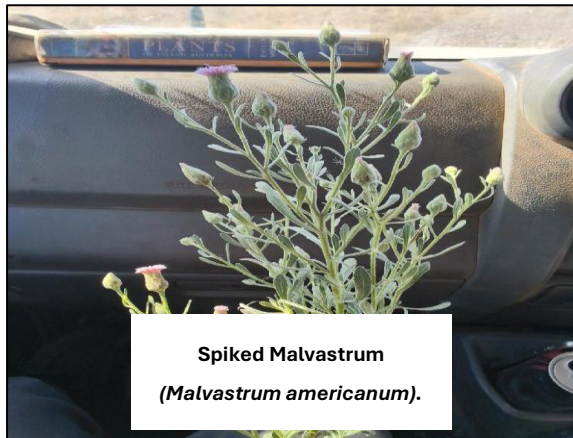
**Photo:** Representative weeds recorded within the eastern section of the NT ROW.

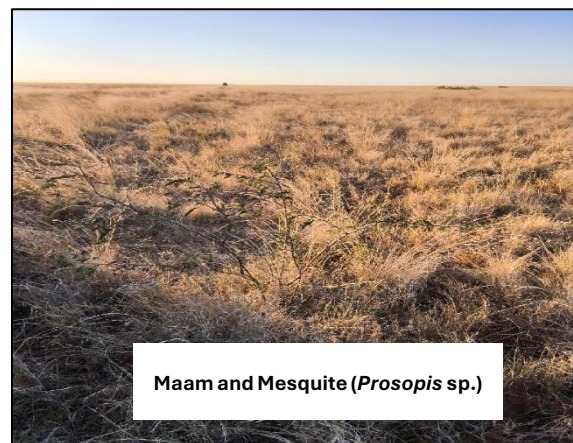
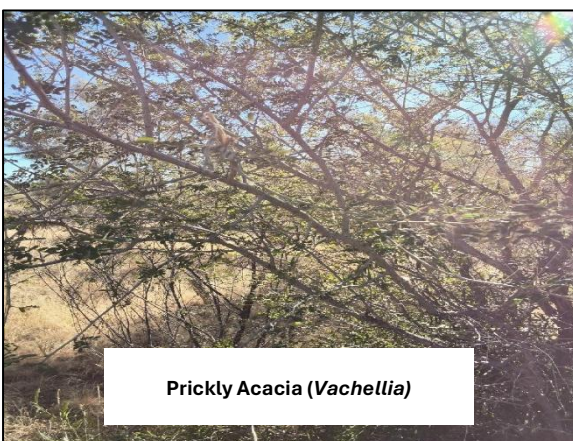
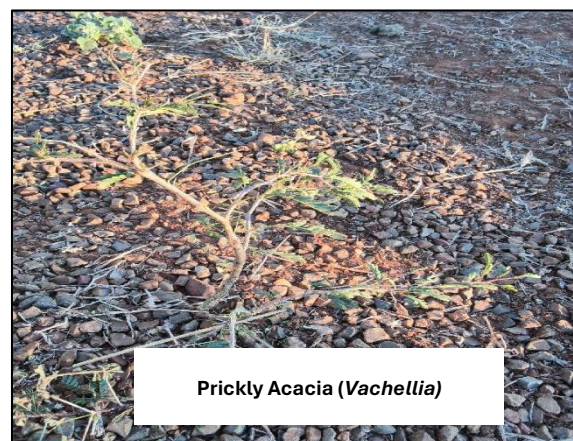
**Photo:** Representative weeds recorded within the eastern section of the NT ROW.
