# **HAZOP Report**

Project Marlin: EGP Reversal

Jemena Ltd

GPA Document No: 20617-REP-020

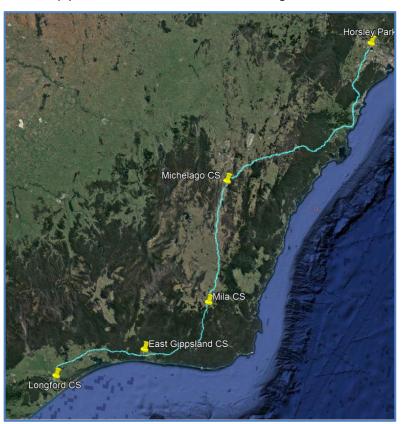
Figure 1: Eastern Gas Pipeline

The EGP, shown in Figure 1, was commissioned in 2000 to supply natural gas from Victoria to the Sydney region. The EGP is a DN450 pipeline with an MAOP of 14,895 kPag.
